# Magnet Fracture within a Magnetically Controlled Growing Rod: A Case Report of a New Mechanism of Failure

**Case Report:** We report a novel mechanism of device failure in a 14-year-old patient following multiple revisions of MCGRs.

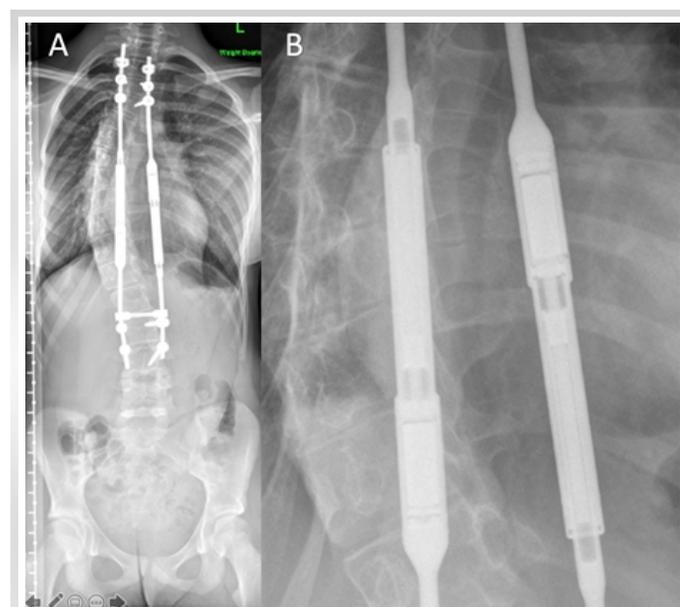
Definitive fusion was performed 18 months after the second revision (39 months after the initial revision) when the patient had reached sufficient skeletal maturity. Radiologically, the rods appeared intact and there was no clinical indication of device failure (Fig. 2). Pre-explantation radiographs demonstrated coronal Cobb angle of 42° with good coronal balance.

**Figure 2:** (a) Anteroposterior whole spine radiograph before explantation with radiologically unremarkable actuator portions (b).

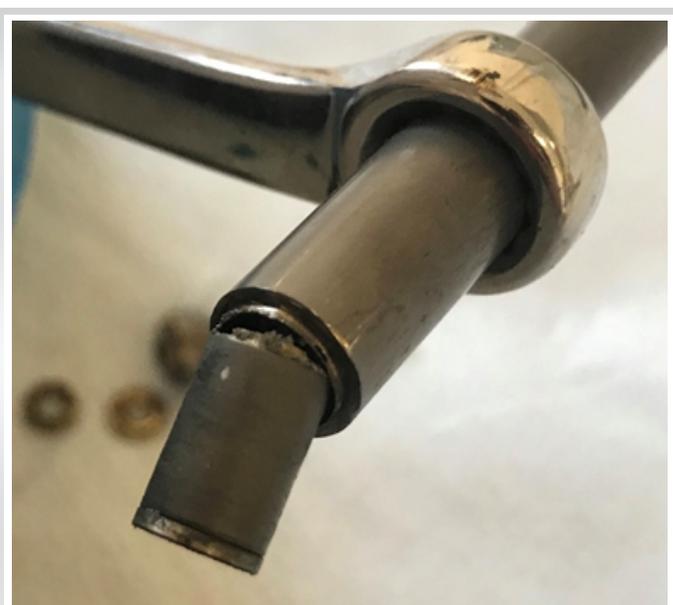
**Figure 3:** The magnet was found to be broken into two pieces in the concave rod, the only example of such to date. Magnet emerging from within actuator outer casing.

was identified within the concave MCGR (Fig. 3). Both rods demonstrated compromise of the sealing mechanism (Fig. 4) and extensive accumulation of black debris. The drive pin was fractured in the concave rod only (Fig. 5).

To date, over 140 MCGRs have been assessed by the retrieval center in Newcastle upon Tyne [9]. However, the phenomenon of complete magnet fracture had not been seen and, to the best of our knowledge, has not been reported in the literature. Other features outlined in Table 1 are more common. The characteristic wear pattern, damage to the radial bearing, O-ring failure, and drive pin fracture have been reported to occur in 100%, 74%, 53%, and 44% of explanted MCGRs, respectively [9]. These features are indicative of offset loading and bending forces placed on the device. Application of these forces across the magnet itself may have driven its failure through fatigue. The fracture point itself appears to be in the center of the magnet in at a junction in the magnet casing. This surface irregularity may indicate notch sensitivity influencing the magnet fracture.
