Unusual Case of Failure of Tibial Polyethylene Insert Locking Mechanism in a Design of Cruciate Retaining Total Knee Arthroplasty – A Case Report

Chandan Mehta¹, Mohan Madhav Desai¹, Kushagra Jain¹, Urvil Shah¹

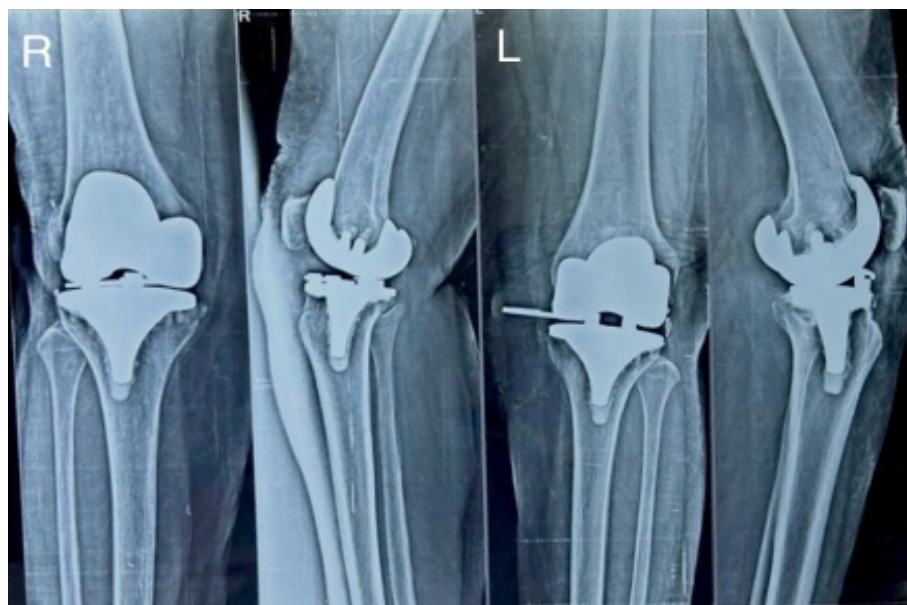
discomfort – with maintained ROM up to 120°. There was a small, localized swelling over medial aspect of knee, which, on superficial palpation, revealed impinging hardware (Fig. 4). Radiographs (Fig. 5) demonstrated the backing out of the locking clip, which is inserted in a medio-lateral manner to keep the polyethylene insert in its place (linear locking mechanism using tongue and groove), with the polyethylene insert being in its place. Immediate post-operative radiographs and radiographs taken at follow-up were examined to confirm the correct initial

Figure 5: Bilateral knee radiograph. On comparing bilateral radiographs, one can see the dislodgement of locking bar.

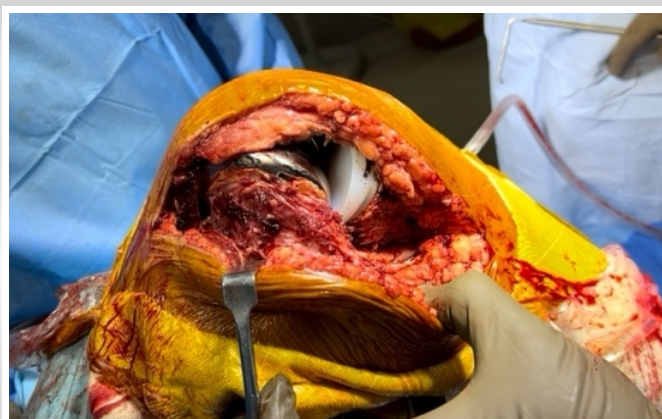
The patient was undertaken for surgery at the earliest possible time, so as to prevent complete perforation of skin and soft-tissue compromise. Medial para-patellar approach through the previous incision was undertaken. Intraoperatively, the locking clip was found to buttonhole through the medial capsule into the subcutaneous tissue (Fig. 6). The polyethylene insert was in its place (Fig. 7) on the tibial baseplate without any evidence of

Figure 6: Intraoperative visualization of the locking clip. Locking-clip button-holed through the medial capsule into the subcutaneous tissue.
