# Awareness of Stress Concentration Points for Prevention and Management of Periprosthetic Fractures Following Plate Installation Reinforcement: A Case Report

Hiroto Taniguchi<sup>1</sup>, Nobuyuki Yoshimoto<sup>1</sup>, Ken Okazaki<sup>2</sup>

## Abstract

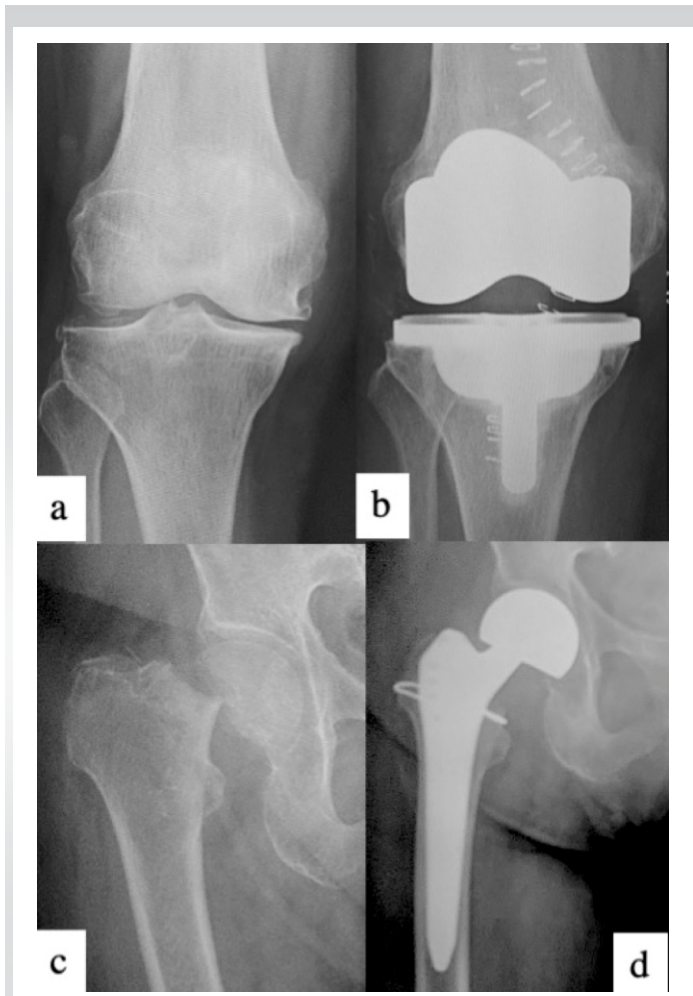
**Figure 1:** Pre-periprosthetic fracture radiographs. (a) Preoperative radiograph of the right knee. Grade III knee osteoarthritis (Kellgren–Lawrence classification). (b) Postoperative radiograph after total knee arthroplasty (NexGen LPS flex®, Zimmer). (c) Radiograph of the femoral neck fracture–Type IV Garden classification. (d) Postoperative radiograph after hip bipolar hemiarthroplasty (Alloclassic®, Zimmer).

surgeries; however, 7 years after her right knee TKA, she sustained a Garden IV right femoral neck fracture due to a fall. The patient underwent BHA on her right hip joint (Fig. 1c and d). Postoperatively, she regained the ability to walk and could live independently at home.

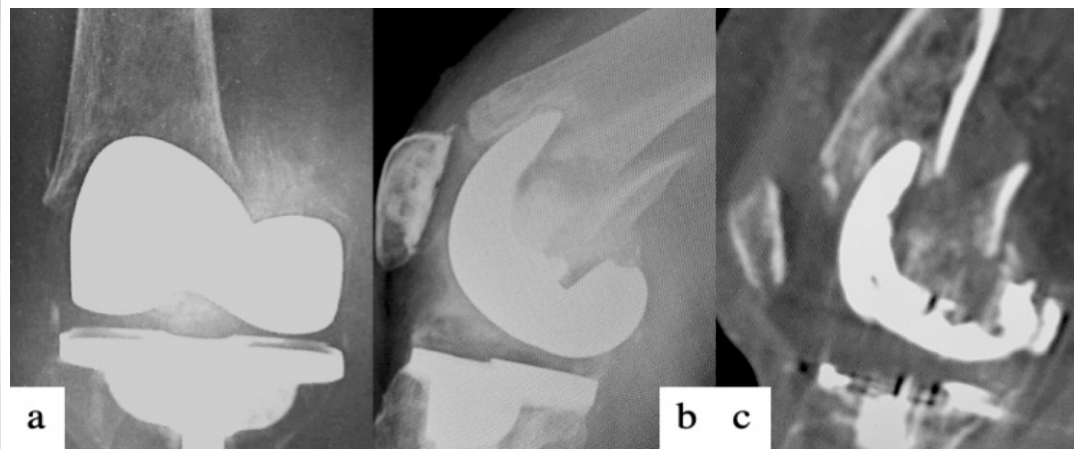
However, at the age of 84 years, that is, 9 years after the right TKA (2 years after BHA), the patient again suffered a fracture due to a fall. On this occasion, it was a periprosthetic fracture of TKA. It was a right femoral condylar fracture (Type III of the Su classification, Fig. 2) [4]. This was not only a knee periprosthetic fracture but also an interprosthetic fracture. In this case, the possibility of osteosynthesis was quite bleak because computed tomography (CT) analysis showed almost no remnant bone tissue in the distal bone fragments (Fig. 2c).

The first periprosthetic fracture in our patient was a Su classification type III fracture.

Some reports have described attempts to perform osteosynthesis for Su type III fractures [4]. However, CT analysis indicated that osteosynthesis was extremely difficult with both intramedullary nails and plates. Additionally, considering bone fragility due to diabetes mellitus and rheumatoid arthritis, strong and tight fixation was unlikely even if osteosynthesis was completed. Furthermore, early ambulation would not have been obtained. In this context, hinge-type TKA contributed to early ambulation. In fact, the patient could regain her walking ability after surgery. Because the risk of interprosthetic fracture increases after the placement of hip and knee prostheses with a stem on the ipsilateral femur, a plate for fracture prevention was installed during hinge-type TKA. Lehmann et al. [6] have conducted a strength simulation study in which a cemented hip stem was inserted into the ipsilateral femur; they compared an intact knee, a knee with a retrograde intramedullary nail, and a knee with a retrograde intramedullary nail and a preventive plate implanted on the lateral side. The results of the four-point bending test showed

**Figure 2:** Preoperative imaging of the first periprosthetic fracture-Type III Su classification. (a) Anteroposterior view; (b) lateral view; (c) sagittal view of computed tomography (CT) multiplanar reconstruction. A comminuted fracture of the femoral condyle is observed, and a few bone beds were observed in the distal fracture fragment. CT: Computed tomography.

Therefore, we planned a revision TKA surgery with a hinge-type prosthesis. However, a BHA stem was already installed in the proximal femur; therefore, the implantation of a hinged prosthesis stem would have increased the stress on the femoral diaphysis between the stem tips. According to the protocol described elsewhere [1, 5, 6, 7], we installed a locking compression plate (LCP) to prevent interprosthetic fractures. The length of the plate was designed to ensure the overlap of the BHA stem by a certain distance [8]. We used more monocortical screws for plate fixation to stabilize the plate on the surface of the bone. Therefore, only one cerclage positioning pin and one metal cable were installed; and, several 5-mm ultra-high-molecular-weight polyethylene cables (Nesplon cable®) were used to bind the LCP to the diaphysis (Fig. 3).

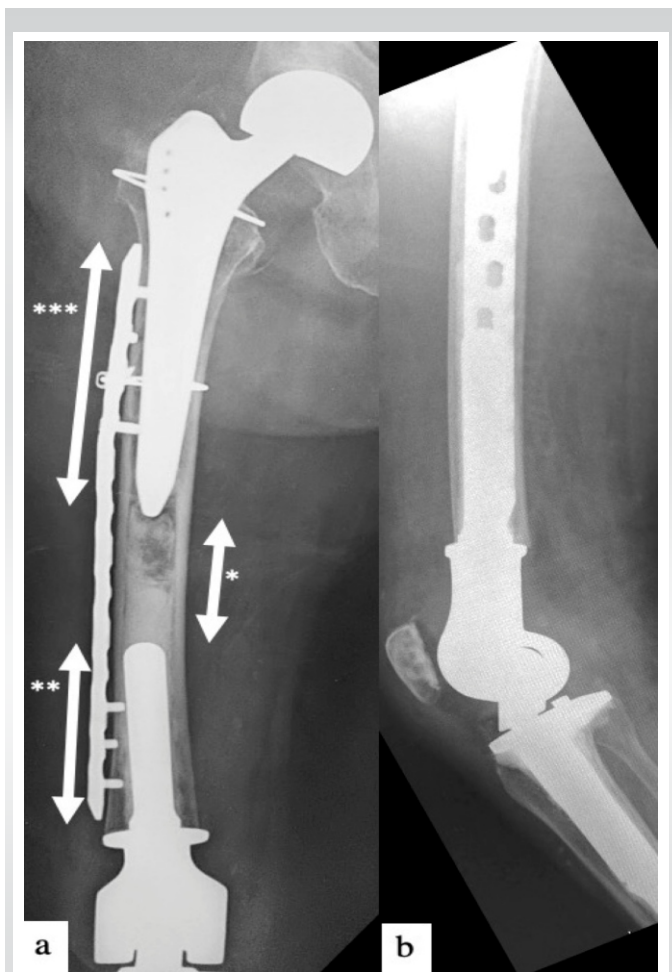
**Figure 3:** Postoperative radiographs of the first periprosthetic fracture. Revision total knee arthroplasty using stemmed and hinge-type prosthesis (OSS®, Zimmer Biomet) and reinforce plate installation using the locking compression plate plating system® (Depuy Synthes) with a metal wiring system and four Nesplon cables® (ultra-high-molecular-weight polyethylene cable, Alfresa) (two cables were used at the proximal overlapping site and the other two were used at the distal site). (a) Anteroposterior view. Single asterisk indicates the distance between the stem tips (53 mm). Double (77 mm) and triple (108 mm) asterisks indicate the overlap distance between the tips of the plate and the hip stem. (b) Lateral view.

Our plate positioning was >6 cm overlapping (108 mm) (Fig.

3a); therefore, there seemed to be no problem with the overlapping distance; however, periprosthetic fractures could not be prevented, although interprosthetic fractures could be prevented.

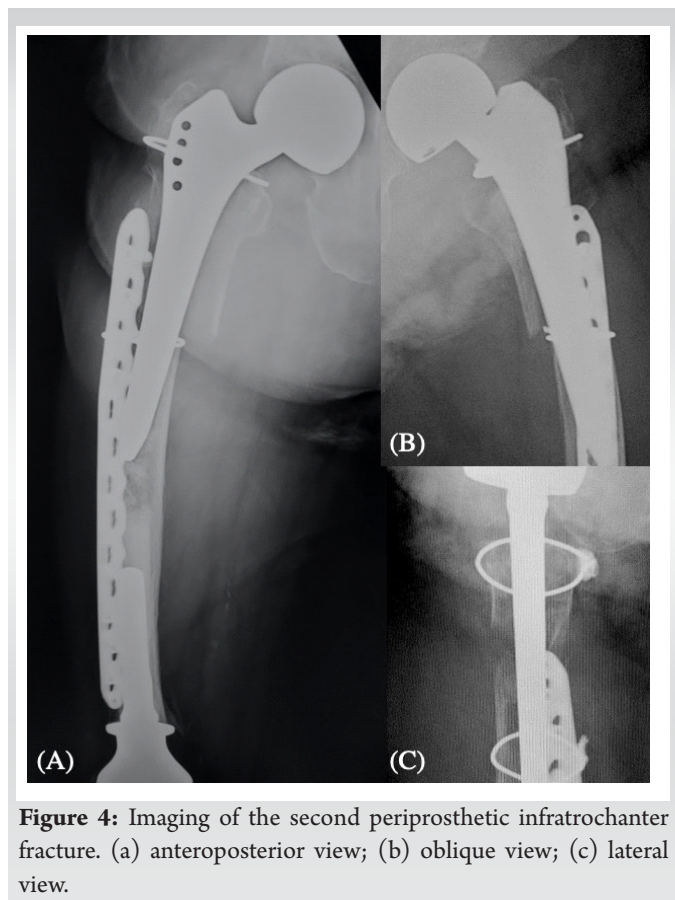
However, at the age of 85 years, that is, 6 months after returning to her home life, the patient again sustained a fracture due to a fall at home. It was an infratrochanteric fracture of her right femur (Vancouver type B2) [9], which occurred near the upper edge of the previously installed preventive plate (Fig. 4). Owing to her old age, we considered total femoral replacement to be highly invasive and opted for osteosynthesis.

**Figure 4:** Imaging of the second periprosthetic infratrochanter fracture. (a) anteroposterior view; (b) oblique view; (c) lateral view.

The second periprosthetic fracture was diagnosed as Vancouver classification type B2. Revision surgery using a long stem is generally recommended for this type of fracture [10]. However, highly invasive procedures, such as stem revision surgery, should be avoided in this setting. Osteosynthesis was completed in this case; however, the patient's walking ability could not be regained. In the literature, osteosynthesis is considered acceptable for this type of fracture in patients with low activity [11]. Therefore, osteosynthesis is relevant in particular cases.

Soenen et al. [7] have developed a model in which a femoral implant of TKA with a stem was inserted into the ipsilateral femur with the THA or BHA stem inserted in the proximal site of the femur. Simulation studies were conducted to replicate walking, lateral fall, and four-point bending loads to evaluate the stress applied to the femoral shaft between the stems by changing the length of the stems for TKA. The results showed that during walking, the stress is dispersed throughout the femur bone without hip and knee prostheses; however, upon installation of the hip joint stem and the elongation of the femoral stem of TKA, the stress is concentrated at the diaphysis between the stem tips. Additionally, in the four-point bending test, the risk of fracture increased as the cutoff value was set to 110 mm between the stems. Therefore, the authors recommended securing a stem tip distance of  $\geq 110$  mm. Furthermore, on simulation of lateral fall, the stress was found to be concentrated on the femoral neck in the absence of any hip stem; however, after the insertion of a hip stem, the stress was largely concentrated on the infratrochanter. Considering that the fracture site at the proximal end of the plate was in the

infratrochanter (an area with a high propensity for stress concentration according to Soenen's study [7]), the occurrence of fractures at this site may not have been entirely accidental. Considering that in a case of hip stem installation, the stress caused by a fall is concentrated on the infratrochanter, this plate reinforcement should have extended to a more upper level to the trochanter; this is a point to reflect in the future. However, this fracture may have occurred even if the range of the plate was long enough. In a study by Zuurmond et al. [3], 14% of patients who underwent surgery for periprosthetic fracture were reoperated due to refracture or implant failure. Generally, periprosthetic fractures in elderly patients will lead to complications, such as infection, pseudoarthrosis, rupture of the fixation site, and re-fall; thus, highly invasive surgeries should be avoided in elderly patients [1, 2]. Therefore, it is considered that the surgical procedure and the degree of invasion must be customized according to the characteristics of each case.

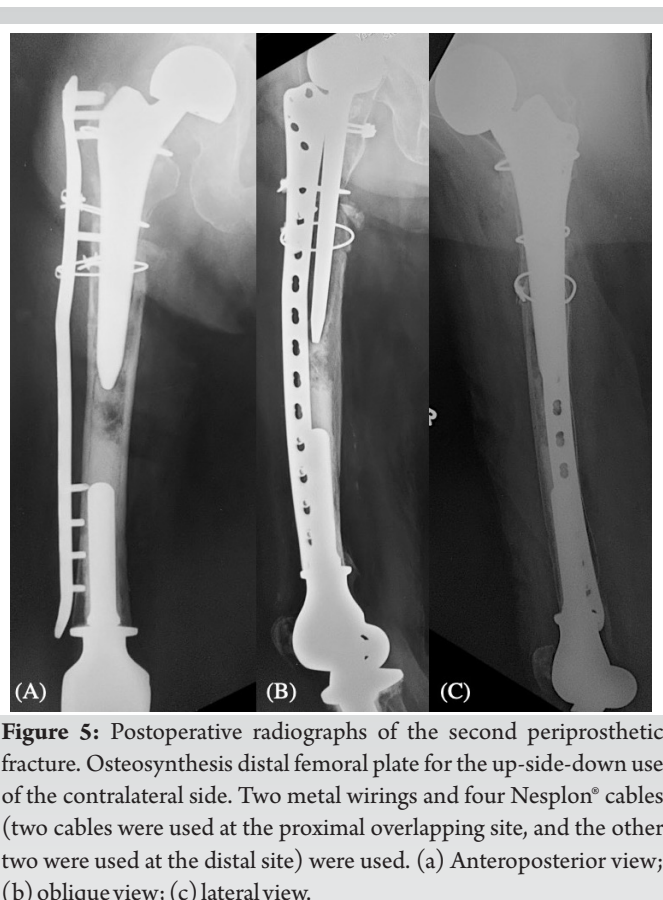
**Figure 5:** Postoperative radiographs of the second periprosthetic fracture. Osteosynthesis distal femoral plate for the up-side-down use of the contralateral side. Two metal wirings and four Nesplon® cables (two cables were used at the proximal overlapping site, and the other two were used at the distal site) were used. (a) Anteroposterior view; (b) oblique view; (c) lateral view.

Intraoperative findings showed that the BHA Zweymuller-type stem was stable after fracture reduction and was preserved; therefore, we could complete osteosynthesis. We installed an up-side-down plate using a left-side distal femur fixation LCP for the right proximal femur. As a previous surgery, we used several polyethylene and metal cables to bind the plate and diaphysis. The range of plate fixation was extended from the infratrochanter to the greater trochanter (Fig. 5).
