An Unusual Case of Onlay Reverse Shoulder Arthroplasty Disassembly Due to Cement Interposition. A Case Report

Learning Point of the Article:

The interposition of cement can cause the disengagement of components of a humeral stem and its respective tray when it expands.

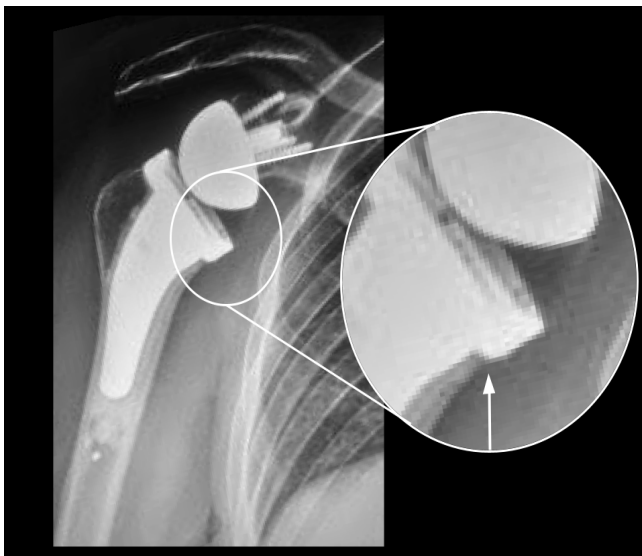
Figure 1: 6-month follow-up X-rays control. An anteroposterior radiograph of the right shoulder shows an adequate position of both the humeral and glenoid components with no signs of loosening.

At the 6-month follow-up, the patient reported 80% of satisfaction and scored 3 in visual analog scale. Shoulder range of motion was measured as 150° of elevation and abduction, 20° of external rotation, and internal rotation to the LS level. Radiographic control was also consistent with the found outcomes (Fig. 1).

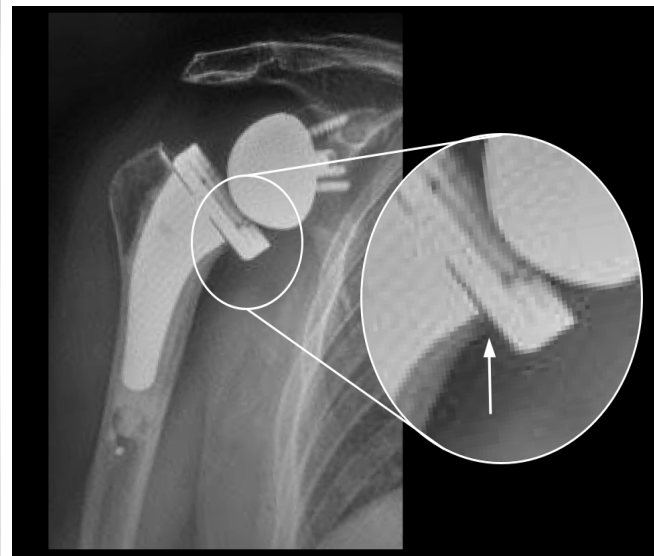
Figure 2: 7-month follow-up X-rays control after a sudden onset of pain and loss of shoulder function. An anteroposterior radiograph of the right shoulder shows a rotation of the metaphyseal plateau around the stem.

One month after, because of sudden onset of pain and loss of shoulder function in the absence of any history of trauma or fever and chills, the patient returned for a follow-up visit. Objective findings on physical examination included maximal elevation and abduction of the arm at 90°, 10° external rotation, and internal rotation to the buttock. Passive range of motion was limited and associated with pain. Radiological imaging demonstrated a rotation of the metaphyseal plateau around the stem (Fig. 2).

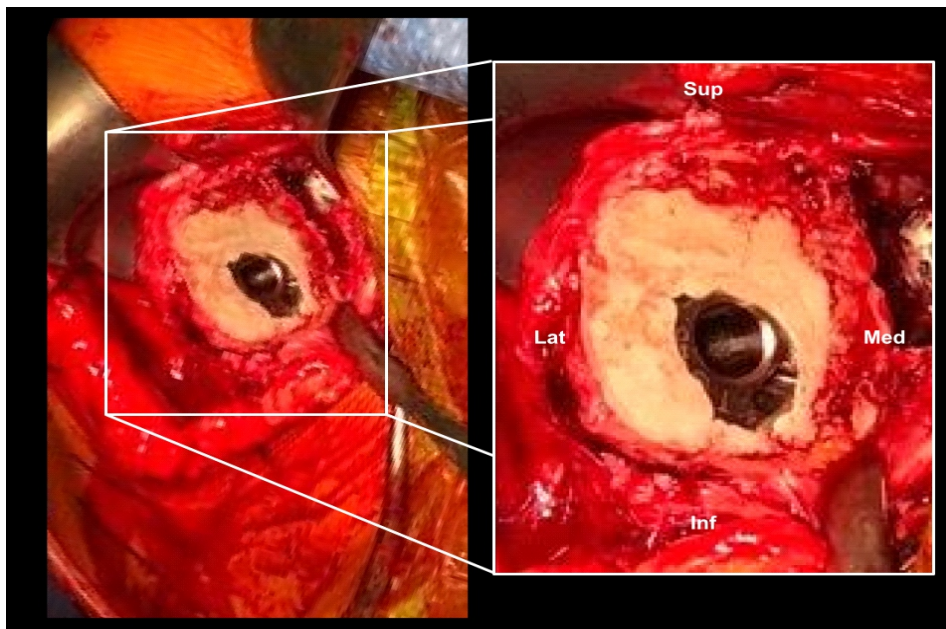
Figure 3: Intraoperative images of reverse shoulder arthroplasty revision surgery. It can be appreciated the interposition of cement covering the coupling surface of the stem.

standard precautionary measure, which ultimately resulted in a negative report after an extended culture period. During the inspection, it was detected an interposition of cement backflow between the tray and the stem which had expanded and decoupled the taper bond (Fig. 3). The cement interface was meticulously removed using an osteotome, the metaphysis was reamed, the stem was well fixed and retained, and a new tray and polyethylene liner of the same size were impacted. The remaining steps of the procedure were carried out according to standard care, and rehabilitation was resumed.

Regarding the cause of the humeral metaphysis disassembly presented in this case report; the identified cause was the interposition of cement between the humeral stem and its metaphysis during implantation, which expanded during the setting phase, generating enough pressure to disassemble the Morse taper junction. A similar complication has been reported in knee prostheses where the cement interposition generated mismatches between the liner and the tibial plateau [18, 19, 20].

However, unlike knee prostheses which can limit the visibility of cement fragments on the posterior surface, the base of the humeral stem is directly visible when impacting the metaphysics, making it difficult to avoid recognizing that cement is interposed. Analysis of the previous studies has indicated that the use of cementless fixation of humeral components in RSA may be preferable to cement fixation, as it carries a reduced risk of complications arising from the treatment of rotator cuff arthropathy [21]. Therefore, avoiding the use of cement whenever possible when using this type of implant is therefore recommended, and if required because of poor bone quality, it is recommended that the humeral stem should be placed first, and once the cement has set, the humeral tray may be impacted.

To prevent a cement interposition between the humeral stem and its humeral trail in an RSA, a two-step implantation procedure is recommended, which consists in cementing the stem before inserting the metaphyseal tray.
