A Case of Varus Collapse and Bone Defects in Revision Total Knee Arthroplasty, after 12 Years of Primary Total Knee Replacement: Surgical Challenge and Bailout

Keywords: Varus collapse, bone defects, revision total knee arthroplasty.

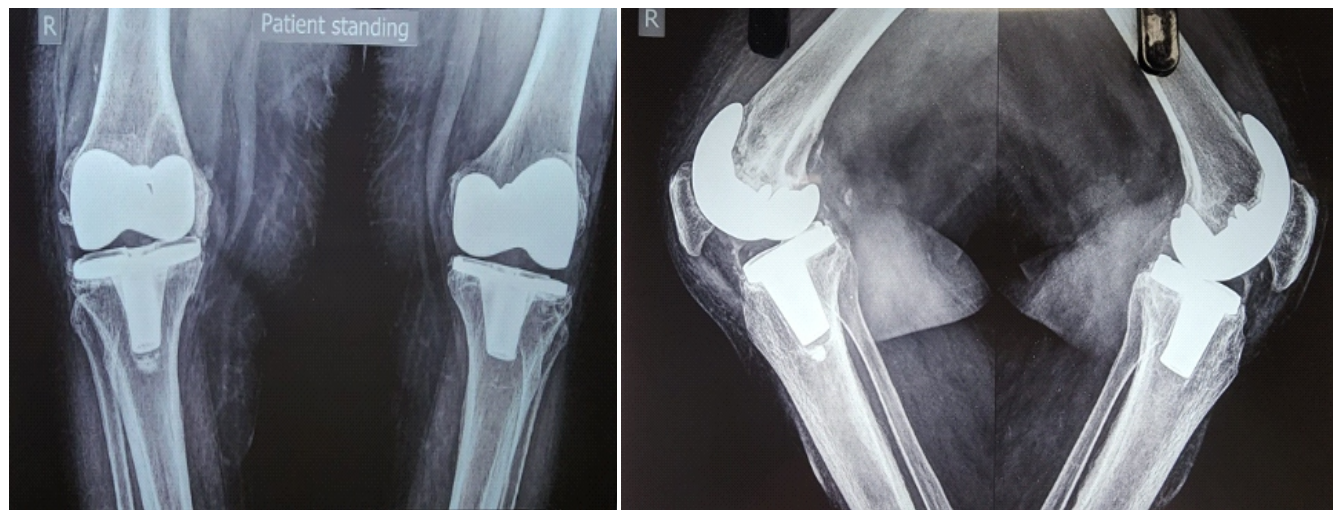
Figure 1: Pre-operative X-rays (anterior-posterior and lateral views of both knee joints).

arthroplasty presented with a limping gate with radiological evidence of medial femoral bone collapse and implant loosening. Appropriate pre-operative workup of the case was done along with the counseling for the revision surgery (Fig. 1).

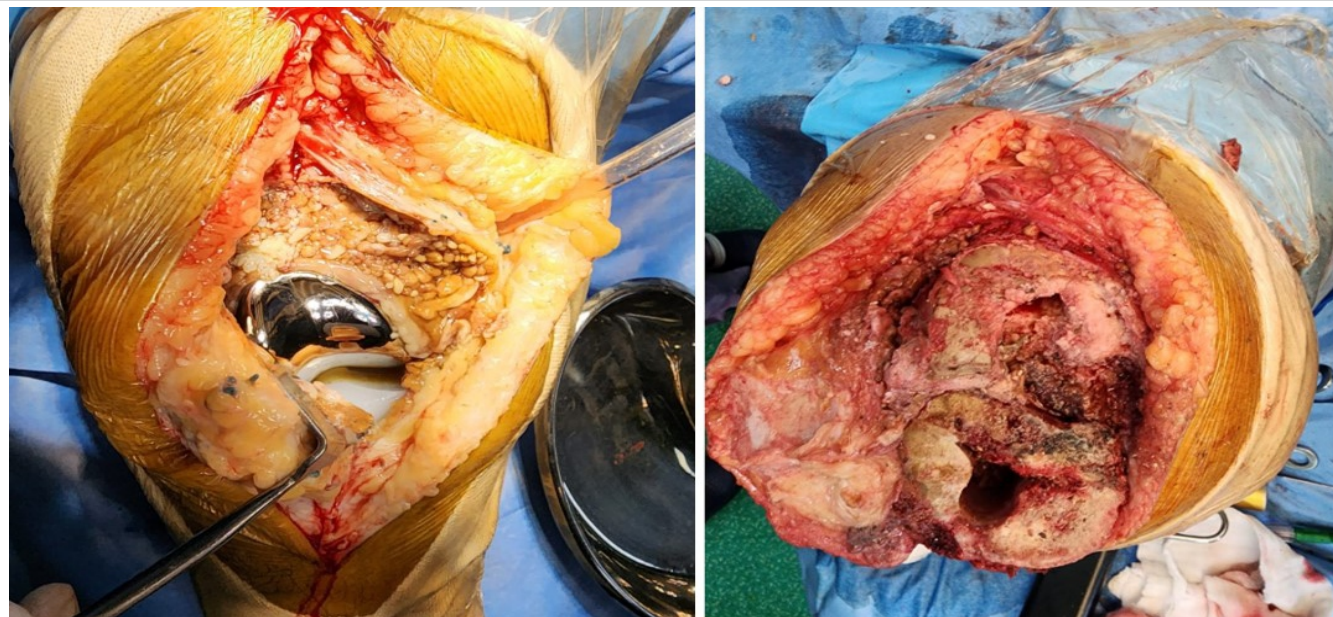
Intraoperatively, we discovered that the femoral implant was loose, but bone loss was still present (Fig. 2) Implant loosening does not always indicate that bone is preserved. Removing the well-fixed tibial implant was a challenge, and we used a thin saw blade meticulously and patiently around the stem to avoid any bone loss. It is essential to clear the tibial canal using a thin saw blade with curettage and ensure proper cementation of the new

Figure 2: Intra-operative images showing synovitis and bone loss.

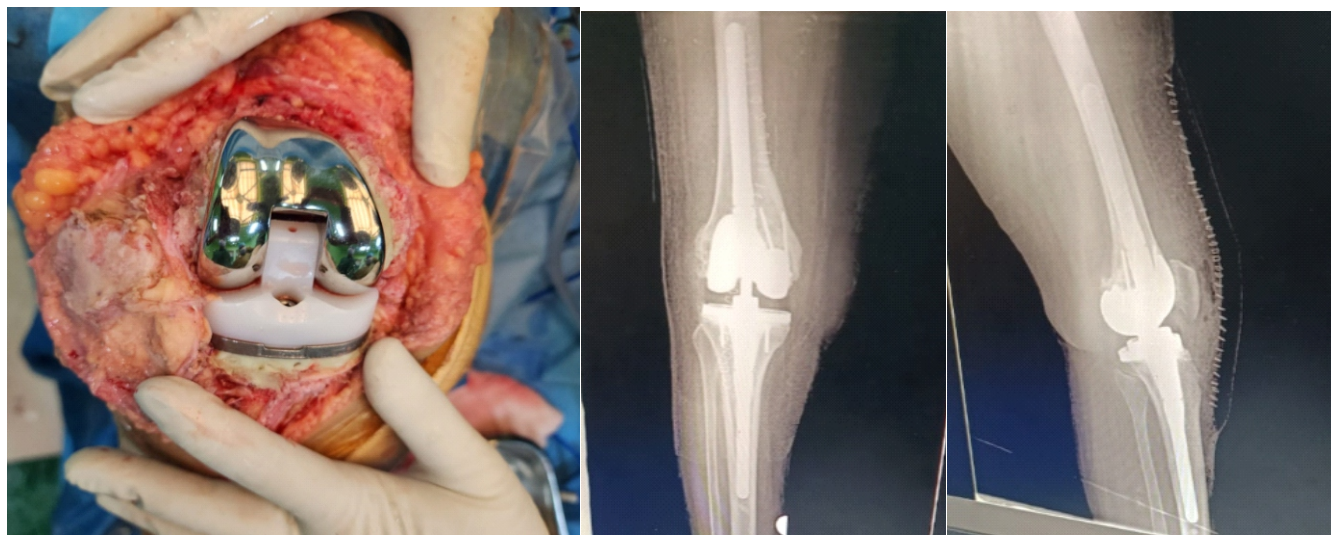
Figure 3: Post-implant intraoperative images and post-operative X-rays.

To prevent collapse due to bone loss, we utilized stems (Stryker LCCK implant) on both sides and additional screws on the medial femoral end, along with cement to fill the gap (Fig. 3). Ideally, appropriate cones and wedges should be used, but due to economic constraints, we were unable to do so but clinically constrict was very stable. We opted for a semi-constrained type of implant to improve stability, which can be avoided if stability is good intra-operatively. Thicker stems were used in our case for additional stability. The post-operative period was uneventful and periodic follow-up was done. After 5 years of follow-up, the patient is doing well with a painless full range of

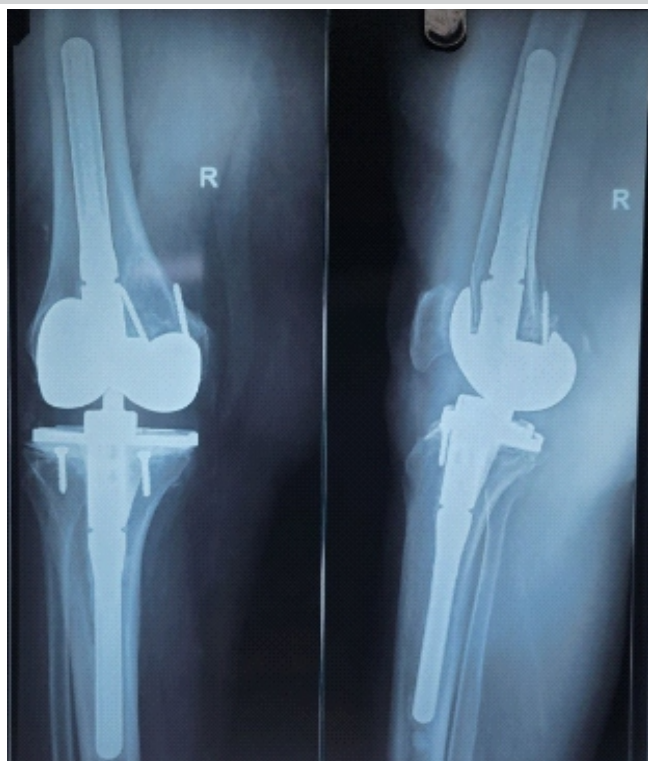
movement of the knee joint (Fig. 4).

Figure 4: 5-year follow-up X-rays showing implant in well position.
