Novel Strategy for Incarcerated Broken Broach Retrieval in Total Hip Arthroplasty

Sanjay Agarwala¹, Avinashdev D Upadhyay¹, Mayank Vijayvargiya¹

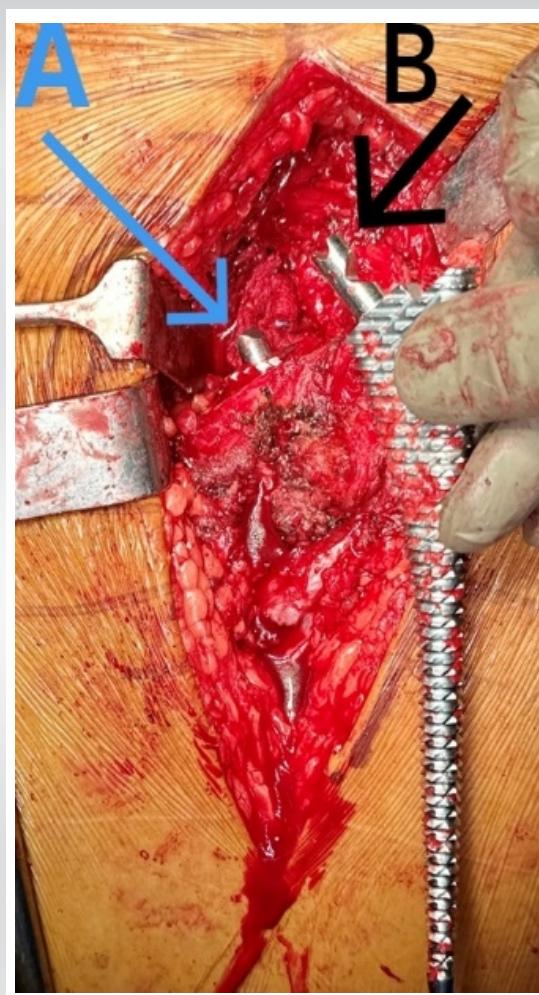
Figure 1: (a) Blue arrow showing Trunnion fracture at U-shaped recess (b) Black arrow showing another broach for comparison.

Femoral preparation involved using a femoral canal reamer up to size 13, followed by sequential broaching up to size 13. However, the final size 13 broach fractured at the broach trunnion during extraction (Fig. 1a). Attempts to extract the broach by gripping the remaining broken trunnion of the broach with the help of a vise grip orthopedic plier were unsuccessful. The design of the broach of this system has a small hole in the shoulder of the broach (Fig. 2). However, this was not accessible as the broach was buried in the metaphyseal area. To address this, a cortical window of approximately 2 cm × 1 cm was created using a Midas Rex Burr to expose the hole (Fig. 3a). A Kuntscher nail extractor (Fig. 4) was then hooked into the hole (Fig. 3b) and back hammered, successfully extracting the broach (Fig. 5).

Moreover, the occurrence of a broach fracture may be attributed to metal fatigue resulting from repeated use of the same instrument in multiple cases and exposure to multiple sterilization cycles. Broach fractures commonly occur at the U-shaped recess on the superior part of the broach, designed to attach the insertion handle, which is identified as the weakest part of the broach assembly. This portion of the trunnion has decreased material strength and is prone to excessive shear forces generated during broaching, thereby increasing the likelihood of failure [5-9].

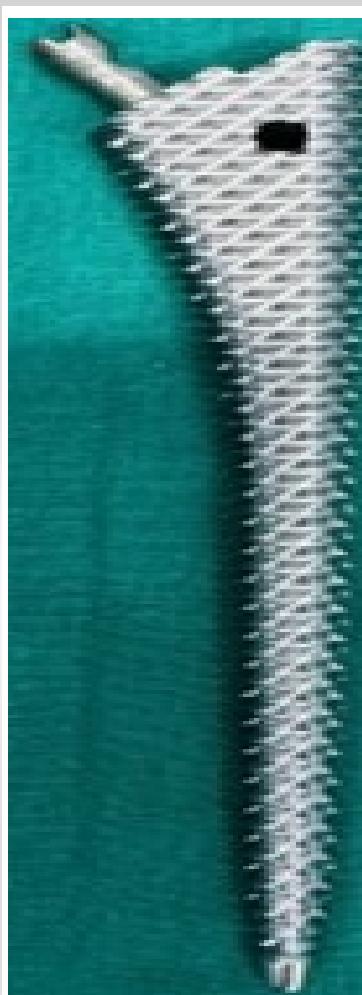
Figure 2: Showing a hole in the shoulder of the broach, which helped in broach removal.

In personal communication with Smith and Nephew company, we shared our interesting experience of a broach fracture and inquired about the rationale behind designing a hole in the shoulder of the broach. The designer clarified that the hole in the shoulder was intended to regulate the metal temperature when exiting an autoclave cycle, preventing material fatigue. The designer emphasized that the hole was not designed for the extraction of the broken broach.

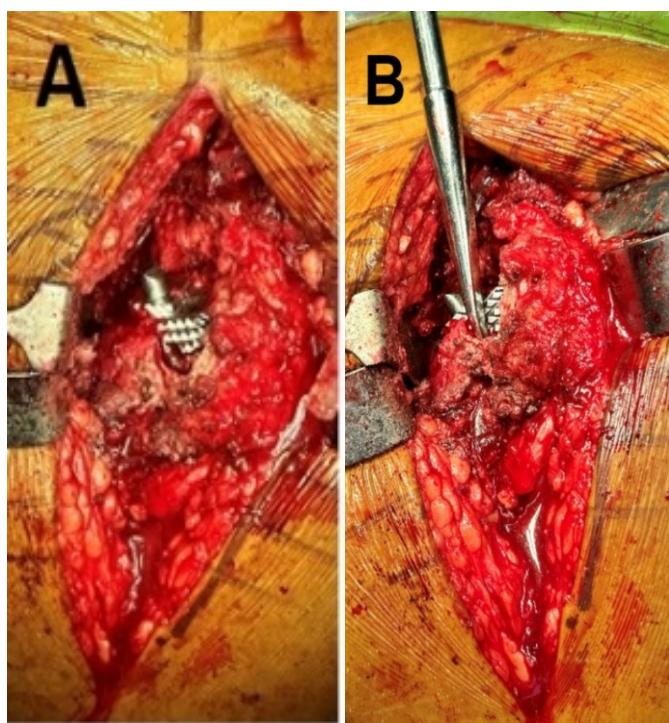
Figure 3: (a) Cortical window near the proximal part of the femur to expose the hole (b) showing the Kuntscher nail extractor engaged in the hole of the broach to remove the broach.

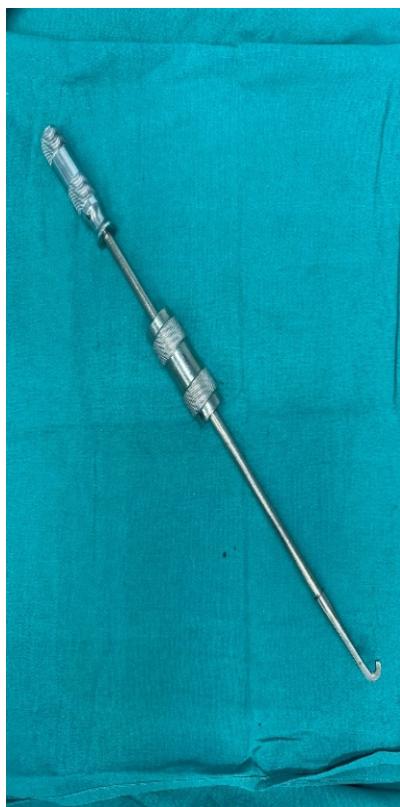
Figure 4: Kuntscher nail extractor used to remove the fractured broach.

We have introduced a technique of creating a small cortical bone window and extraction of the fractured broach using a Kuntscher nail extractor. This method did not significantly impact operative time, blood loss, pain management, or the post-operative rehab protocol. Importantly, it did not necessitate an extended surgical incision, the use of an extended

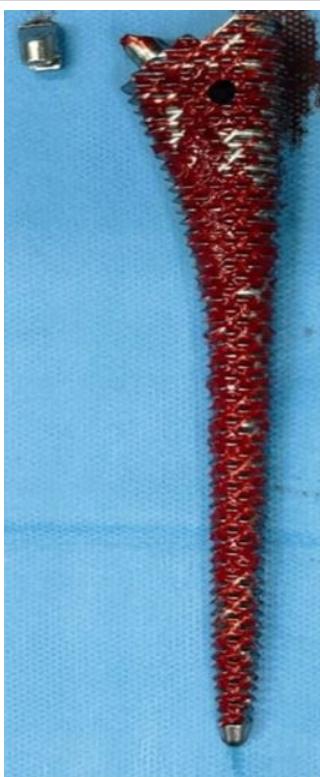
Figure 5: Showing the extracted broken broach.

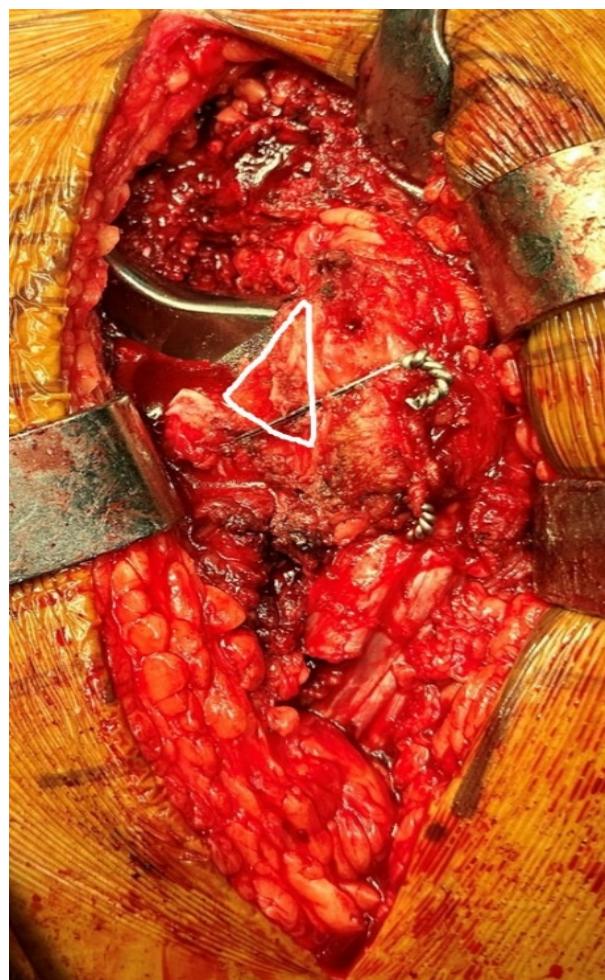
Figure 6: The white marked area shows an autogenous bone graft from the head of the femur applied at the cortical window and secured using 1.5 mm stainless steel wire.

femoral component of the same size as the last broach was implanted and found stable; a ceramic head (Oxinium, Smith and NephewR) size 36 mm/+0 was used. The cortical window was grafted with an autogenous bone graft from the femur head and was secured using 1.5 mm stainless steel wire (Fig. 6). The surgical time was 80 min, and the estimated blood loss was 100 mL. The post-operative X-ray (Fig. 7) was satisfactory, with excellent implant alignment and position. The patient was mobilized to bear full weight on the day of surgery, experiencing an uneventful post-operative recovery and resuming his routine activities 1 month after the procedure. At the 2-year follow-up, the patient remained asymptomatic, demonstrating satisfactory hip function and radiographic stability of the implant (Fig. 8).

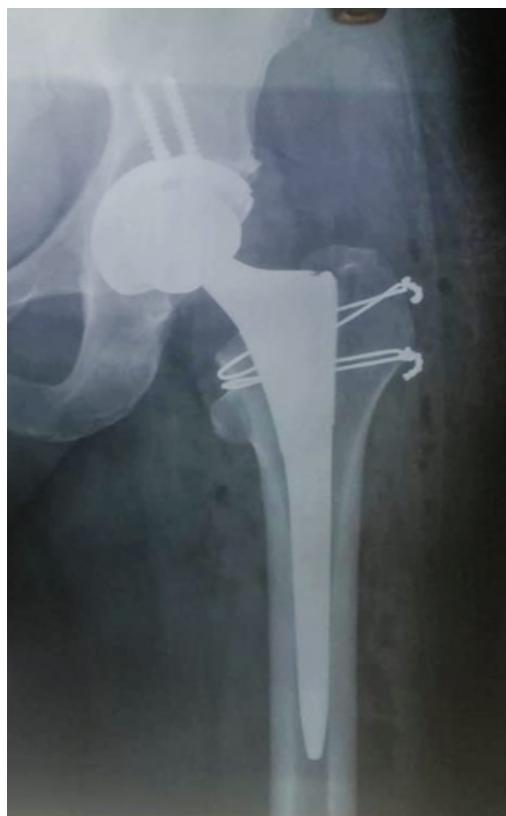
Figure 7: Post-operative X-ray.

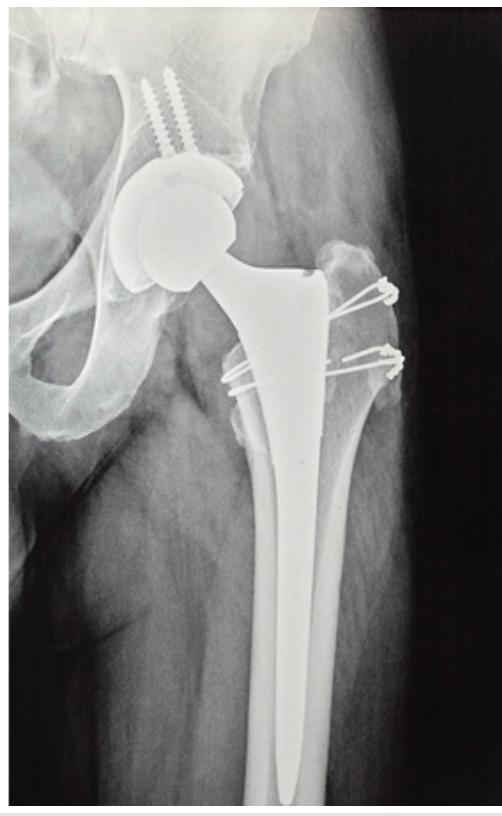
Figure 8: 2-year follow-up X-ray.
