Removal of Hartshill Rectangle and Wires with Revision Pedicle Screw Fixation: Technical Challenges, Safety Considerations, and Clinical Outcomes in Complex Spinal Reconstruction – A Case Report

Ajay Kothari¹, Siddharth Aiyer¹, Parth K Shah¹, Parag Sancheti²

Keywords: Hartshill rectangle, o-arm navigation, revision surgery.

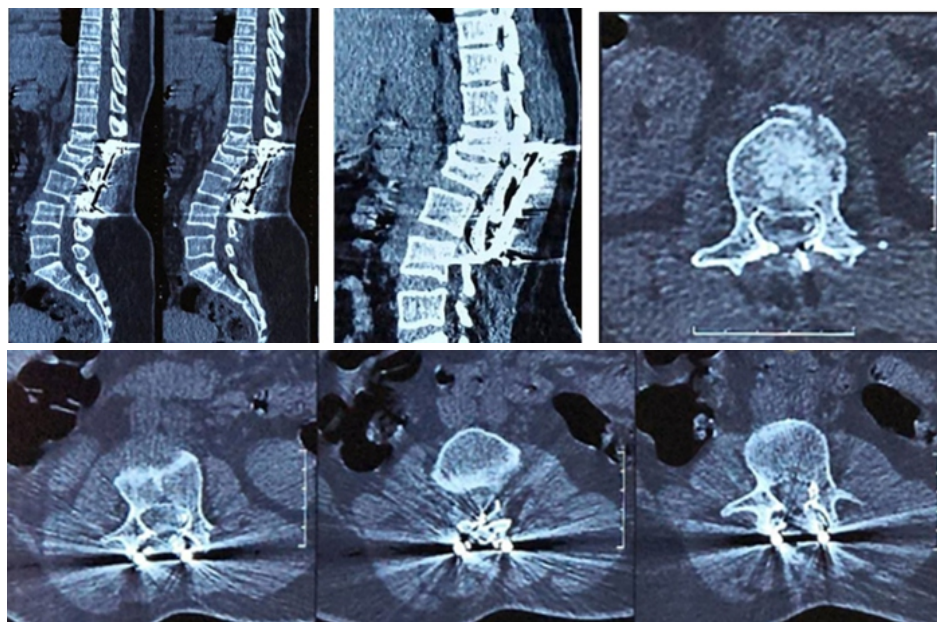
Figure 2: Computed tomography myelography showing no significant canal compression

We took a radiograph (Fig. 1), which indicated a previous L2–L4 Hartshill with sublaminar wires operation 15 years ago for an acute L2 burst fracture. At that time, the patient had left-sided knee extension and ankle dorsiflexion weakness 3/5, with left lower-limb radicular pain. After Hartshill with sublaminar wire, the patient recovered. Due to unsatisfactory visibility in magnetic resonance imaging (MRI) with Hartshill in situ, we chose computed tomography (CT) myelography (Fig. 2), which revealed an L1 burst fracture.

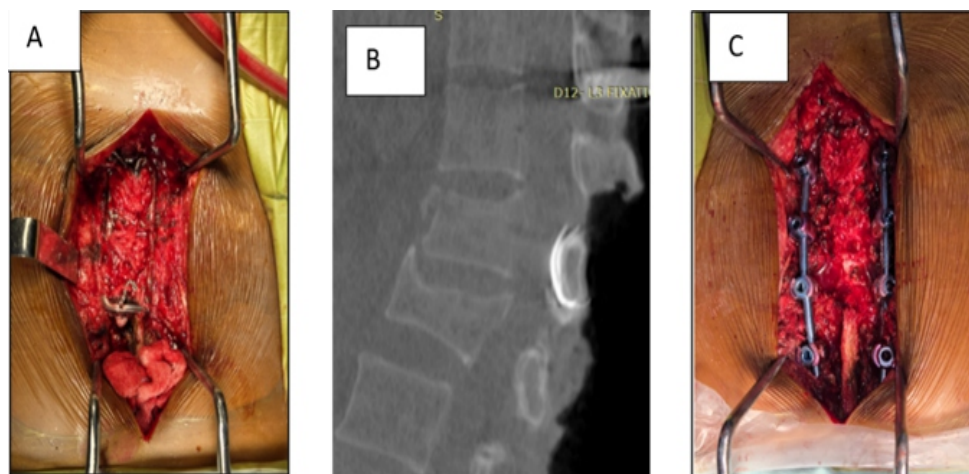
Figure 3: [A] Hartshill rectangle with sublaminar wire, [B] Broken sublaminar wire seen on computed tomography scan under O-arm navigation, [C] Final construct with pedicle screws and rods

stainless steel implant. We have to expose the rods from adherent tissue. The Hartshill rectangle was exposed (Fig. 3a), and the laminar wires looped over the implant were cut. We have to cut the laminar wires just below the knot, or if we cannot access the part below the knot, we have to unwind it to remove it. If we forcibly try to remove the wire, it will cause iatrogenic dural damage. Hartshill rectangle removed. Inside the canal, it was discovered that the L2 and L3 sublaminar wires were broken (Fig. 3b). Sublaminar wires have now been confirmed to be located beneath the lamina with the aid of O-arm navigation. Burr was used to carefully remove the window that was created over the wires. The O-arm is very useful for removing the wires;

otherwise, we would have to perform a laminectomy, which was a challenging procedure since epidural fibrosis develops over time when sublaminar wires are present. There is a potential that a dural tear could occur during a laminectomy. After the implant was removed, all of the tissues impacted by Hartshill's metallosis were likewise removed. Rods were fastened after the pedicle screw from D12 to L3 was placed. Over the contoured rods, we have observed a nice reduction in fracture (Fig. 3c).

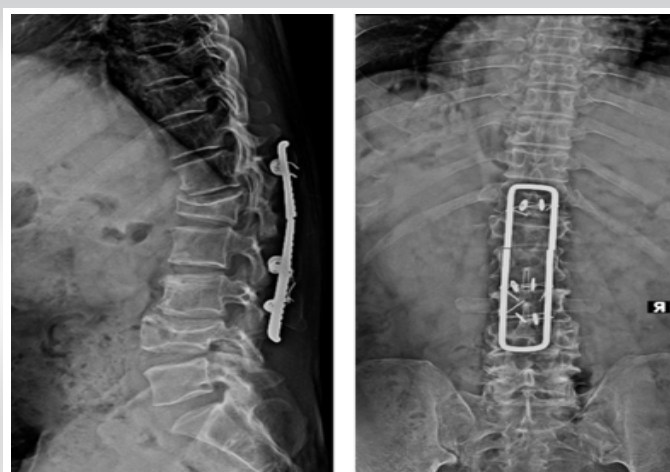
Figure 5: Pre-operative X-rays

Radiographs were taken (Fig. 5), and they revealed that the procedure was previously performed from D12 to L4 with Hartshill rectangle and spinous process wires, with burst fractures of L1 and L4, implant back out, and breakage. An MRI and CT scan were done (Fig. 6), which showed cord compression at the D12 level due to implant breakage and kyphotic deformity at the proximal junctional level. The patient explained about the surgical intervention in the form of implant removal and instrumented fixation with decompression.

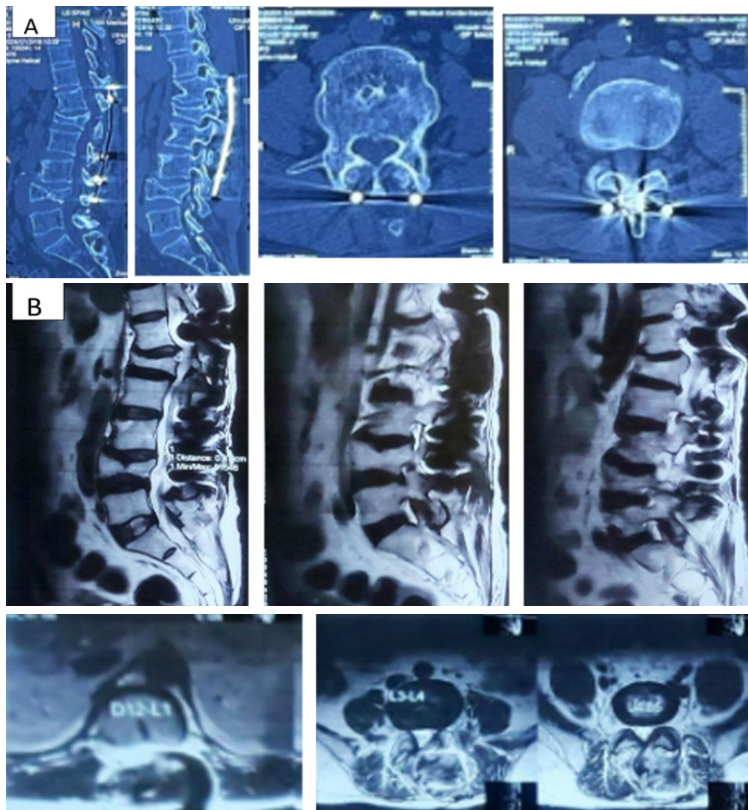
Figure 6: [A] Computed tomography scan showing retro pulsed fragment at L1 and L4. [B] Magnetic resonance imaging showing cord compression at D12-L1 level and both-sided foraminal stenosis at L4-L5 level.

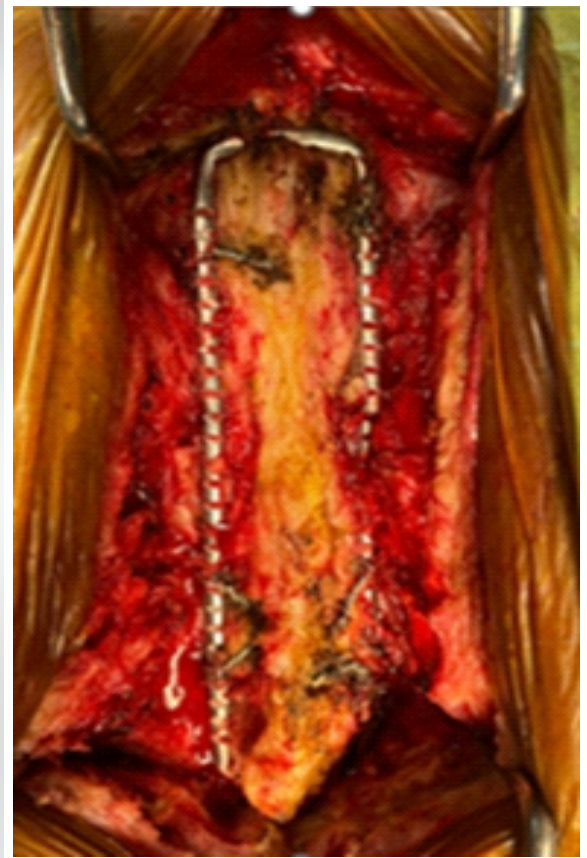
Figure 7: Hartshill rectangle (intraoperative image).

Midline incision is placed over the previous incision. Implant exposure is done without the use of cautery. Spinous process wires were removed as discussed in the previous case, but L4 vertebrae laminar wire failed to be removed. Hartshill rectangle was found broken (Fig. 7) and explanted. Pedicle screws were inserted under O-arm navigation from D10 to L4. Dorsal decompression was done.

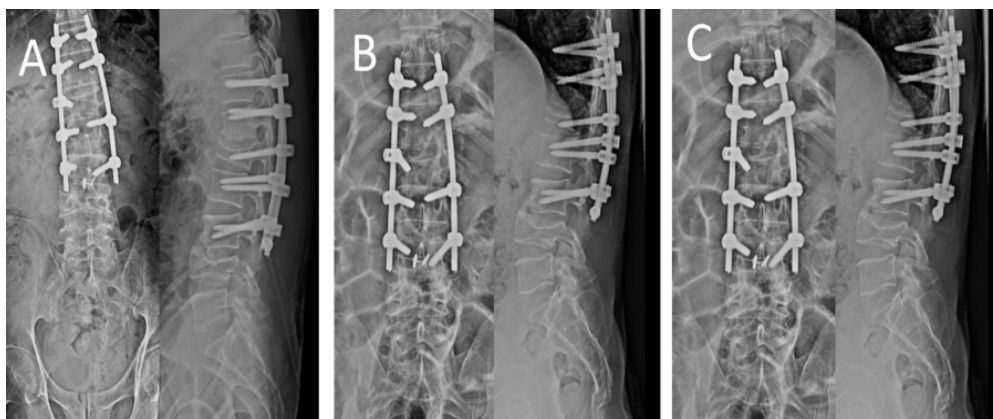
Figure 8: [A] Immediate post-operative X-ray. [B] 3-month post-operative X-ray. [C] 12-month follow-up X-ray.

Postoperatively, gradually shifted to neurorehabilitation. The patient was able to walk with support from POD1 without any difficulty. At 3 months, the patient was able to walk without support, and lower limb power improved. The patient was followed up for 3 months, 6 months, and 9 months. Follow-up showed a well-maintained curve (Fig. 8).
