Late Atraumatic Ceramic Head Fracture in Total Hip Arthroplasty: A Case Report

Case Report: A 68-year-old Caucasian female presented with an atraumatic ceramic femoral head fracture in the setting of a ceramic-on-ceramic THA 17 years after primary surgery. The patient was successfully revised to a dual-mobility construct with a ceramic femoral head and a highly cross-linked polyethylene liner. The patient returned to normal function without pain.

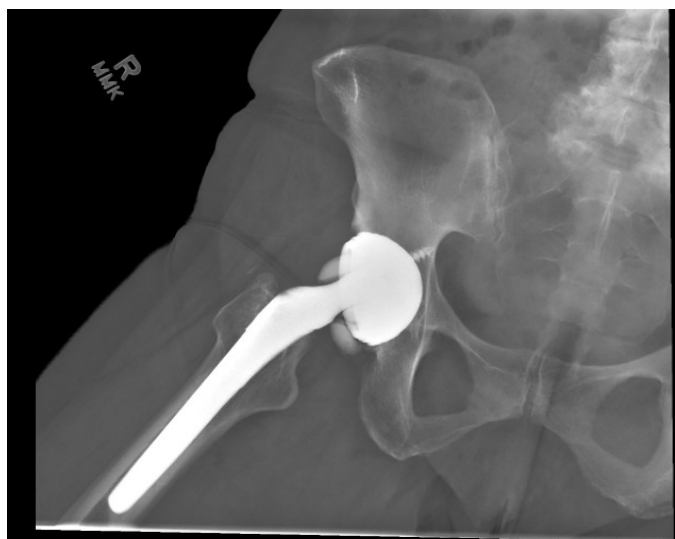
Figure 1: X-ray hip AP lateral right reveals a fractured ceramic femoral head and a vertical acetabular cup.

crunching sensation. Films revealed that the ceramic femoral head had fractured, and she was again indicated for revision of her right THA. No other radiographic changes were noted (Fig. 1).

In our case, the patient had an elevated acetabular abduction angle of 66° and a clinical history of subluxation. She also had a 28-mm head with a short neck. Both are common risk factors for fracture. She was indicated for revision 2 years prior to her eventual femoral head fracture.

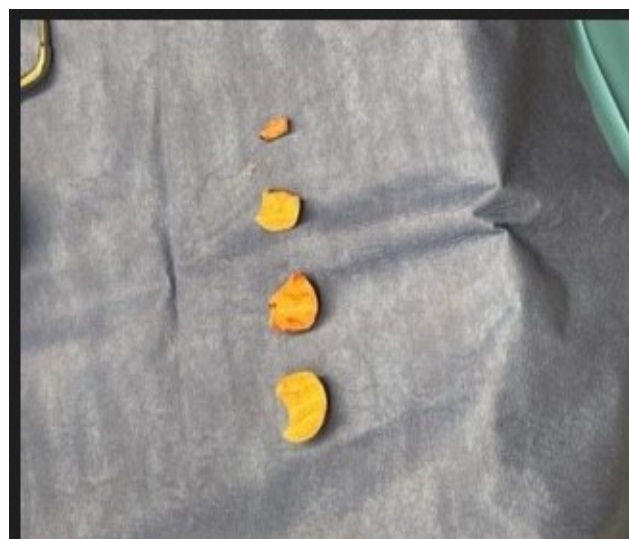
Figure 2: Intraoperative ceramic femoral head in four major fragments.

The patient's THA was revised through a Hardinge direct lateral approach. Metallosis of the tissues was noted, the ceramic femoral head was in four major fragments (Fig. 2). The patient was seen in May 2023, 1 year following revision surgery. The patient had no pain, limp, or disability and a perfect score on the Hip Disability and Osteoarthritis Outcome Score for Joint Replacement Questionnaire.

The ceramic liner showed metal staining from stem abrasion and the trunnion had a small notch along the proximal rim that did not affect the body of the trunnion itself. The fragments were removed. The ceramic liner was removed, and the acetabular cup was removed. The stem was well fixed and in good position and was left in place. A dual-mobility head was placed together with a ceramic head and a titanium sleeve on the original trunnion (Stryker Biolog Dual Mobility Vit E 42 mm/28 mm/E; Stryker, Howmedica, Osteonics Inc., Rutherford, N.J., USA). The patient tolerated the procedure well. The patient had an uncomplicated recovery and returned to normal function without pain. The patient was seen 2 weeks, 6 weeks, and 1 year following revision. They reported no post-operative complications and were
