# Eccentric Wear of Polyethylene Liner in a Bipolar Hemiarthroplasty Leading to a Revision Total Hip Arthroplasty

**Case Report:** A 70-year-old female patient underwent a bipolar hemiarthroplasty of the right hip for a transcervical neck of femur fracture 5 years ago. She presented to us with a subluxated femoral head within the cup on radiographs with clinical limp and pain. She was taken up for revision total hip replacement surgery.

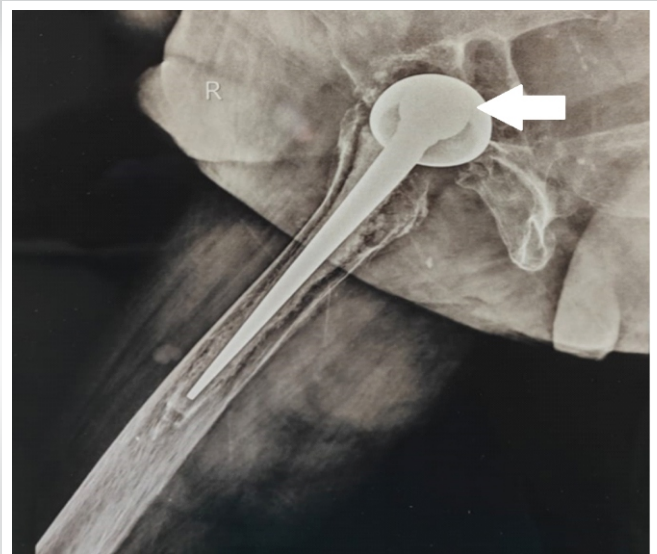
**Figure 2:** Lateral radiograph showing acentric position of the femoral within the bipolar cup marked by the arrow.

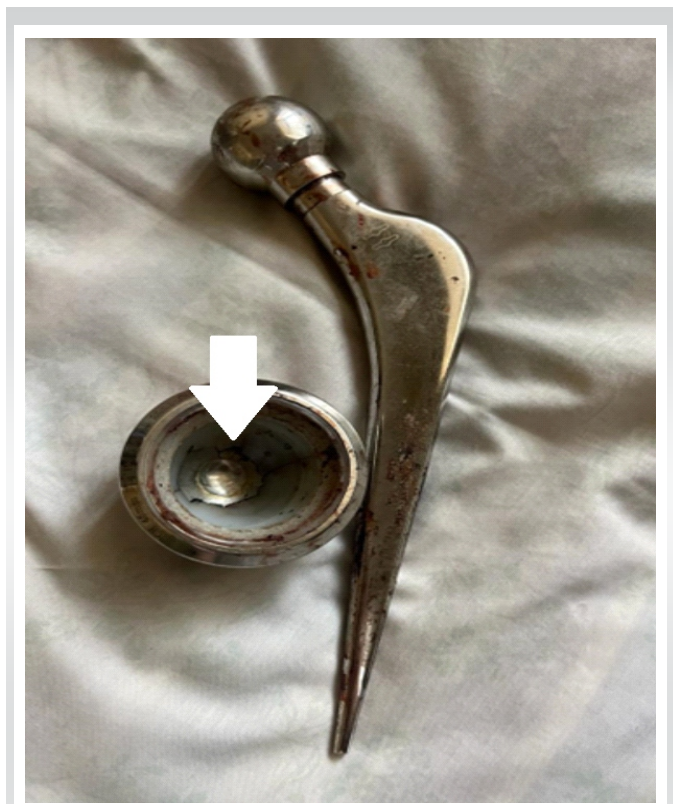
with it. On inspecting the cup, we saw a complete erosion of the polyethylene liner in the posterosuperior region (Fig. 3). The implants were of an unknown company with the femoral head measured to be of size 44 mm.

**Figure 3:** Implants after removal showing polyethylene liner wear in the cup (marked by arrow) and the femoral stem.

Given the substandard nature of the primary implant and cost constraints, the liner must have been of non-cross-linked polyethylene which would explain the accelerated wear. Non-cross-linked polyethylene liners are known to have higher wear rates as compared to highly cross-linked polyethylene liners. In a prospective randomized control trial, Engh et al. compared the 10-year results of polyethylene liners that were crosslinked and non-crosslinked. They found that during a 10-year period, 94.7% of non-cross-linked polyethylene and 100% of cross-linked polyethylene survivorship occurred. Osteolysis risk has been linked to a polyethylene wear rate of  $>0.1$  mm/year [11].

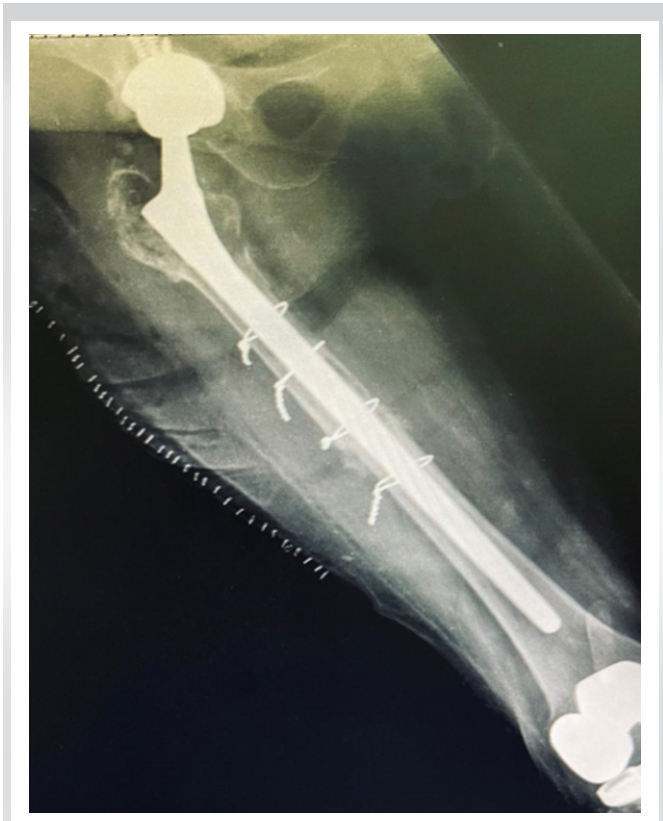
**Figure 4:** Anteroposterior post-operative radiograph.

Initial attempts at removing the bone cements were unsuccessful so considering the osteoporotic nature of her bone; we performed an extended trochanteric osteotomy (ETO) for ease of cement removal. Acetabular reaming was done and a 46 mm Continuum multihole acetabular cup was fixed after checking alignment and version with three acetabular locking screws and a 10° polyethylene liner over it (Zimmer Biomet, Warsaw, Indiana, USA). Femoral reaming was done and a Wagner diaphyseal long stem was used with a 32 mm metal minus three femoral head (Zimmer Biomet, Warsaw, Indiana, USA). The ETO was fixed by passing four stainless steel cerclage wires at different levels (Fig. 4). Stability was checked and closure was done. The patient was mobilized after 24 h with pain control by multi-modal analgesia.
