# Anterior Hip Dislocation Following Total Hip Arthroplasty, Caused by Broken Trial Femoral Head Particles: A Case Report

**Introduction:** Dislocation is one of the most common causes of patient and surgeon dissatisfaction following total hip arthroplasty (THA). In this case, we describe the presence of broken plastic particles, originating from the plastic trial femoral head (TFH) which caused total hip dislocation.

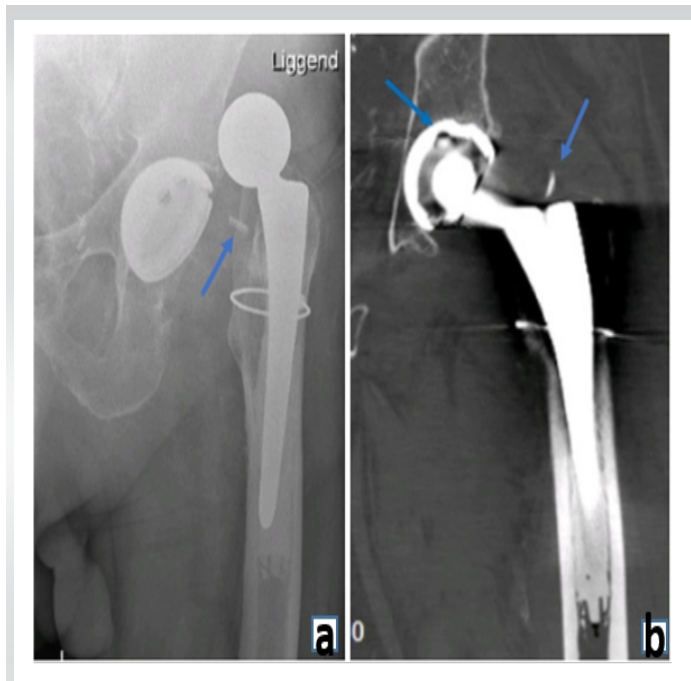
**Figure 1:** (a) Anteroposterior radiograph of the left hip shows the anterior hip dislocation with a dense radiopaque particle (blue arrow). (b) On the computed tomography scan after reduction, two radiopaque particles are visible (blue arrow).

acetabular cup and the other was visualized directly superior to the femoral stem (Fig. 1). An open exploration and implant inspection were performed through the direct anterior approach. After anterior capsulotomy, one dense plastic particle was immediately visualized and resected. Once the hip was perioperatively dislocated, the second particle became visible, located between the polyethylene liner and the oxinium head. Clear scratch marks were found on the polyethylene liner. The particles were later identified as parts of the implant head trials used, during the initial surgery (Fig. 2). The damaged polyethylene liner and femoral head were replaced without any issues. The patient was ambulating the day after the procedure and was discharged from the hospital after 2 days. No clinical or radiographic complications occurred 3 months and 1 year postoperatively (Fig. 3).

In this case, one would expect an eccentric position of the femoral head on perioperative fluoroscopy, but this was not visible. This two-dimensional image of a three-dimensional reality could, however, hide the eccentric anteroposterior position. The CT-scan performed after the first dislocation visualized the two prominent solid radio-opaque pieces but did not demonstrate an eccentric position of the femoral head in the acetabulum, possibly because these particles were partially lodged into the polyethylene.

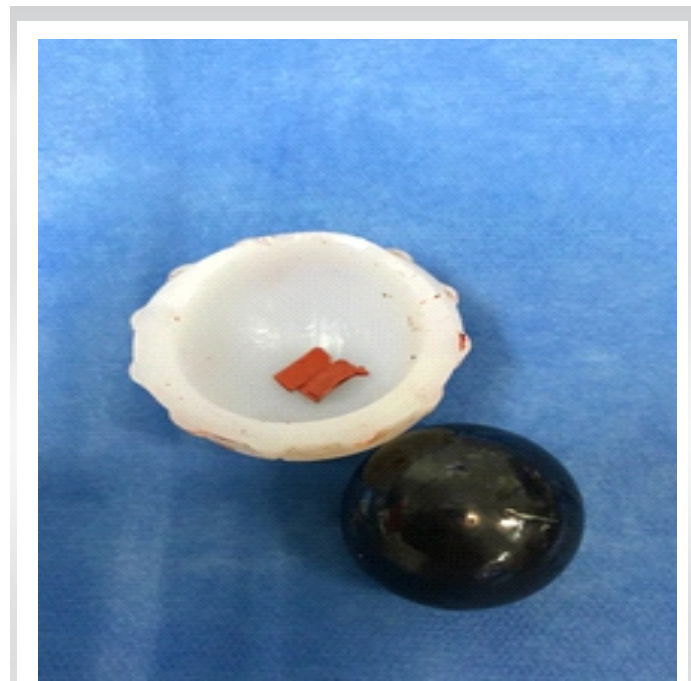
**Figure 2:** The two particles – measuring  $3 \times 1 \times 8$  mm – originating from the trial femoral head implant with the scratched polyethylene liner.

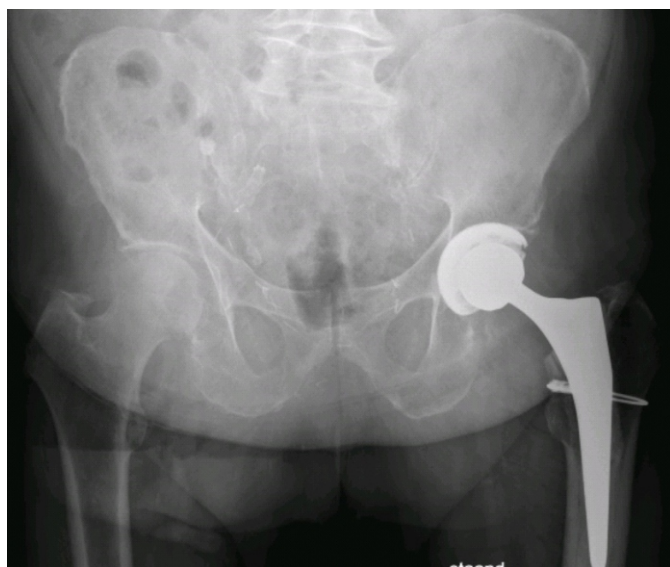
**Figure 3:** Anteroposterior radiograph of the pelvis shows the left total hip arthroplasty postoperatively with normal findings, and good length, and offset.

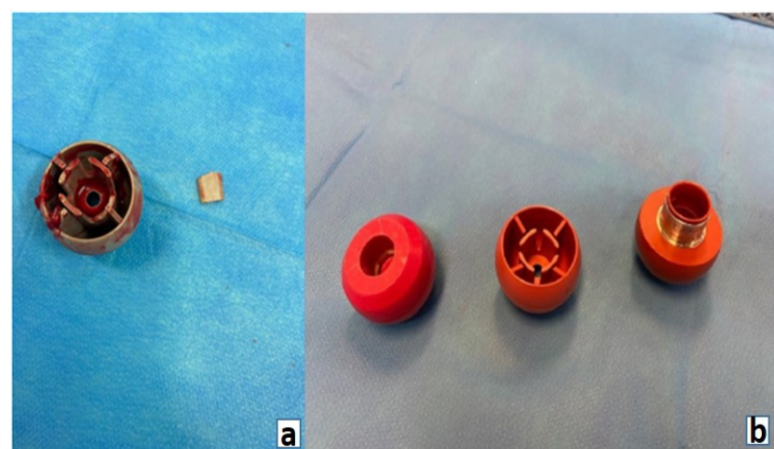
**Figure 4:** (a) Brittle trial femoral head implant with a broken particle and (b) different types of trial designs illustrating the fragility of certain designs, with the middle one being more fragile.

A similar event occurred in another patient a few months after this described case. During a routine THA procedure, a TFH was damaged during perioperative testing. At this time, the surgeon was consistently checking all the used trials and the components could easily be completely removed (Fig. 4). This

highlights the importance of a thorough investigation of intraoperative trial components, especially when they are assumed to be made of fragile materials such as plastic, even when no intraoperative abnormalities are present during testing.
