Tracking Pin Site Fractures and Measures to Overcome During Robotic-Assisted Total Knee Arthroplasty: Two Case Reports

Hyun-Min Lee^{1,2}, Yong-Chan Ha¹

Learning Point of the Article:

Pin site fracture can be avoided with appropriate placement of tracking pins.

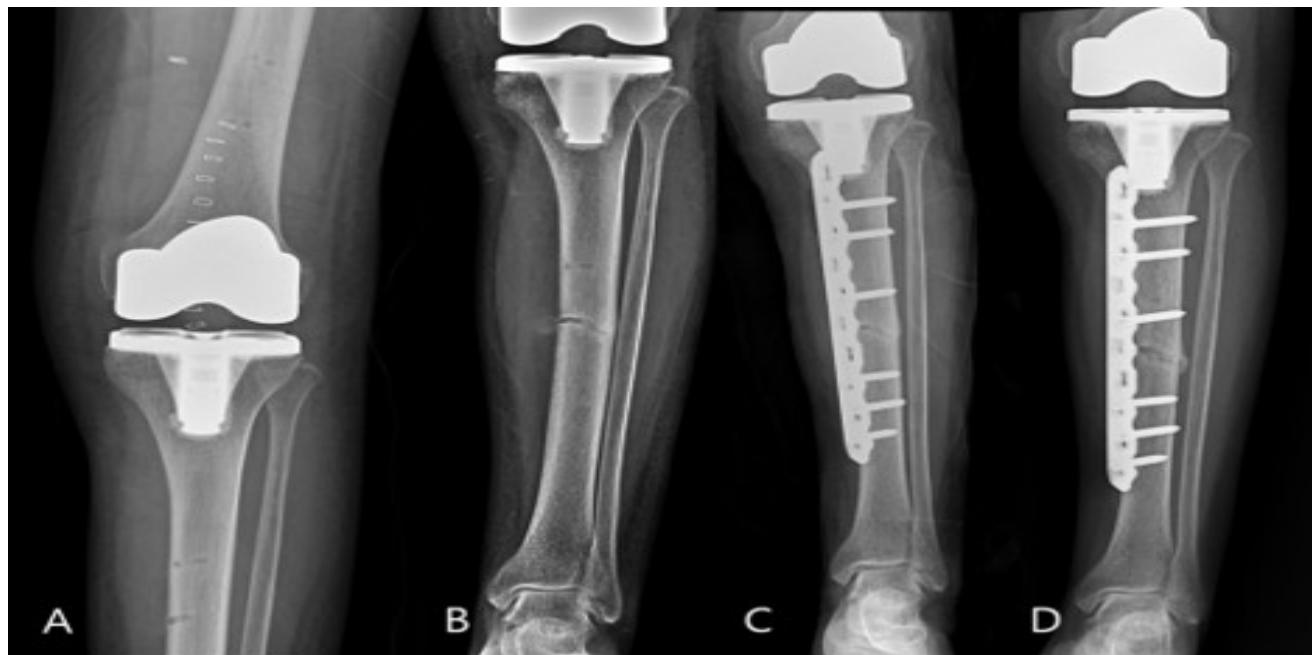
Figure 1: (A-D) Radiographs of tibial pin site fracture; (a) 67-year-old female who underwent robotic-assisted total knee arthroplasty had left lower leg pain. (A) There are no abnormal findings on immediate post-operative knee anteroposterior radiography. (B) At 2-month follow-up, a minimally displaced tibial fracture was found. (C and D) Open reduction and internal fixation were performed using a narrow, limited-contact dynamic compression plate and were well-maintained at 3-month follow-up.

patient showed no improvement with conservative treatment or injections, and her activities of daily living were deteriorating. Her weight, height, and body mass index (BMI) were 47 kg, 150 cm, and 20.8, respectively. She underwent staged bilateral total knee arthroplasty using the CUVIS-Joint Robotic System (CUREXO Inc.). Four 3.2 mm diameter pins were used to place tracker arrays with two pins each for the femoral and tibial diaphysis. For the tibia, the first pin was placed 10 cm below the joint line, perpendicular to the anteromedial surface, and the second pin was placed through the drill guide provided with the system. Both were placed with separate stab incisions. For the femur, the first pin was placed 10 cm above the joint line, and the second pin was placed through the drill guide with a separate stab incision. Post-operative radiographs were normal with good alignment of the components. In the post-operative period, she was allowed immediate weight-bearing as tolerated and underwent normal physiotherapy as per our institutional protocol without the need for aggressive rehabilitation or manipulation. The patient was discharged without complications. At the 2-month follow-up, she reported aggravated pain in the left lower leg. Physical examination revealed swelling and tenderness in the mid-third of the left lower leg, with abnormal mobility and crepitus. Radiography revealed a transverse fracture of the left tibia at the distal pin tract site. The patient underwent open reduction and internal fixation with a narrow, limited contact dynamic compression

plate (LC-DCP). During the post-operative period, the patient was kept non-weight-bearing for 6 weeks with quadriceps strengthening and knee range of motion (ROM) exercises. Partial weight-bearing was started after 6 weeks, with follow-up radiographs showing the progress of fracture union. After 3 months, bony union was identified, and the patient resumed her activities. The patient had full knee ROM at the final follow-up (Fig. 1a, b, c, d).

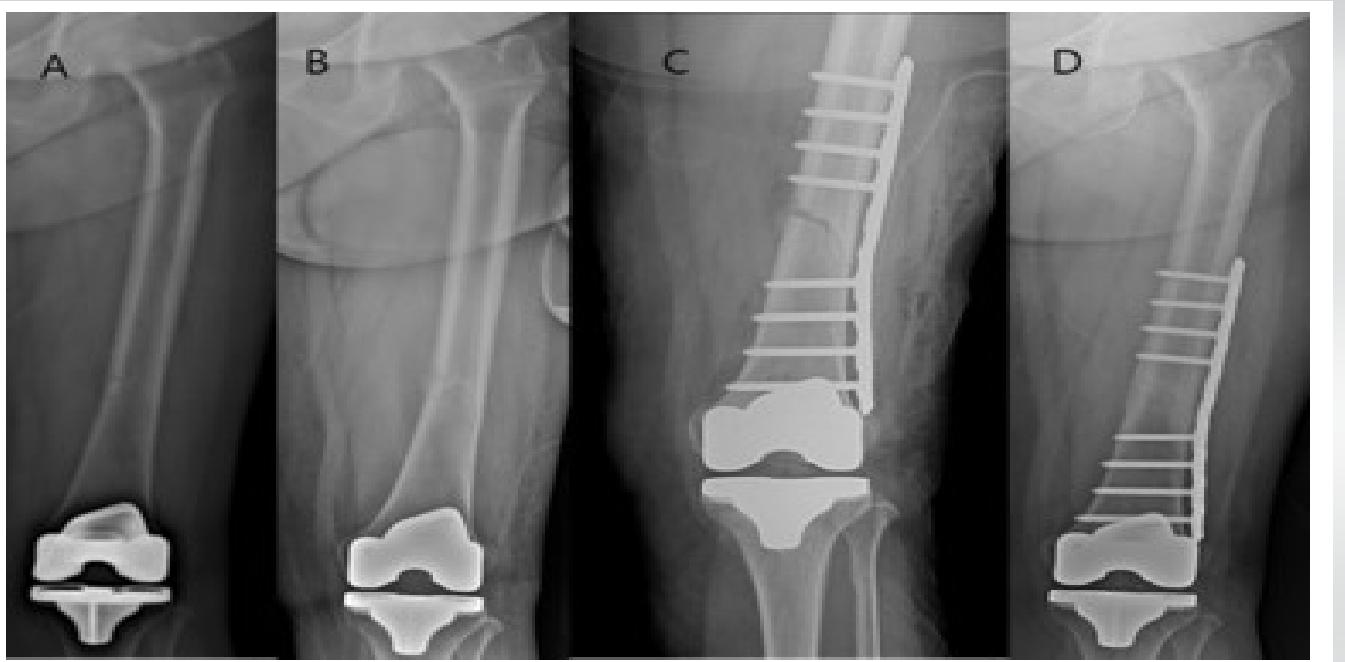
Figure 2: (A-D) Radiographs of femoral pin site fracture; A 69-year-old female who underwent robotic-assisted total knee arthroplasty had left thigh pain. (A) There are no abnormal findings on immediate post-operative knee anteroposterior radiography. (B) At the 7-week follow-up, a minimally displaced femoral fracture was found. (C and D) Open reduction and internal fixation were performed using a broad, limited-contact dynamic compression plate; the fracture completely healed at 12 months follow-up.

A 69-year-old female presented with bilateral knee pain for the past 3 years due to severe OA. Her weight, height, and BMI were 70 kg, 153 cm, and 29.9, respectively. Physical examination revealed diffuse swelling of both knees with crepitus, joint line tenderness, and limited ROM. The patient underwent staged bilateral total knee arthroplasty using a Mako robotic system (Stryker Inc.). Four 3.2 mm diameter pins were used to place tracker arrays with two pins each for the femur and tibia. For the tibia, the first pin was placed 10 cm below the joint line, perpendicular to the anteromedial surface, and the second pin was placed through the drill guide provided with the system. Both were placed with separate stab incisions. For the femur, the first pin was placed 13 cm above the joint line. The patient was discharged without complications. Seven weeks after the index surgery, she reported aggravated pain in the left thigh and difficulty walking. Radiography revealed a transverse fracture of the left femoral shaft at the distal pin tract site. The patient underwent open reduction and internal fixation with a broad

LC-DCP. She was kept non-weight-bearing for 6 weeks with quadriceps strengthening and knee ROM exercises. Partial weight-bearing was started after 6 weeks, with follow-up radiographs showing the progress of fracture union. After 6 months, bony union of the fracture site was identified, and the patient resumed her activities. The patient had full knee ROM at the final follow-up (Fig. 2a, b, c, d).

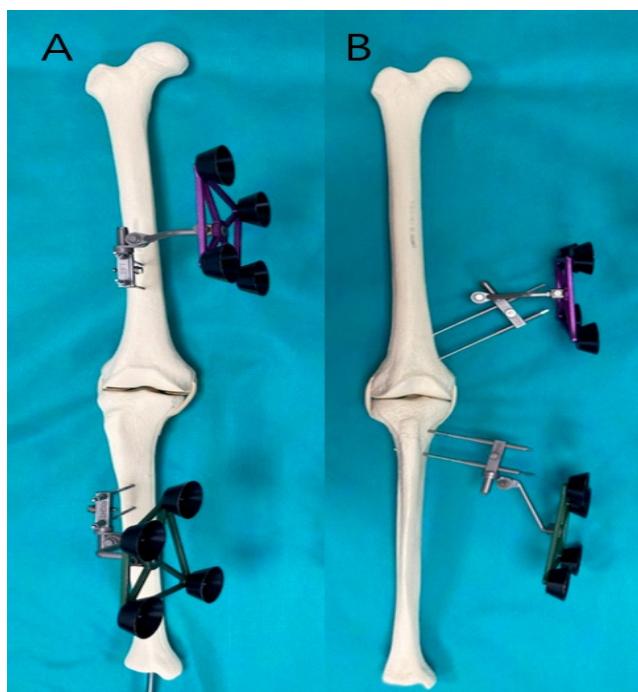
Figure 3: (a and b) Old and new locations of the tracking pin. Phonograph (a) shows traditional fixation methods of the femur and tibia pin tracker. (b) We changed the positions of pin trackers to the metaphyseal area of the distal femur and proximal tibia using a 3.2 mm diameter pin.

Our recommended technique for minimizing pin tracker-related fractures is the placement of the first tibial pin 2 cm medial to the tibial tuberosity within the wound perpendicular to the tibial surface, just touching the opposite cortex. The

second pin is inserted through the drill guide with a separate stab incision in the same direction. On the femoral side, the first pin is placed within the wound, 2 cm above the medial epicondyle, from the anteromedial to the posterolateral direction to a depth of 4 cm, and the second pin is placed through the drill guide with a separate stab incision in the same direction (Fig. 3a and b). We prefer a 3.2 mm diameter for all four pins. With these modifications, we have not encountered any pin-related periprosthetic fractures in our practice.
