A Case Report of the Complete Union of an Impending Failure of Patellar Fracture Treated with Cannulated Cancellous Screws and Tension Band Wiring for Failed Modified Tension Band Wiring Technique

Gautam Rava¹, Pranjal Mahanta¹

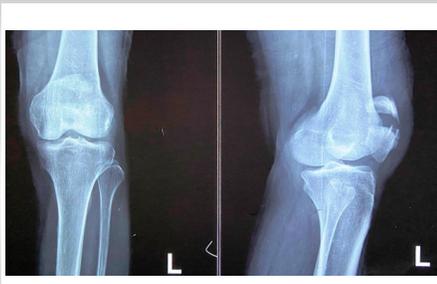
Figure 1: Anteroposterior and lateral X-ray view of the left knee joint showing type 34-C1 fracture of the patella.

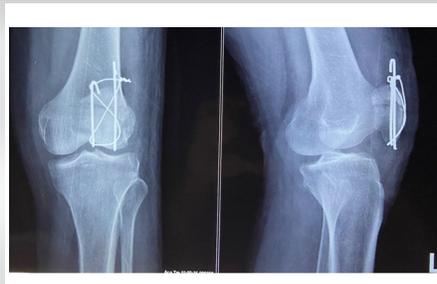
Figure 2: Anteroposterior and lateral X-ray view showing well-reduced patellar fracture with modified tension band wiring.

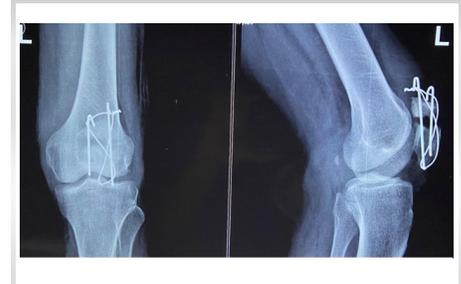
Figure 3: Anteroposterior and lateral X-ray view showing distraction at the fracture of the patella with Kirschner wire migration.

was well healed, without any signs of inflammation, on palpation tenderness was present, the temperature was normal, and a palpable gap of around 1 cm was noted at the fracture site. Immediately, an X-ray was obtained which revealed distraction at the fracture site due to pulling out of the medial sided K-wire, leading to loosening of the construct (Fig. 3). After counseling the patient regarding fixation failure, and after obtaining informed consent, planning was done for revision fixation of the fracture. Pre-operative investigations and pre-anesthetic clearance were obtained as routine protocol, then the patient was taken for the operation. After sterile draping of the part, the previous incision was used and 4.0 mm CCS and SS wire (18 Gauge) was used to fix the fracture under spinal anesthesia. Wound closure was done without drain and an absorbable stitch for skin was applied.

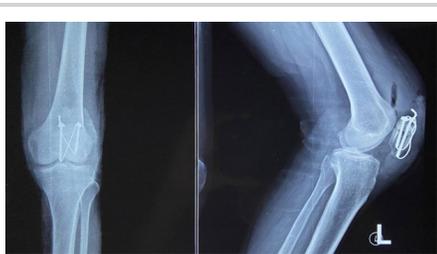
Figure 4: Anteroposterior and lateral X-ray view showing well-reduced patellar fracture with cannulated cancellous screws and tension band wire.

Immediate post-operative X-ray showed a very satisfactory reduction (Fig. 4). The patient was discharged uneventfully from the hospital after the 2nd day and the same rehabilitation protocol was started as used previously after the first operation.

We believe in our case we achieved a satisfactory reduction by the MTBW using CCS construct as evident on the immediate post-operative X-ray (Fig. 4). However, we have observed that there was a slack in the tension band probably due to its rigidity and slight protrusion of the tip of the cancellous screw from the distal end of the patella, which finally led to the loosening of our construct and impending failure. However, as the construct was stable and knee bending was gradually increased, thereby leading to gradual compression and bony union at the fracture site finally as evident in (Fig. 6, 7), respectively.

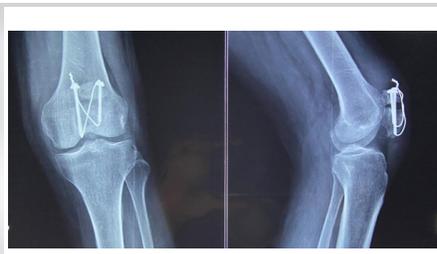
Figure 5: Anteroposterior and lateral X-ray view of the knee joint showing mild distraction in fracture fragments of the patella without any gross signs of implant loosening.

After around 3 weeks, the patient presented to us again with a history of sudden slip without any fall and pain and mild swelling over the operated area. On examination, the knee was mildly swollen, the surgical wound completely healed, the temperature normal, and tenderness over the fracture site. Immediately, an X-ray was obtained (Fig. 5) which showed mildly distracted fracture without any signs of implant failure. This time we were in a dilemma whether to treat it or just wait and watch.

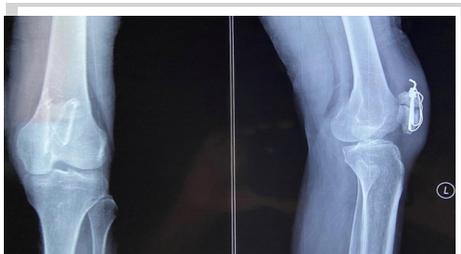
Figure 6: Anteroposterior and lateral X-ray view of a knee joint showing reduced fracture fragments of the patella with an excellent alignment of the articular margin.

The patient was routinely followed up after a month, and to our surprise, X-ray showed a very satisfactorily reduced fracture (Fig. 6). At this time, active SLR also improved and the patient was allowed to walk with a walking stick only.

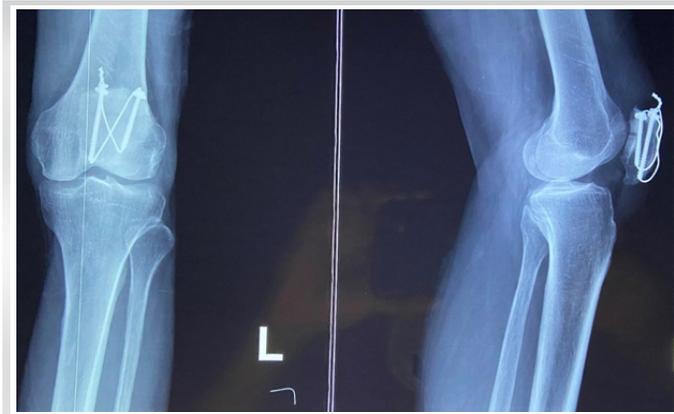
Figure 7: Anteroposterior and lateral X-ray view of a knee joint showing a completely healed fracture.

Subsequently, the patient appeared again after a year for a check-up, during which time, he gradually improved the function of the knee joint. At this time, X-ray showed a completely healed fracture (Fig. 7).
