Retrieval of a Sunken Interference Screw during Core Decompression and Autologous Adult Live-cultured Osteoblast Injection for Bilateral Hip Avascular Necrosis: A Case Report

An interference screw sinking during core decompression for avascular necrosis of the hip is a dreaded complication during surgery and this time, it was successfully retrieved using Schanz pins in a minimally invasive manner.

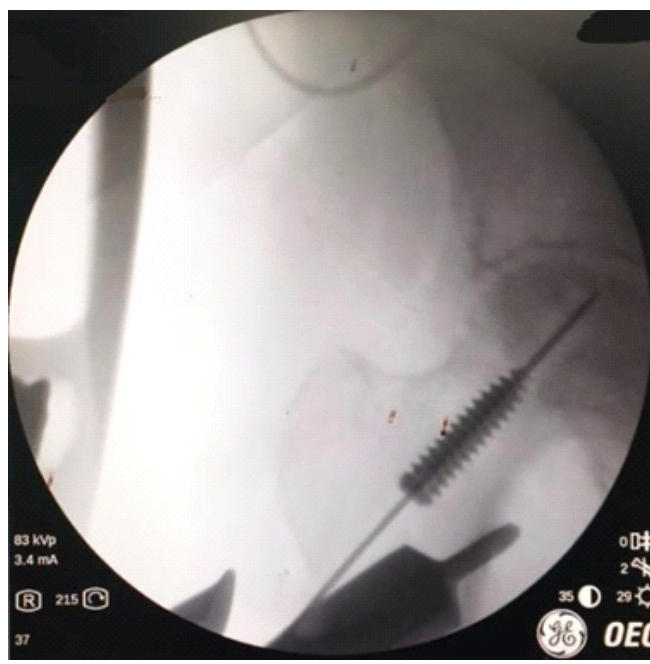
Figure 1: Interference screw sunken in the femoral neck.

We present a case in which a metal interference screw became sunken within the femoral neck during bilateral hip core decompression and AALCO injection, as shown in Fig. 1. We describe our technique for minimally invasive retrieval using standard operating room instruments found in an orthopedic operating room, thereby avoiding extensive exposure, need for specialised instruments and bone loss, allowing completion of the planned procedure.

reamer was used to drill over the guide wire. To prevent backflow of the injected material, an 8 mm metallic interference screw was introduced at the track opening. During insertion, the screw migrated into the femoral neck, and the full length of the screw was sunk.

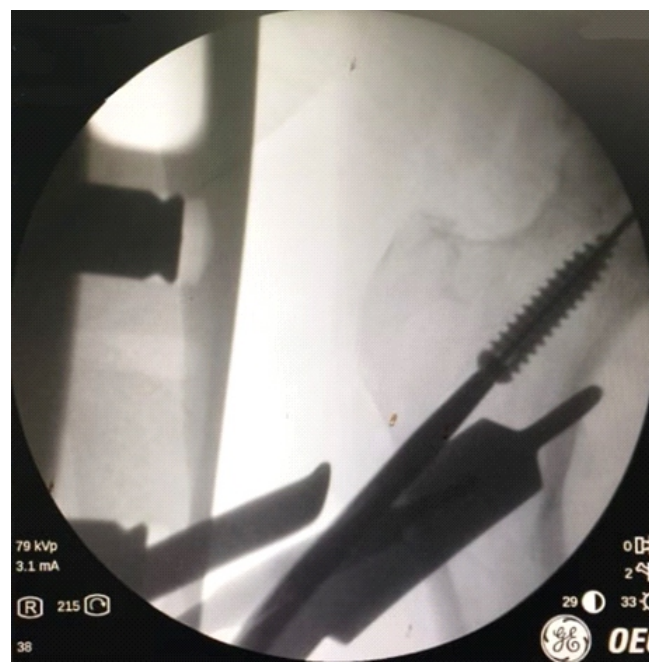
Figure 2: Attempting removal with gentle counterclockwise screwing with a screwdriver.

Direct attempts to grasp the screw risked enlarging the core tract. As shown in Fig. 2, gentle retrieval using the screwdriver over the guide wire was initially attempted. This did not work as force is required to mate the screwdriver tip to the screw head, which would lead to further burial of the screw. Subsequently, a guide wire was bent to create a hook at the end and insertion across the interference was attempted (Fig. 3). This proved to be challenging as a large hook would not go across the screw and a small hook would not be able to get adequate purchase at the screw tip to be able to pull it back [6, 7].

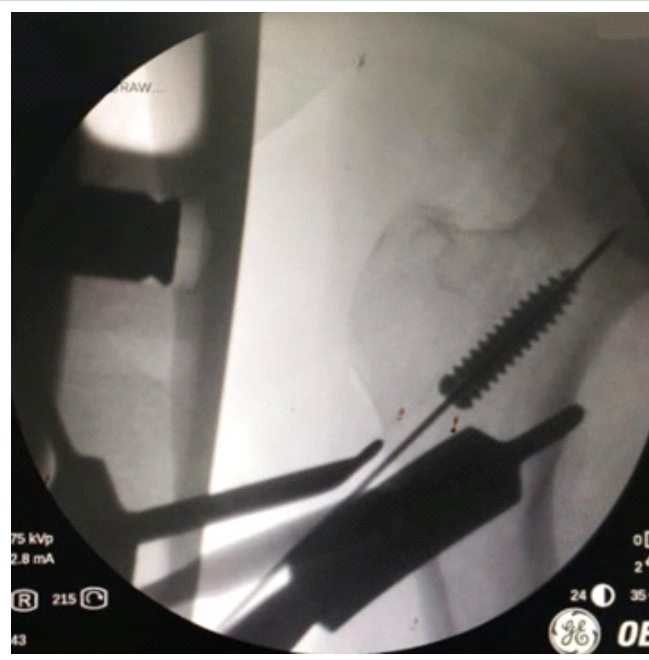
Figure 3: Attempting removal with a hooked guide wire.

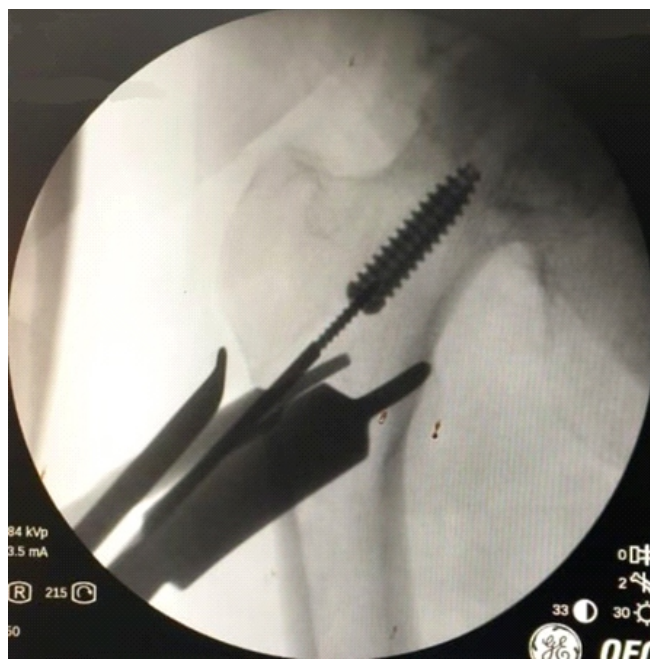
Figure 4: Attempting removal with a Schanz pin.

The next method that was attempted, as shown in Fig. 4 was to thread a thin 2.5 mm Schanz pin into the canal of the interference screw and pull it back. This proved to be partially successful, and the screw was pulled back a certain distance. Following this, the Schanz pin was passed into the screw head and the threads of the Schanz pin engaged with the head of the screw and thus, the screw could be pulled out without the need for additional exposure, enlargement of the reaming track, or creation of a bone window (Fig. 5) [8]. The procedure was then completed and repeated on the contralateral side without complications.

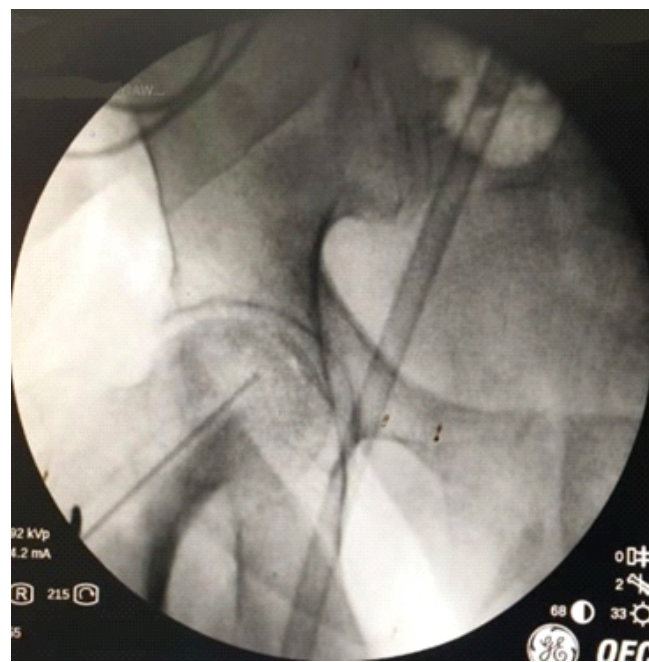
Figure 5: Screw successfully removed.
