A Rare Case of a Fractured Exeter V40 Stem in Revision Hip Arthroplasty

Conclusion: The current case report documents a rare case of a fractured Exeter V40 stem and its subsequent treatment.

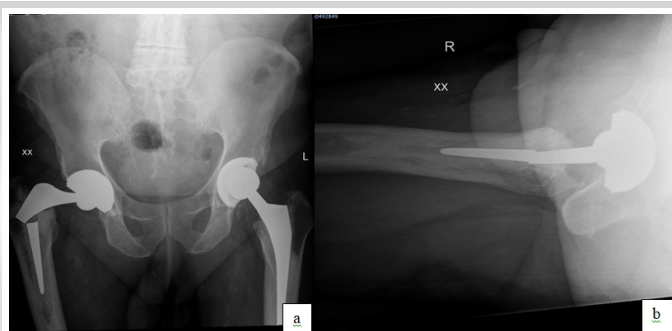
Figure 1: (a and b) AP and Lateral radiographs showing a fracture through proximal and middle third of V40 Exeter stem.

28.4kg/m²) presented with a 10 day history of pain in the right hip and a 4 day history of inability to fully weight bear following a fall. He originally had a right uncemented total hip replacement for osteoarthritis performed in May 2009. Due to aseptic loosening, the original replacement failed and was revised to a cemented Exeter V40 stem in 2012. A further revision was performed in 2017 for dislocation. On examination, his right leg was short and externally rotated. There was also tenderness in the right groin. Radiographs showed the hip still in joint and a fracture of the Exeter stem (Fig. 1).

The patient had revision surgery through the posterior approach utilizing the old incision. Before this, he underwent aspiration of this right hip to exclude infection. Prophylactic antibiotics and tranexamic acid were administered at induction as per hospital protocol. Following dislocation of the hip, the acetabular component was found to be well fixed and was left in situ. The proximal fragment of the Exeter stem was removed with ease. The distal fragment was removed with difficulty following a 1cm × 3cm osteotomy distal to the tip of the stem, a drill to penetrate the cement mantle and explanted using a punch (Fig. 2). There was no overt sign of infection and the tissues looked healthy macroscopically. Five tissue samples were sent to microbiology for culture and sensitivity. Subsequently, the femur was prepared for a V40 Exeter revision stem (44 offset and 125mm length) after trial reduction. A 1.5 mixture of Palacos cement with gentamicin was used. The hip was reduced with a Dual mobility bearing using a 28mm Biolox Delta head and a 28/52mm X3 insert for modular dual mobility. Intraoperatively, the hip was stable and leg length restored.

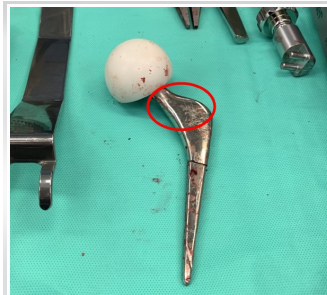
Figure 2: Demonstrating fractured retrieved V40 Exeter stem

The most common reasons for revision surgery are aseptic loosening, osteolysis, infection, and dislocation. Within the body, the greatest amount of stress is placed on the middle third of the stem, and this is where fractures most commonly occur. In vivo, cantilever bending, stress placed on the stem, and stress concentration can lead to fracture [1]. The factors associated with increased risk of metalwork fracture relate to the patient (e.g., increased BMI and reduced bone stock) are biological (e.g., osteolysis and inadequate proximal osseous support), and relate to the implant (e.g., undersizing and material defects) [5].
