Fourth-Generation Ceramic Head Fracture in Dual Mobility Total Hip Arthroplasty: A Case Report

Case Report: We report a case of fourth-generation delta ceramic head fracture 4.5 years after implantation in a dual mobility total hip replacement constructs as a result of a ground-level fall. The patient underwent revision arthroplasty with another delta ceramic dual mobility construct and was able to return to work in custodial services 2 weeks after the revision procedure.

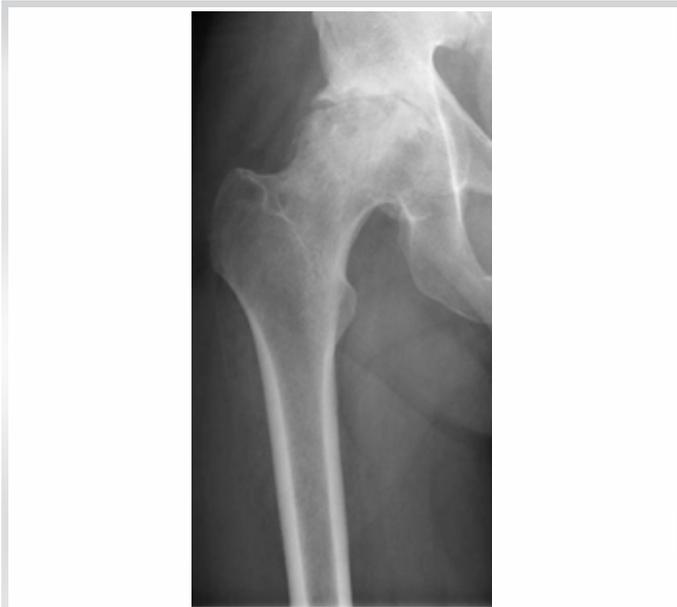
Figure 1: AP radiograph of right hip taken at initial clinic visit (07/2013) demonstrates advanced collapse of the right hip with associated joint degeneration.

A 45-year-old African American male presented with right hip pain secondary to avascular necrosis of the femoral head, with collapse (Fig. 1). The patient failed conservative treatment including physical therapy, non-steroidal anti-inflammatory

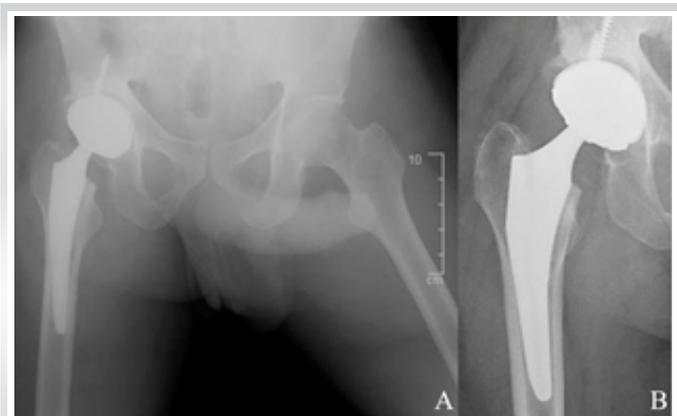
Figure 2: (a) Post-operative AP pelvis radiograph taken day of index RTHA on 11/2013 demonstrates a Stryker MDM construct with ceramic femoral head. No radiographic signs of periprosthetic fracture of component malpositioning. (b) AP right hip radiograph taken 9-months status post index RTHA demonstrating a stable Stryker MDM construct with ceramic femoral head with no radiographic signs of periprosthetic fracture or component failure.

impacted into the bony acetabulum using press-fit technique and two 6.5 mm cancellous screws were used. At the conclusion of the case, all components were deemed well-fixed, and the patient demonstrated appropriate leg length and range of motion intraoperatively (Fig. 2). Upon discharge, the patient maintained standard post-operative hip precautions and attended outpatient physical therapy. He was seen in clinic for routine post-operative care at the 3-week, 6-week, 3-month, and 9-month marks.

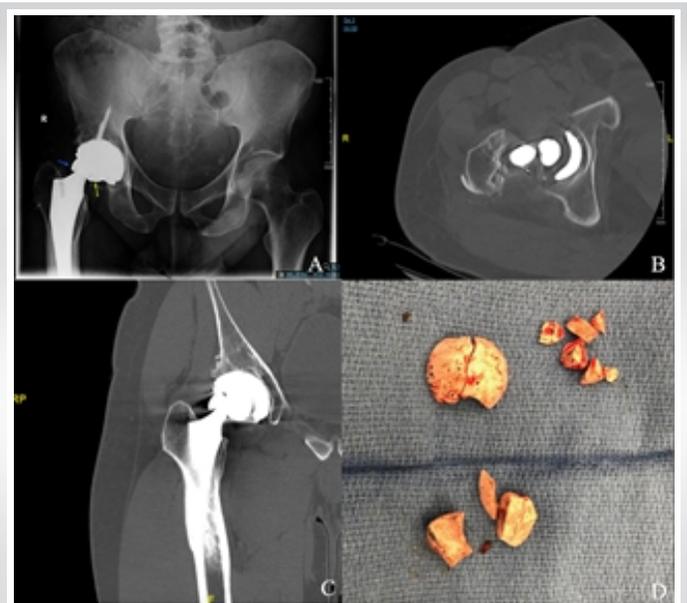
Radiographs revealed gross deformity of the right femoral head, with fine, radiopaque particles adjacent to the joint (Fig. 3). CT scan confirmed fragmentation of the delta ceramic head without signs of other component failure or loosening (Fig. 3). At the time, the patient refused urgent surgical management before agreeing to revision THA at his outpatient follow-up 2 days later.

Figure 3: (a) AP pelvis radiograph taken day of injury on 8/2018 demonstrating a Stryker MDM construct with fractured ceramic femoral head. No radiographic signs of periprosthetic fracture or component loosening. (b) Axial and (c) coronal CT slices of right hip status post fall on 8/2018 demonstrating a ceramic head fracture with a significant amount of joint debris. (d) Intraoperative photograph of the retrieved ceramic femoral head component with 4 large main fragments and multiple smaller pieces.

The previous posterolateral incision was utilized for the revision. Examination of the ceramic femoral head revealed 4 large main fragments with multiple smaller pieces (Fig. 3). After removal of the polyethylene and fragmented ceramic components, the metallic liner was evaluated and deemed to be securely fixed in place. The acetabular shell and femoral stem components were ingrown and well-fixed. The femoral component taper did not show any severe corrosion. Extensive synovectomy and irrigation were performed to ensure the removal of any remaining ceramic fragments. Trials of the original sized components demonstrated good stability. Thus, replacement 28 mm +0 Biolox® delta ceramic femoral head, Stryker Universal Titanium Taper Adapter, and Restoration MDM polyethylene liner (inside diameter 28 mm, outside diameter 48 mm) were implanted.

Our case demonstrates rare catastrophic failure of a Biolox[®] delta femoral head in a dual mobility THA construct. While atraumatic failures have been reported, our case was likely secondary to a traumatic etiology [11]. Our revision procedure including copious irrigation and debridement, selection of new ceramic component with titanium taper sleeve, and retention of stable hardware, was consistent with previous suggestions on how to address this atypical scenario [12]. Severe, complication rates of ceramic head fracture revision procedures have been reported to be as high as 29% [13].
