Complex Scapulothoracic Disruption Managed with Scapular Dual Column Plating and Acromion Tension Band Osteosynthesis: A Radiological and Functional Success Story

In rare and complex scapulothoracic disruptions involving both scapular and acromial fractures, a multistructural approach using dual-column scapular plating and acromial tension band osteosynthesis can achieve excellent anatomical restoration and functional outcomes.

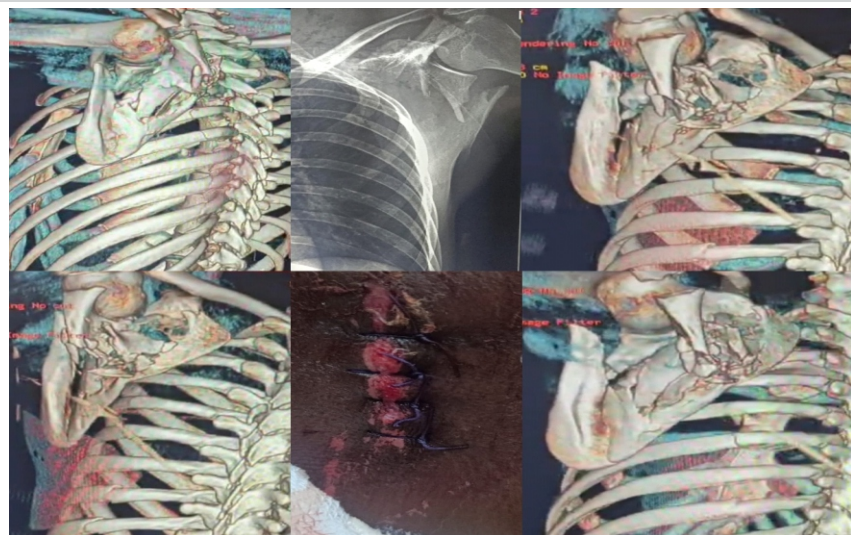
Figure 1: Pre-operative imaging and clinical presentation of a complex scapular injury; the anteroposterior (AP) shoulder radiograph and three-dimensional computed tomography scans of the left scapula demonstrate a comminuted fracture involving the infraspinous fossa, scapular spine, lateral border, and acromion process. These indicate a high-energy scapulothoracic disruption. Also shown is a clinical photograph of the posterior shoulder region with a lacerated wound that was primarily closed using silk sutures at a peripheral health center before referral. The combination of osseous fragmentation and soft tissue compromise highlights the severity of the injury and the need for advanced surgical intervention.

displaced fractures of the left (non-dominant side) scapular body, lateral column, and acromion process (Fig. 1) without any vascular or neurological deficits (Type 1, Zelle et al. [1]). Computed tomography scans confirmed significant disruption of the scapular architecture with lateral displacement of more than 2 cm and shortening, as well as fracture of the acromion (Fig. 2).

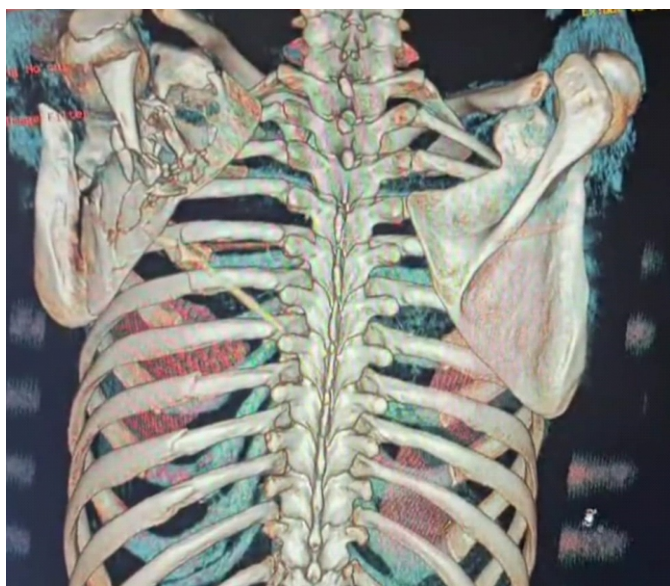
Figure 2: Three-dimensional computed tomography reconstruction of the left shoulder girdle demonstrating a lateral displacement of the scapula exceeding 2 cm from its normal anatomical position, consistent with scapulothoracic dissociation; the scan reveals gross disruption of the scapular architecture, including loss of anatomical continuity and orientation of the scapular body, spine, and acromion. This degree of displacement is indicative of high-energy trauma and is often associated with concurrent injuries to the clavicle, rib cage, and surrounding musculature. The imaging underscores the severity and complexity of the injury, aiding in pre-operative planning for surgical stabilization.

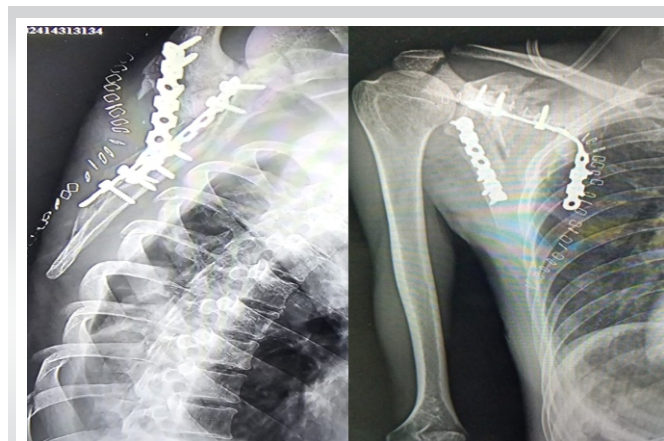
Figure 3: Immediate post-operative anteroposterior (right) and scapular Y-view (left) radiographs of the left shoulder following the first surgical procedure; the images show dual-column reconstruction of the scapula with plate fixation of both the medial and lateral columns. Restoration of scapular alignment and structural integrity is evident, reflecting the initial phase of surgical stabilization in the management of complex scapulothoracic disruption.

Informed consent was taken from the patient and his relatives, following which he underwent surgical stabilization. Through the Judet approach, after elevating the infraspinatus muscle from the infraspinous fossa and retracting it laterally, the posterior aspect of the scapula was exposed in its entirety. After securing the suprascapular nerve and artery at the spinoglenoid notch, anatomical reduction of the scapular body and lateral column was achieved and fixed with 3.5

mm reconstruction plates in a dual-column configuration (Fig. 3). The acromion fracture was separately addressed through superior scapular approach. Tension band wiring was done using two 2 mm Kirschner wires and a 1.5 mm stainless steel wire wound in a figure-of-eight fashion to achieve compression and restore the deltoid insertion (Fig. 4).

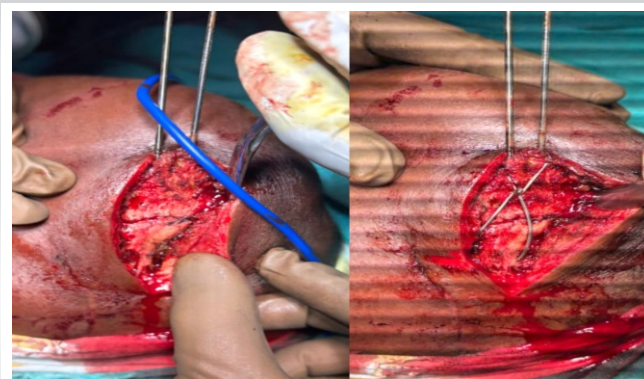
Figure 4: Intraoperative images demonstrating anatomical reduction of the acromion fracture; the fracture fragments are accurately realigned and temporarily stabilized using two parallel 2.0 mm Kirschner wires (K-wires). A 1.5 mm stainless steel wire is applied in a figure-of-eight configuration around the K-wires to achieve tension band osteosynthesis. This construct provides dynamic compression across the fracture site, enhancing stability and promoting union in the anatomically complex region of the acromion.

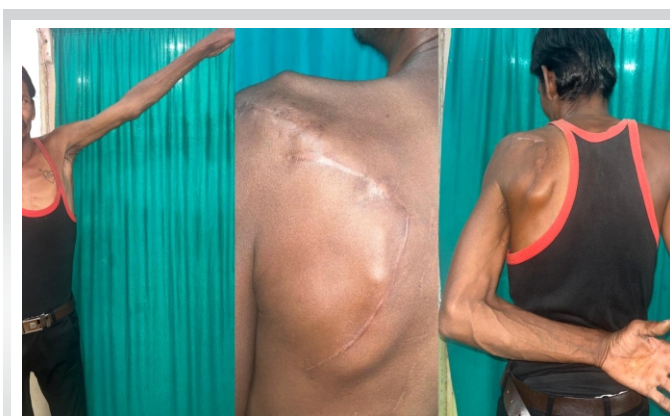
Figure 5: Clinical photographs showing active left shoulder abduction up to 120° (left), well-healed surgical site without scar-related complications (middle), active internal rotation of the shoulder in extension indicating progressive functional recovery, and satisfactory rehabilitation outcome, considering this was his non-dominant arm.

Post-operative rehabilitation included early passive motion followed by active-assisted range of motion at 4 weeks. At 4 months, the patient demonstrated active shoulder abduction up to 120° (Fig. 5), minimal pain (Visual Analogue Scale 1/10), and radiographic evidence of fracture union (Fig. 6). The University of California, Los Angeles Shoulder Score following a questionnaire was found to be 34/35 and the Constant–Murley score was 95/100, again confirming an excellent outcome [2,3].

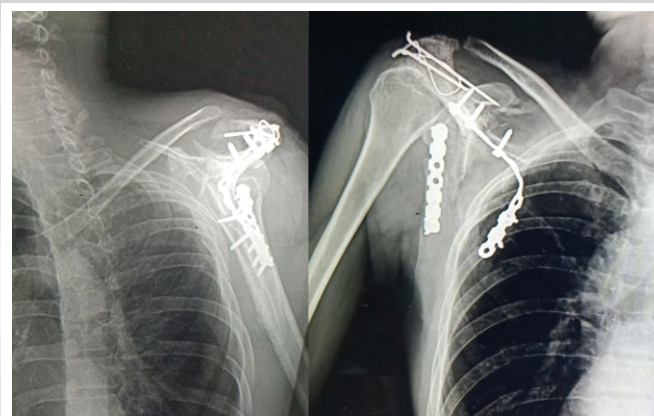
Figure 6: Four-month post-operative evaluation following surgical management of complex scapular fracture; left: Scapular Y-view radiograph; right: anteroposterior radiograph showing stable fixation with dual-column scapular plating and acromial tension band wiring alongside signs of fracture healing.
