Use of Dynamic Radiography to Detect Acetabular Cup Gross Mobility in Early Total Hip Replacement Loosening: A Case Report

Case Report: A single case of early acetabular cup loosening in a 57-year-old female patient is presented. The patient complained of pain during weight-bearing 2 months postoperatively with progressive aggravation. Dynamic radiography is very rarely proposed in the literature as a valid method to detect gross movement of the acetabular cup in a suspected loose THA.

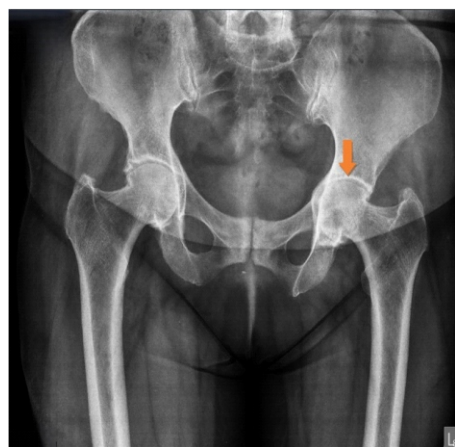
Figure 1: Pre-operative pelvis X-ray, anteroposterior view. Moderate left hip joint arthritis.

Press-fit type THA was performed on a 57-year-old patient who suffered from chronic symptoms of hip osteoarthritis (Figs. 1 and 2). Although no instability or gross motion of any of the components was detected intraoperatively, the acetabular cup was fixated with two screws to reinforce the stability of the construct. The post-operative protocol comprised non-weight-bearing for the first 2 weeks, partial weight-bearing for the following weeks and initiation of full weight-bearing at 6 weeks postoperatively. At the 2-month follow-up visit the patient was able to weight bear and walk but complained of pain when rising from the seated position and during the first steps. The symptoms were improving during walking. Clinical examination revealed a leg-length discrepancy of approximately 2 cm, but the radiological evaluation showed no pathological findings. The patient was encouraged to continue rehabilitation, return to moderate daily activities, but to avoid overload. Six months postoperatively, the symptoms significantly worsened with severe pain during loading and a “snapping” feeling on every step. A thorough laboratory investigation was obtained showing no increase in inflammation markers and no other pathological findings. Further imaging with new X-rays, MRI, and CT was also inconclusive (Figs. 3, 4, 5). Taking into consideration the short post-operative time, it was decided to avoid any nuclear medicine examination, such as single-photon emission computed tomography (SPECT)-CT or positron emission tomography (PET) to limit the risk of exposure. It is shown that these imaging modalities present lower accuracy in the early post-operative period.

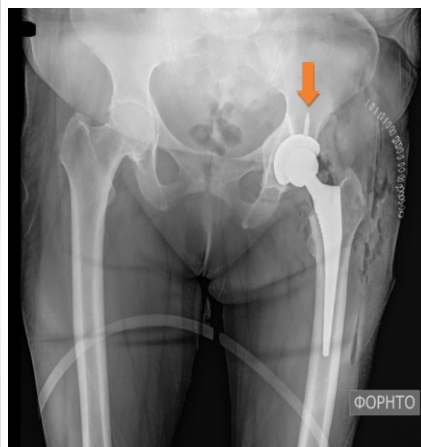
Figure 2: Post-operative X-ray of the hips. Left total hip replacement.

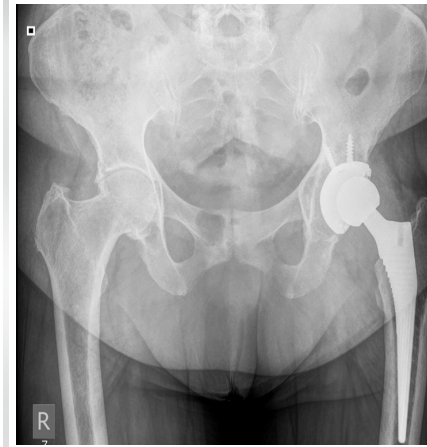
Figure 3: No periprosthetic lucencies at the 6-month post-operative X-ray.

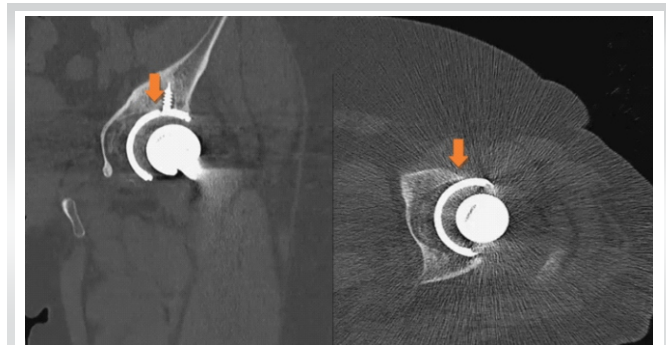
Figure 4: Pre-operative computed tomography scan with no sign of acetabular cup loosening.

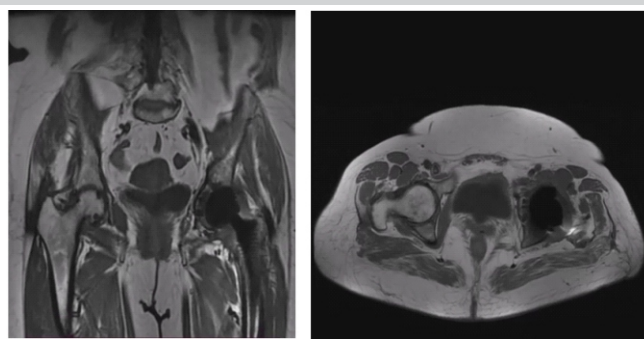
Figure 5: Pre-operative evaluation with MRI, no loosening findings.

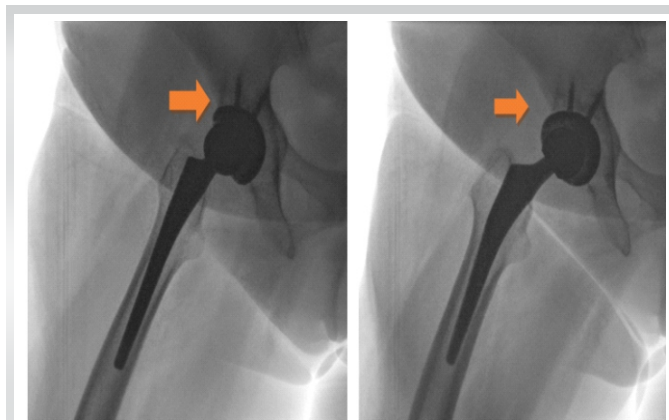
loosening of the THA components was suspected, and so a dynamic radiographic imaging was scheduled to examine the THA prostheses during movement. The examination was undertaken in the radiology department with the equipment of a barium meal gastrointestinal series for high-resolution imaging. The patient was placed in a supine position with the affected limb free and the chest, abdomen, and genitalia of the patient covered with a radioprotective gown. The surgeon passively performed hip flexion, hip extension, internal and external rotation to the extremes of the hip range of motion of the left lower extremity under radiography. The movements were performed in a circular manner, anti-clockwise starting from 60° flexion and internal rotation to full external rotation followed by hip extension. The same movement protocol was followed in 90° flexion and in 100° of hip flexion. Dynamic imaging revealed gross motion of the acetabular cup during passive movements of the hip joint, so the diagnosis of aseptic loosening was established (Fig. 6 and Video 1: Gross motion and instability of the acetabular cup during dynamic radiography.). The patient was scheduled for revision arthroplasty. The surgery was undertaken 2 weeks after, and loosening of acetabular cup was confirmed intraoperatively. There were no signs of loosening of the femoral component or infection. Samples were sent to detect possible infection. Loosen cup was removed and exchanged to a larger tantalum cup. The post-operative course was uneventful, and a full recovery was succeeded. At 2, 6, and 12-month follow-up the patient had a painless range of motion and had fully returned to her activities (Fig. 7). At a final follow-up at 18 months, the patient presented with a significant improvement in function and quality of life compared to the pre-operative evaluation. Her pain was limited from a Visual Analog Scale (VAS) = 7 preoperatively to VAS = 2 postoperatively.

Figure 6: Images during dynamic radiography.

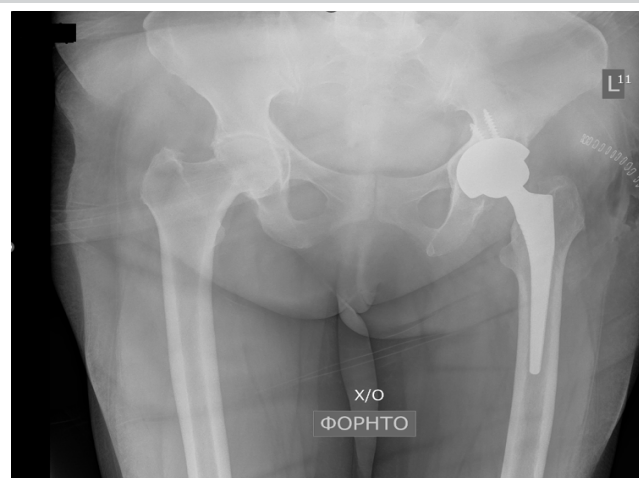
Figure 7: Post-operative imaging after revision surgery.
