A Rare Case of Posterior Dislocation of Hinge Knee Prosthesis due to Wear of Anti-Luxation Device: A Case Report

Abstract

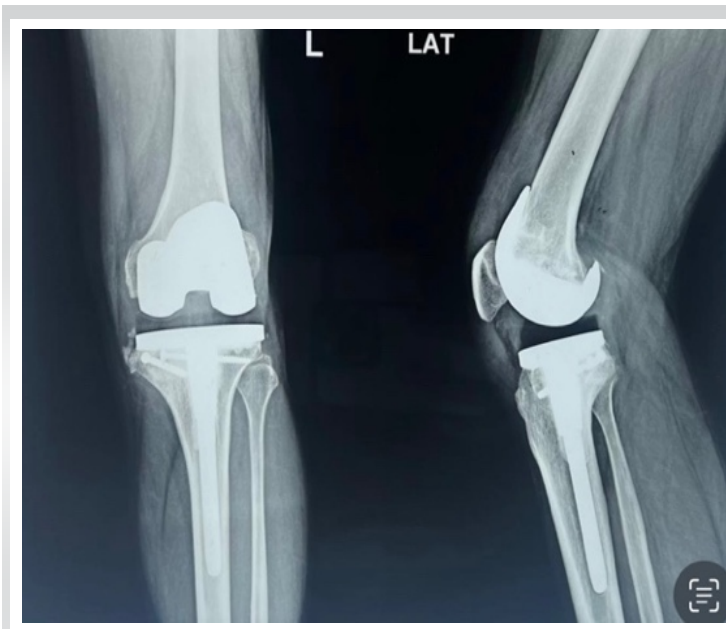
Figure 1: Radiographs demonstrating primary knee replacement.

A 42-year-old man with a history of two total knee replacements (TKRs) 4 years apart presented to us with chief complaints of pain, swelling of the left knee, and inability to bear weight for 2 months. The patient had undergone a primary total left knee replacement 8 years ago (Fig. 1). Four years later, the patient sustained an aseptic failure of primary TKR, after which a revision TKRs was performed (Fig. 2). Revision was performed through the previous incision (medial parapatellar approach), and loosening of the femoral component was noted. The medial tibial bone graft was resorbed (F2B defect in both femoral

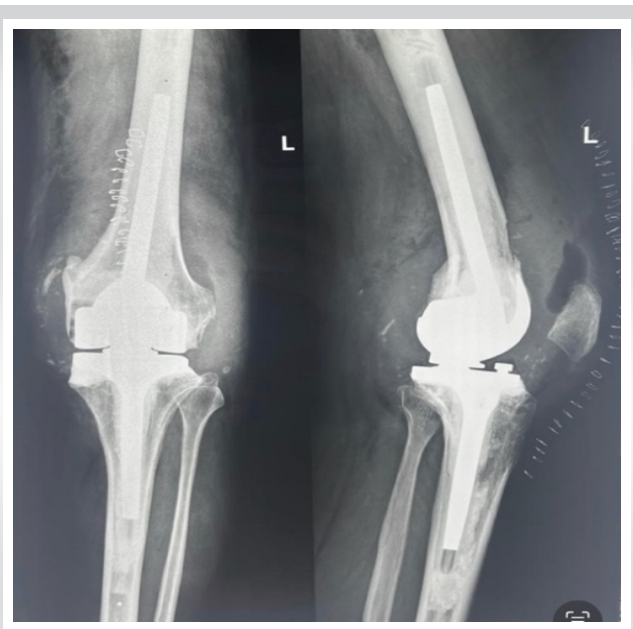
Figure 2: Radiographs demonstrating revision knee replacement.

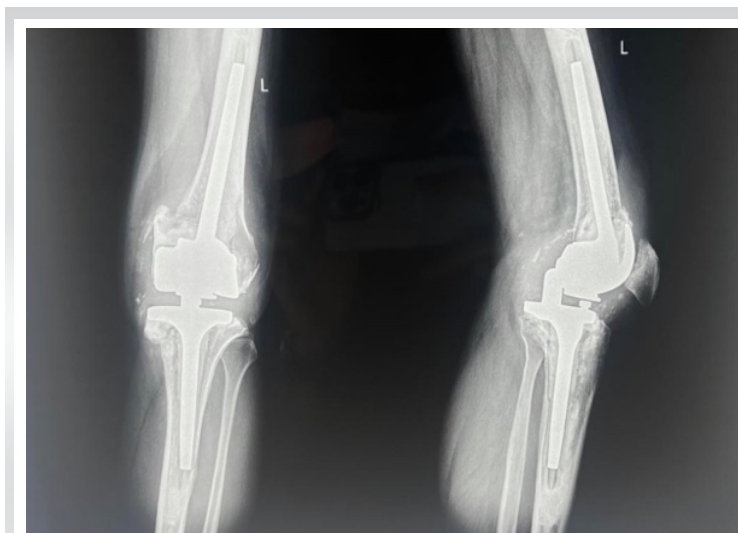
Figure 3: Radiograph demonstrating posterior dislocation of hinged knee prosthesis.

condyles and T2A defect in the medial tibial condyle). In view of this, the prosthesis was explanted and a rotational knee replacement with anti-dislocation mechanism was inserted (Link-Waldemier, non-modular (rotational) joint endo-model). In this procedure, the femoral defect was reconstructed with a polyethylene spacer, and the tibial defect was reconstructed with cement. After the revision surgery, the patient was asymptomatic for 3 years. Subsequently, he began to experience episodes of instability. He presented to us 2 months after the onset of symptoms, with complaints of pain in the knee. A radiograph was obtained and a posterior dislocation of the hinge prosthesis was diagnosed (Fig. 3). The patient was taken for surgical intervention through the previous incision. When the knee joint was exposed, it was found that there was complete polyethylene wear of the anti-dislocation mechanism (Fig. 4). The fixation screw which had loosened was removed, the polyethylene insert was replaced, and a new polyethylene insert was implanted. The anti-dislocation mechanism's wear and tear has no specific cause. An examination of the literature does point to aseptic loosening as one of the causes in our situation, although improper placement is also a possibility. Stability was confirmed intraoperatively. The post-operative period was uneventful (Fig. 5). The patient achieved a range of motion of 0–120° in the knee at 4 weeks post-operative with complete resolution of pain. The knee society score of the patient improved from 40 pre-operatively to 90 postoperatively at 1-year follow-up (Fig. 6).

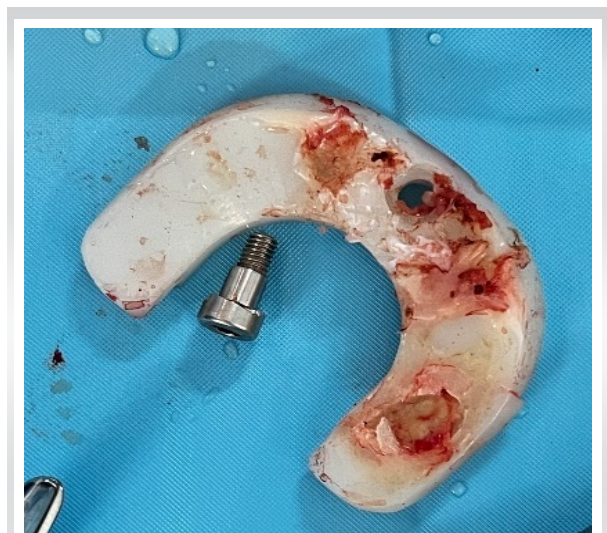
Figure 4: Worn-out polyethylene liner with complete wear of anti-luxation device.

During repetitive activities, fatigue fracture of the dislocation guard can occur. This gradually loosens and allows excessive distraction, whereupon the patient experiences instability and dislocates. This occurs over a long period of time and is therefore often not detected until 3–5 years later. In the case of early onset, trauma to the dislocation guard may be the cause.

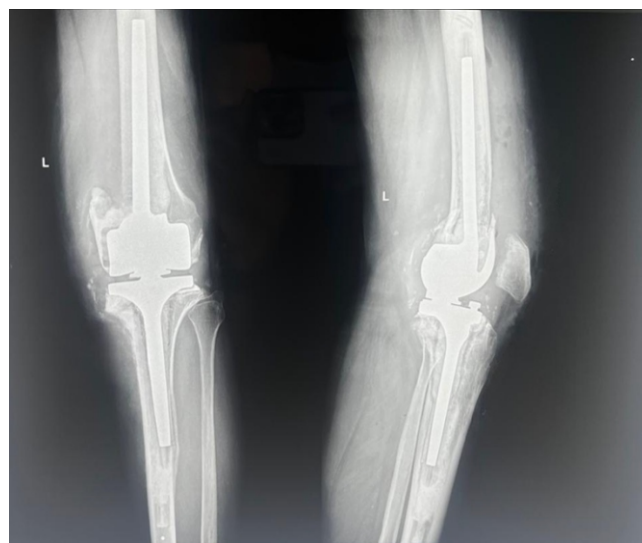
Figure 6: Radiographs at 1-year follow-up.
