# Retrieval Technique of a Broken Guidewire During Core Decompression: Bailout Options – A Case Report

**Case Report:** We report a case of a 19-year-old male presenting with avascular necrosis of bilateral femoral heads (Association Research Circulation Osseous Stage II) who underwent core decompression with platelet-rich plasma injection. The guidewire used broke in the femoral head and migrated into the acetabulum during the surgery, which was successfully retrieved using a combination of over-reaming and an arthroscopic grasper.

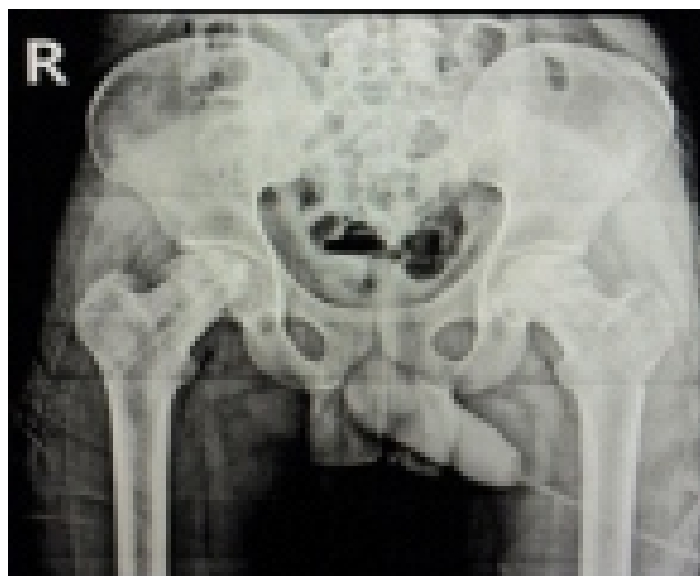
**Figure 1:** Post-operative X-ray.

A 19-year-old male presented with bilateral hip pain and gait abnormality of 1 year's duration. He had a prior history of steroid therapy for tuberculous meningitis. Magnetic resonance imaging (MRI) revealed bilateral AVN of the femoral heads (ARCO Stage II), and he was scheduled for bilateral core decompression with platelet-rich plasma injection (Fig. 1).

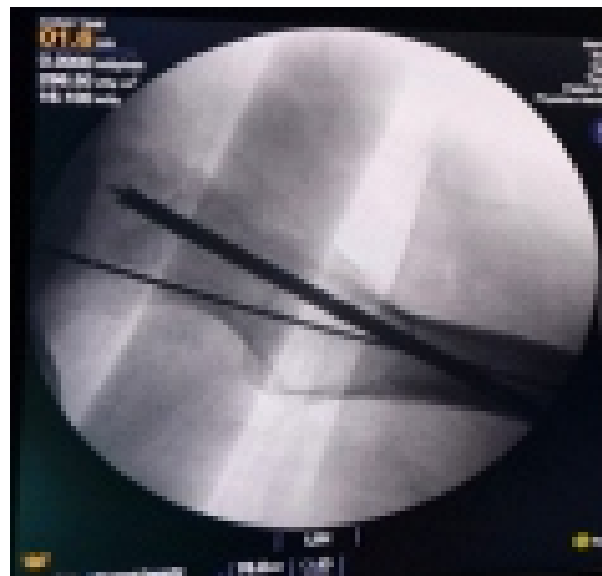
**Figure 2:** Broken guide wire aligned with the broken tip before trying to over-ream.

To retrieve the broken wire, the remaining part of the guidewire was aligned with the broken tip (Fig. 2) over which a dynamic hip screw inner reamer was gently hand-reamed (Fig. 3). This made sure the reaming did not create another tract. This maneuver facilitated mobilization of the wire but also pushed it further (Fig. 4). Finally, using an arthroscopic grasper under continuous fluoroscopic guidance, the fragment was successfully retrieved (Fig. 5).

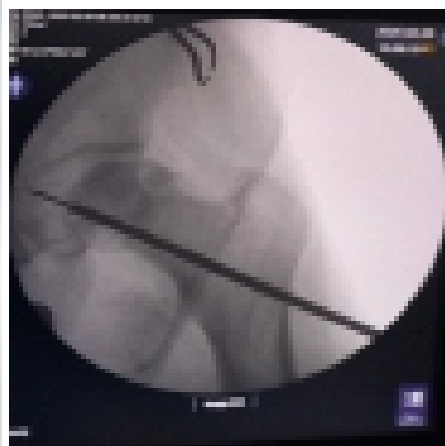
**Figure 3:** Guide wire pushed further inside the acetabulum cavity while trying to over-ream.

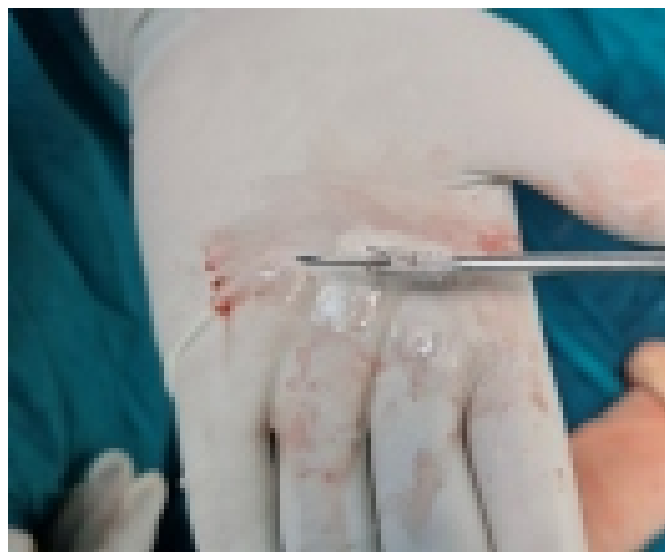
**Figure 5:** Retrieved K-wire tip using arthroscopic grasper.
