# Severe Metallosis-Induced Osteolysis and Polyethylene Liner Dissociation as a Cause of Total Knee Replacement Failure

**Introduction:** Metallosis is a rare but recognized complication following total knee replacement (TKR). It is characterized by metallic particle deposition within periprosthetic tissue, triggering chronic inflammation, progressive osteolysis, and implant loosening.

**Case Report:** A 63-year-old female with bilateral TKRs, performed 12 and 15 years earlier, presented with pain, swelling, and restricted flexion of the right knee following a fall. She had a history of recurrent instability and locking for 3 years. Imaging revealed extensive osteolysis, polyethylene liner dissociation, and loosening of the tibial component. She underwent one-stage revision with implant removal, synovectomy, and implantation of a constrained modular revision prosthesis. Postoperatively, she showed stable function without recurrence.

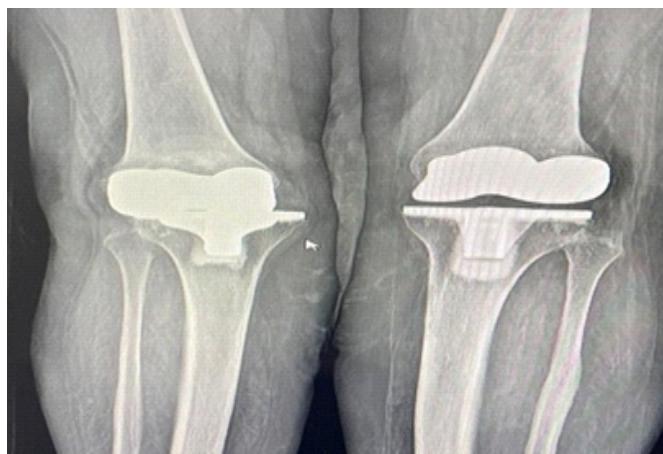
**Figure 1:** There is osteolysis, dislocation, and implant loosening in the right knee, whereas the left knee appears normal in anteroposterior X-ray.

A 63-year-old female presented with pain, swelling, and reduced flexion in the right knee following a fall 2 months earlier. She also reported a 3-year history of recurrent instability, sudden locking, and restricted motion, which she occasionally relieved by self-manipulation. She had undergone bilateral TKR (left knee 15 years ago and right knee 12 years ago) using the Stryker Duracor system. At a local hospital, X-ray imaging, as shown in Figs. 1 and 2, revealed tibial component loosening, polyethylene liner dissociation, and marked osteolysis. Laboratory parameters

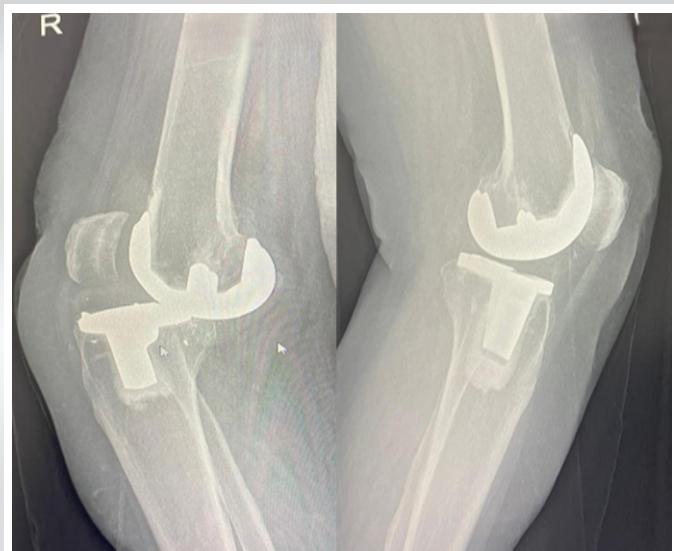
**Figure 2:** Dislocation is well noted in the lateral right knee X-ray, whereas the left knee appears normal.

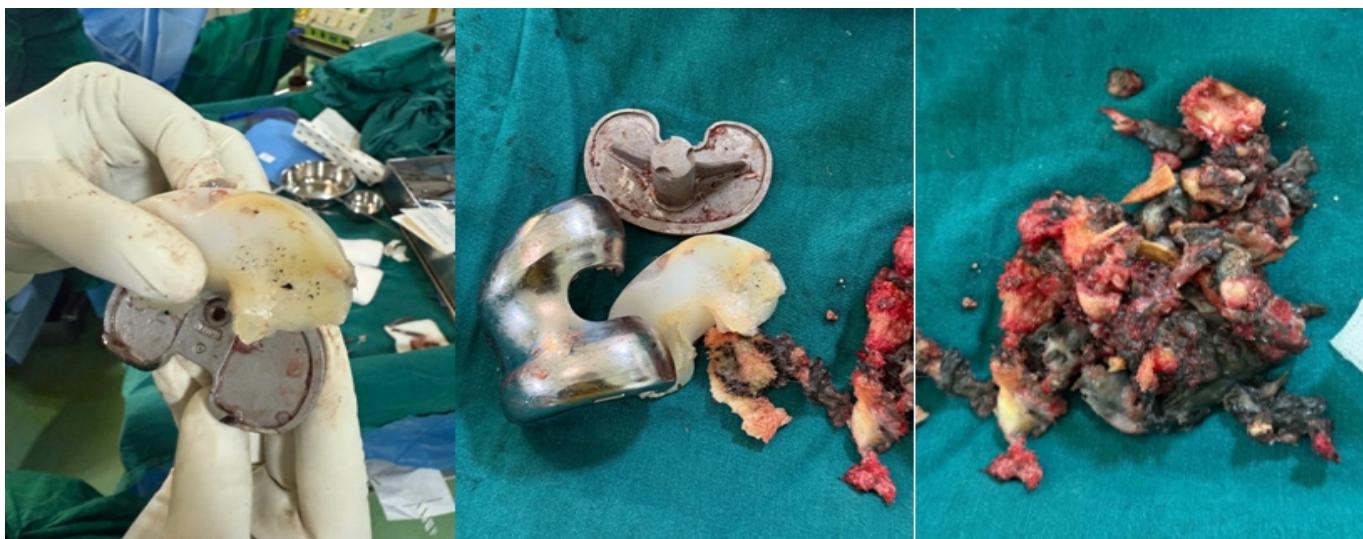
In TKR, common etiologies include polyethylene liner wear, dissociation, or patellar component failure [6, 7]. Rader et al. observed metallosis in 7 of 30 cases with metal-backed patellae, and more than half also showed liner dissociation [6]. In our case, tibial liner dissociation led to direct metal-on-metal contact, accelerating wear and osteolysis.

**Figure 3:** Metallic debris, a worn-out polyethylene liner, gives us a diagnosis of metallosis.

On admission to our center, she had persistent swelling and pain with restricted mobility. A one-stage revision TKR was performed, involving implant removal, extensive synovectomy, and reconstruction with a constrained modular revision system. Intraoperative images, as per Fig. 3, show metallic debris and a worn-out polyethylene liner, which gives us a diagnosis of metallosis. Post-operative radiographs confirmed stable implants without evidence of loosening, as shown in Fig. 4.

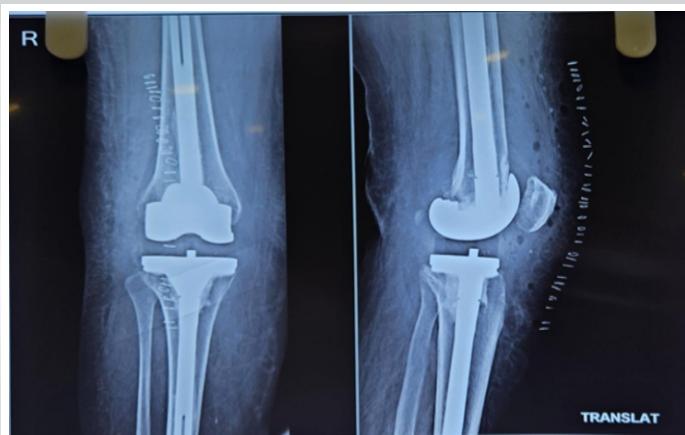
**Figure 4:** Post-operative X-ray following revision total knee replacement of the right knee.
