Severe Metallosis after Tumor Mega-Prosthesis: Revise or Retain? - A Case Series

Introduction: Tumor mega-prostheses are widely used for limb salvage following resection of bone tumors. Although infection and aseptic loosening are the most common causes of failure, metallosis secondary to structural failure is uncommon and may mimic other complications. We describe a case series of two cases of severe metallosis following tumor mega-prosthesis reconstruction.

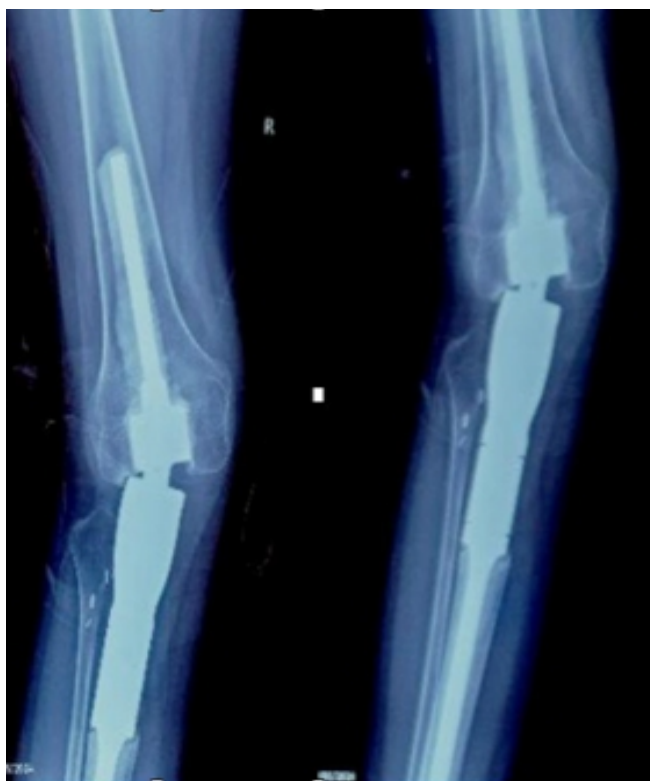
Figure 1: Knee radiograph showing valgus deformity.

A 34-year-old male presented to us with the inability to bear weight and valgus deformity at the knee. He had a history of a giant cell tumor in the right proximal tibia, for which he was operated on elsewhere with a hinge knee tumor prosthesis 3 years back. The patient was advised to undergo a total revision of the prosthesis in another hospital due to prosthesis failure. We took a detailed history from the patient. There was no history of trauma, fever, or any other clinical symptoms suggestive of infection. Blood investigations, including the total leukocyte count (TLC), erythrocyte sedimentation rate (ESR), and C-reactive protein (CRP), were within normal limits. His X-ray revealed valgus deformity (Fig. 1).

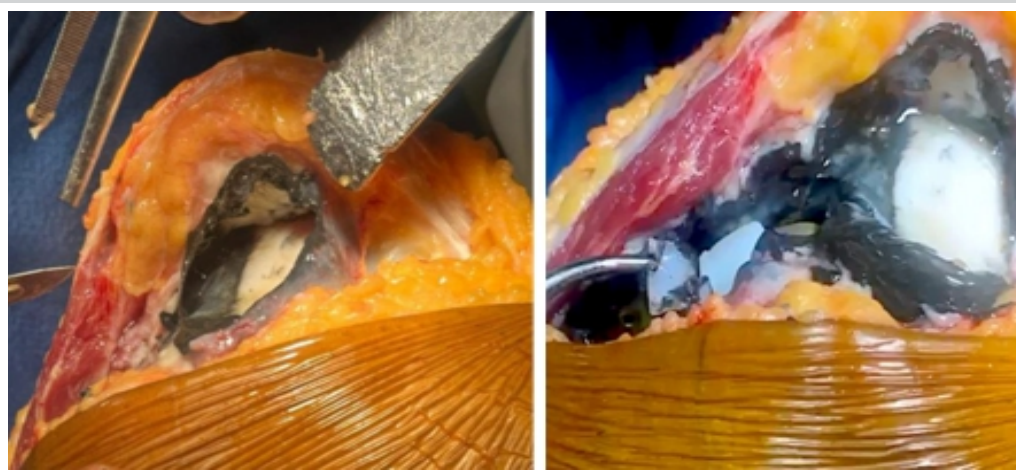
Figure 2: Severe metallosis in the adjacent tissues and broken bushing of the hinge mechanism being taken out.

After taking valid consent, under combined spinal and epidural anesthesia and all septic conditions, a midline incision and medial para-patellar arthrotomy were done. The prosthesis was exposed, and severe metallosis was found in the adjacent tissues. On further examination, there were no signs of infection or loosening in the femoral or tibial component. The hinge of the prosthesis was then examined in detail, and the bushing was found to be broken (Fig. 2). Hence, we decided to change the polyethylene bushing only. Radical debridement of tissue having metallosis was done, and the bushing was changed. The deformity was corrected, and the range of motion improved significantly compared to the pre-operative condition (Fig. 3) shows

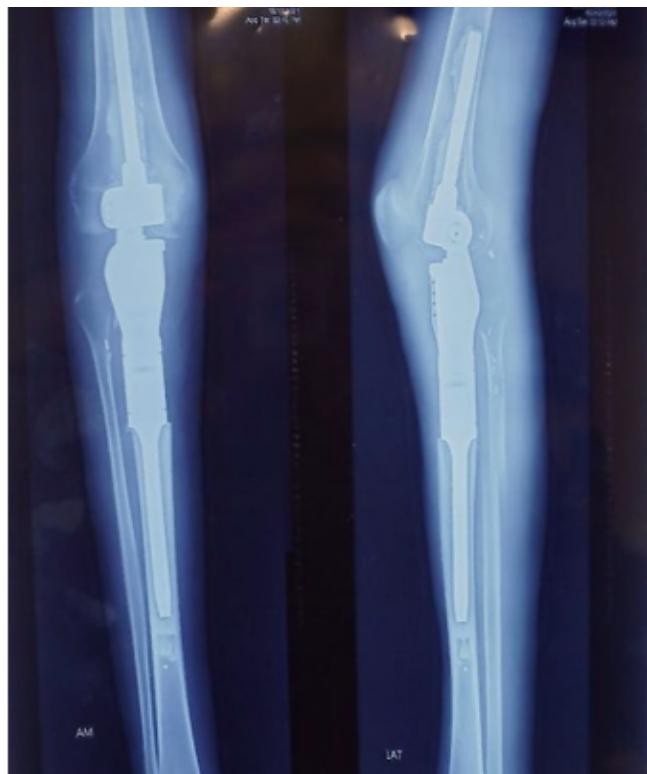
Figure 3: Post-operative radiograph shows correction of deformity.

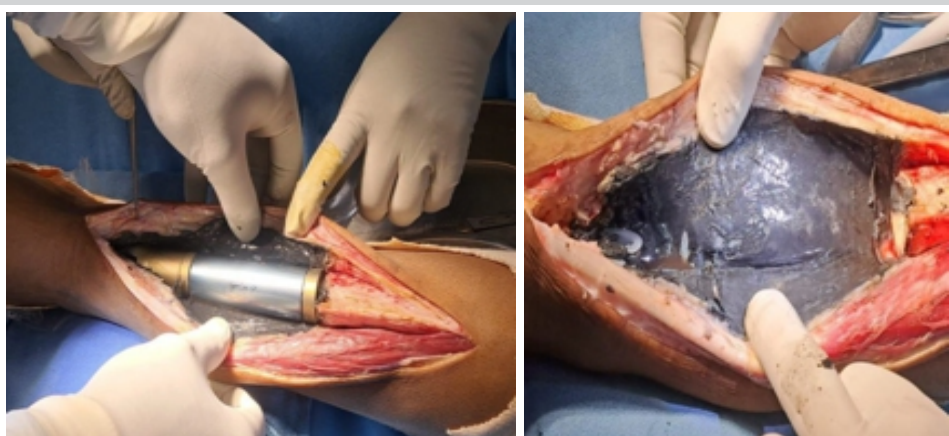
Figure 4: Metallosis in the periprosthetic tissue and osteolysis in the bone-prosthesis interface, and severe metallosis is visible after removal of the prosthesis.

Intraoperatively, features consistent with severe metallosis were noted, including dark-stained periprosthetic tissues and evidence of implant loosening (Fig. 4). The procedure involved removal of the failed distal tibia implant, radical debridement of metallic tissues (Fig. 5), and reconstruction with a cemented distal tibia with a longer stem (Fig. 6). Prophylactic encirclage was done to reduce the risk of iatrogenic fracture. Thorough debridement of metallic tissue was performed to reduce inflammatory burden and prevent further soft tissue compromise.

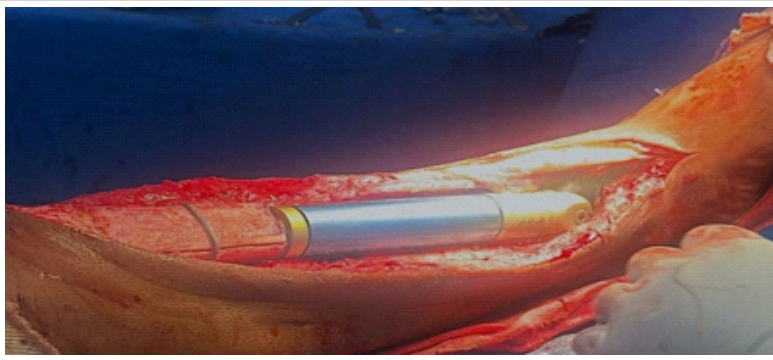
Figure 5: Reconstruction with a cemented distal tibia prosthesis with a longer stem.

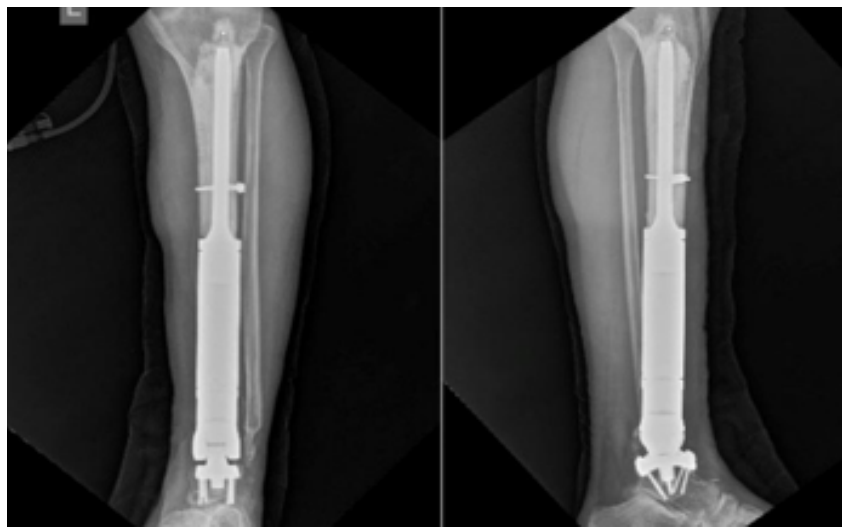
Figure 6: Post-operative radiograph shows revision of prosthesis with a long cemented stem.

Management of severe metallosis requires aggressive surgical intervention. Treatment usually consists of complete synovectomy, extensive debridement of stained and necrotic tissues, removal of all prosthetic components, and revision with long stems, constrained reconstruction, and augments to address bone loss [6,8]. Use of an oxidized zirconium (Oxinium) femoral component was intended to reduce future wear potential, given its improved surface hardness and lower metal ion release compared with traditional cobalt-chromium alloys [5]. In this article, in the first case, we changed the broken bushing only, as there was no osteolysis or loosening of the implant, whereas complete revision of the distal tibia replacement was mandatory in the second case, as osteolysis and loosening had already occurred.
