# Metallosis Following Total Hip Arthroplasty: A Case Report

**Keywords:** Metallosis, total hip arthroplasty, revision total hip arthroplasty.

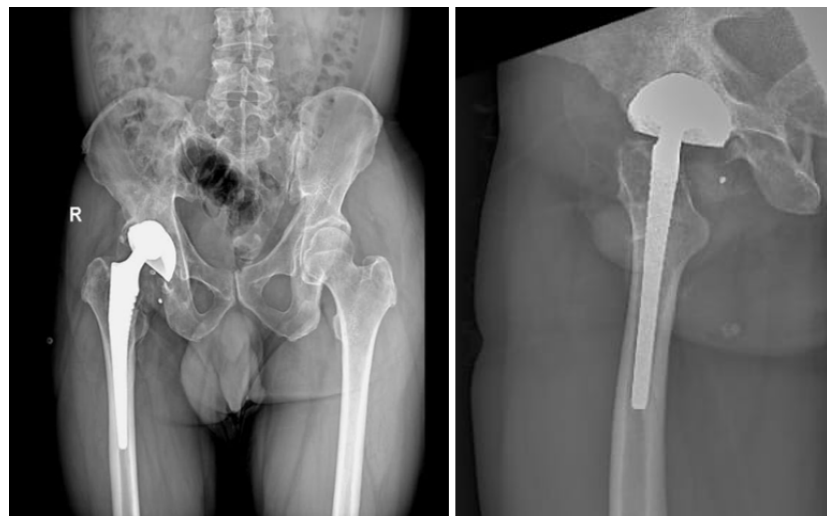
**Figure 1:** Anteroposterior radiograph of the pelvis with both hips and lateral radiograph of the right hip demonstrating eccentric positioning with proximal and medial migration of the femoral head, together with osteolysis around the acetabular component.

inflammatory markers were within normal limits, making infection less likely. Hip radiographs suggested proximal migration of the metallic femoral head in the acetabulum with osteolysis around the acetabular component (Fig. 1). Considering a possibility of aseptic implant failure, the patient was planned for a revision hip arthroplasty procedure.

The clinical presentation of metallosis is variable and may include pain, limp, restricted movement, limb shortening, instability, or progressive loss of function. Reported radiographic findings include eccentric positioning or migration of the femoral head, polyethylene wear, periprosthetic osteolysis, component loosening, the cloud sign, and the bubble sign [10,24,25]. In the present case, proximal and medial migration of the femoral head with acetabular osteolysis strongly suggested catastrophic liner and acetabular component failure before surgery.

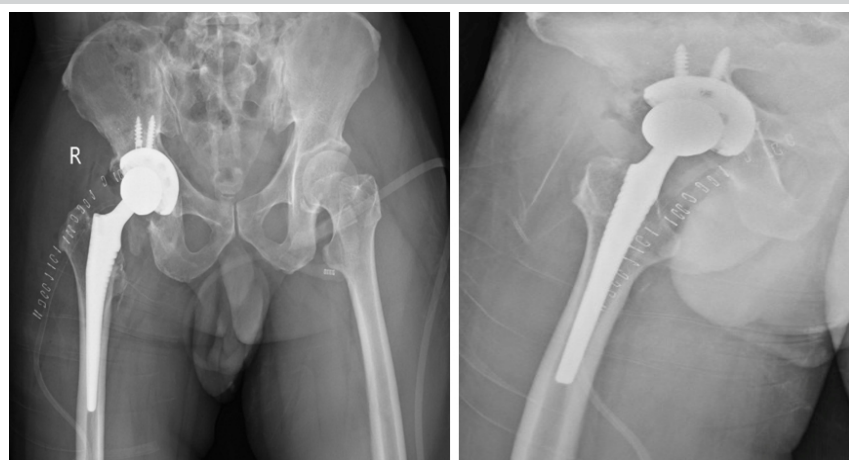
**Figure 4:** Anteroposterior and lateral X-rays of post-operative images (revision total hip arthroplasty).

A 52-mm size acetabular cup was implanted and fixed with two 6.5-mm titanium screws to increase fixation stability. Liner of size 52/36 and a 36-mm cobalt-chromium femoral head were

used (Fig. 4). The histopathology report revealed coarse grey-black pigment within the synovial lining, histiocytes, and foreign-body giant cells, suggestive of metallosis (Figs. 5 and 6). Tissue cultures revealed no growth. At the 12-month follow-up, the patient was pain-free, ambulatory without support, and demonstrated stable implant positioning without radiographic evidence of loosening.
