A Novel Failure Interface in Constrained Total Hip Arthroplasty: Dissociation at the Constrained Liner Insert-Bipolar Head Junction Following Periprosthetic Joint Infection

Abstract

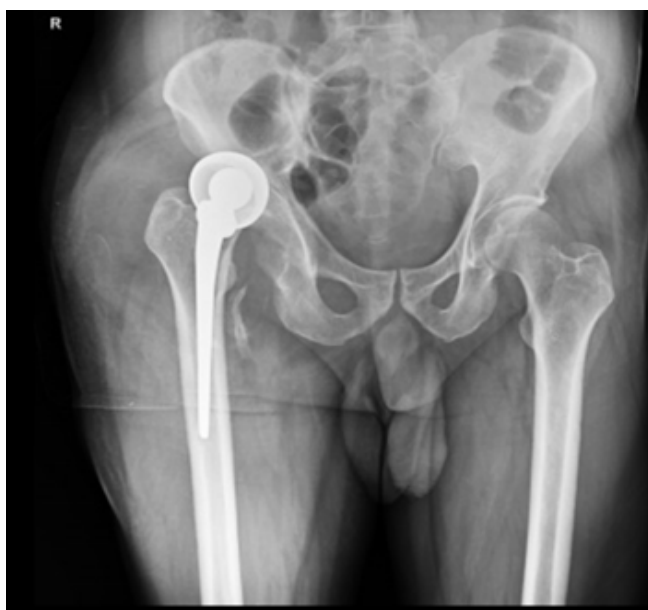
Figure 1: Anteroposterior pelvis radiograph showing right hip hemiarthroplasty with dislocation of the femoral head.

Laboratory investigations revealed elevated inflammatory markers consistent with infection. Plain radiographs revealed a posteriorly dislocated hemiarthroplasty prosthesis (Fig. 1). A diagnosis of PJI with instability was established. The patient was managed with wound debridement and lavage, explantation of the hemiarthroplasty prosthesis, and placement of an antibiotic-impregnated cement spacer (Fig. 2) as the first stage of a two-stage revision. Antibiotic-impregnated cement spacer had also dislocated on the 5th post-operative day.

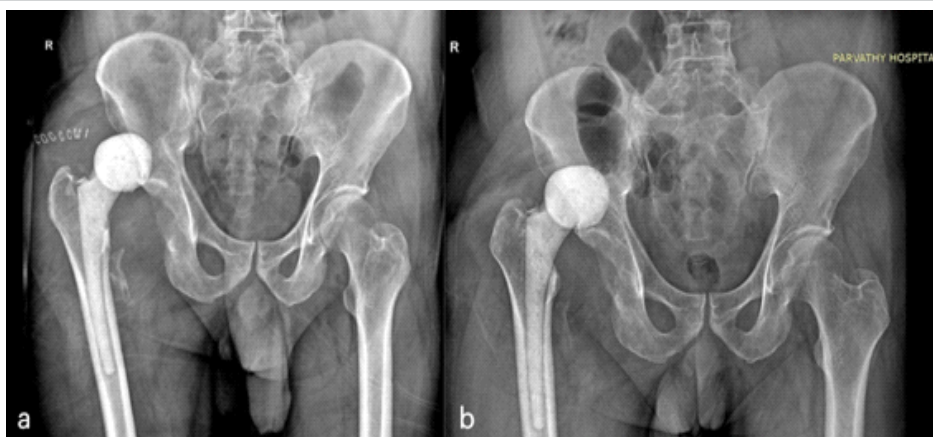
Figure 2: Anteroposterior radiograph of the pelvis showing dislocated antibiotic cement spacer (a) Five days and (b) Three months postoperatively.

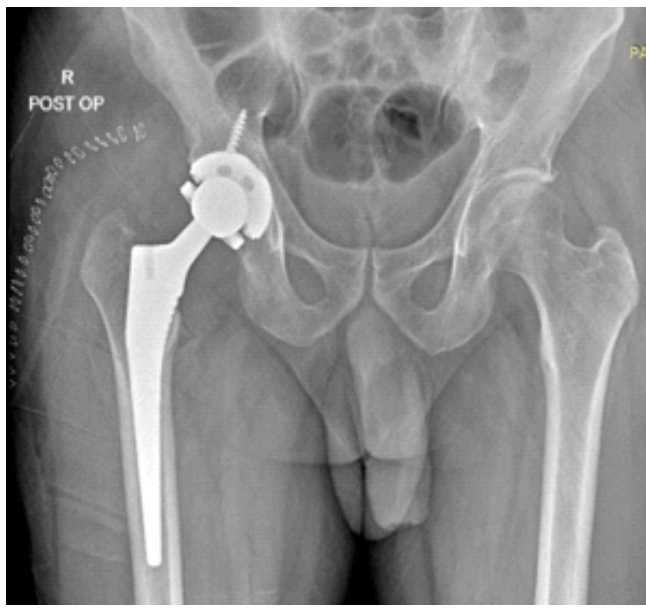
Figure 3: Post-operative anteroposterior radiograph of the pelvis demonstrating a right revision total hip arthroplasty with a cementless femoral stem and a constrained acetabular liner construct.

After an interval of 12 weeks on culture-directed intravenous antibiotics, with normalization of inflammatory markers and a negative aspiration, the patient underwent first-stage revision THA with a constrained acetabular liner construct (Fig. 3 & 4).

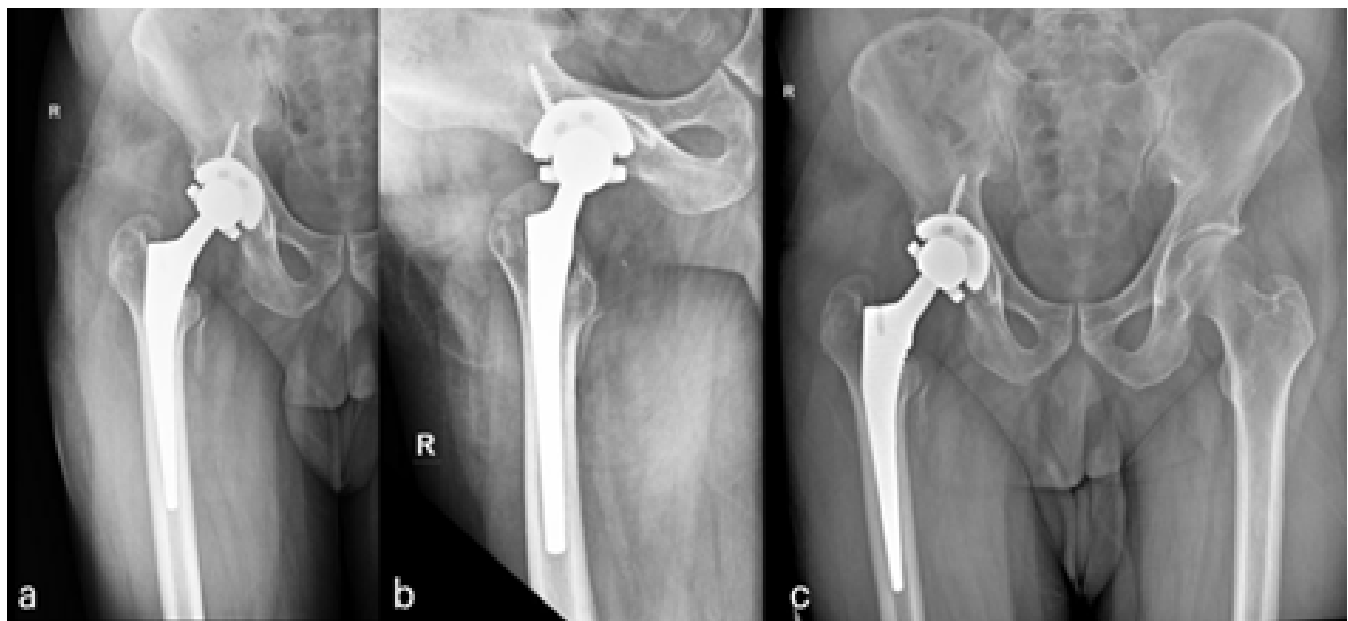
Figure 4: Post-operative radiograph of right hip following revision total hip arthroplasty with a constrained acetabular liner. (a and b) One month Anteroposterior and lateral, respectively, (c) two months anteroposterior view.

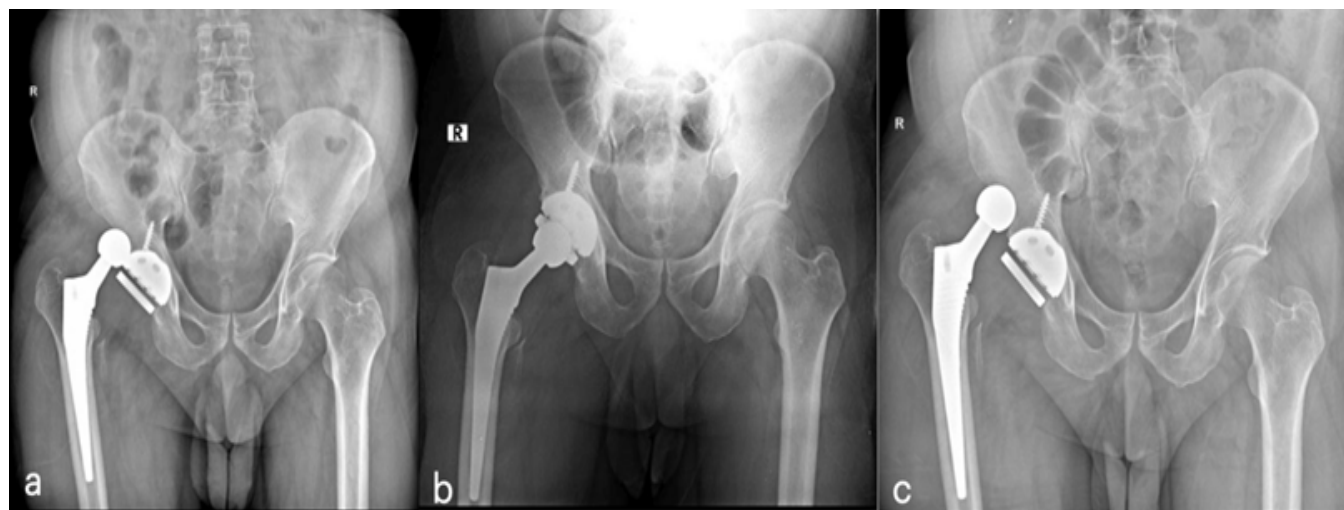
Unfortunately, the patient was poorly compliant with the prescribed post-operative hip precautions. He returned prematurely to ambulation and strenuous activities, including ground-level work, within 2 months of surgery, and was on irregular follow-up. At 6 months following revision THA, he presented with dislocation, which was

successfully managed with closed reduction (Fig. 5). However, he resumed ambulation within 1 week of closed reduction and went on to develop a further dislocation. This sequence of events underscores the ongoing challenge of managing recurrent instability in the setting of compromised soft tissues, poor patient compliance, and a multiply-revised hip.

Figure 5: Anteroposterior pelvis radiograph showing (a) dissociation of the bipolar head from the constrained liner insert without ring disruption at 6 months postoperatively, (b) immediate post-closed reduction radiograph confirming satisfactory reduction of the femoral head within the constrained liner, (c) radiograph obtained 1 week following closed reduction demonstrating recurrent dislocation.

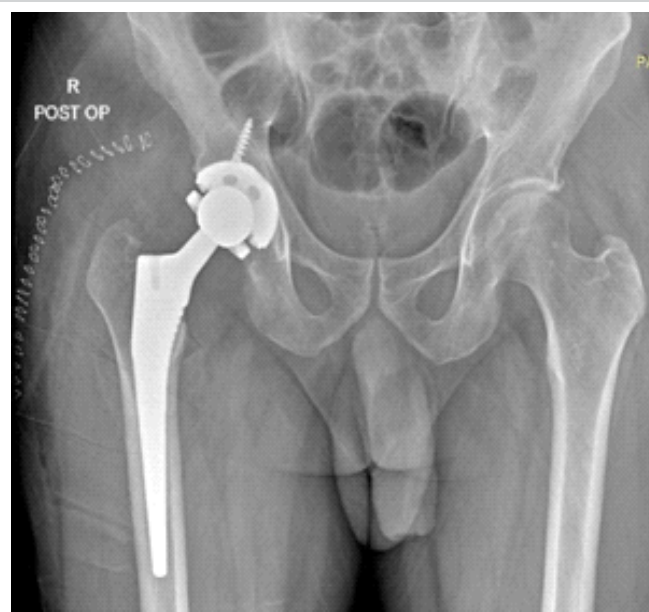
During the second revision, the acetabular component was found to be well-fixed (Fig. 6). The femoral stem was also well-fixed and retained. The polyethylene rim of the constrained liner insert was also found to be undeformed. However, on intraoperative examination of the retrieved failed liner assembly, a previously unreported failure mode was identified; the failure interface was located at the factory-assembled junction between the constrained liner insert and the bipolar head.

Figure 6: Post-operative anteroposterior radiograph of the pelvis demonstrating the second revision right total hip arthroplasty, with a cementless femoral stem and constrained acetabular liner construct.

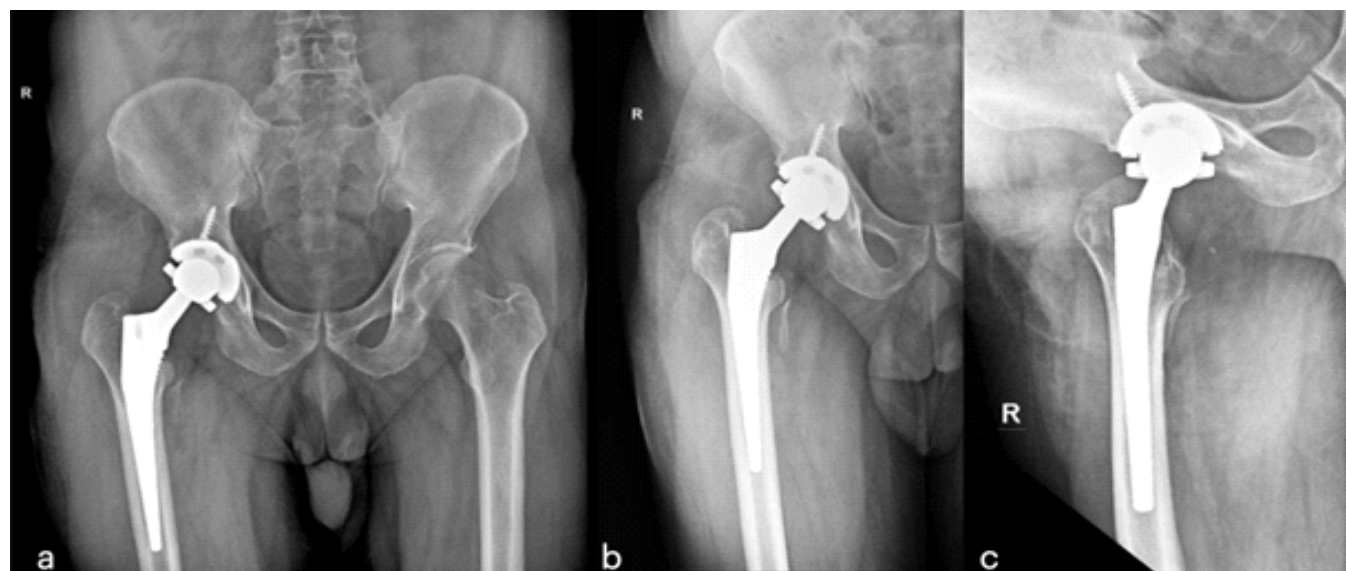
Figure 7: Post-operative radiographs following the second revision right total hip arthroplasty (a) Anteroposterior pelvic radiograph at 1 month, (b) anteroposterior and (c) lateral radiographs of the right hip at 1 year.

Subsequent management involved further counseling regarding activity restrictions, physiotherapy focused on hip abductor strengthening, and close surveillance. At routine clinic follow-up, the prosthesis was well-positioned, and the patient had achieved a satisfactory range of motion (Fig. 7). The patient was advised regarding permanent restriction from heavy manual labor.
