3D Computed Tomography-Guided Management of Retained Surgical Drain in Total Knee Arthroplasty: A Case Report and Technical Note

Learning Point of the Article:

Three-dimensional computed tomography can accurately diagnose and guide treatment planning for impinged surgical drains in knee arthroplasty patients.

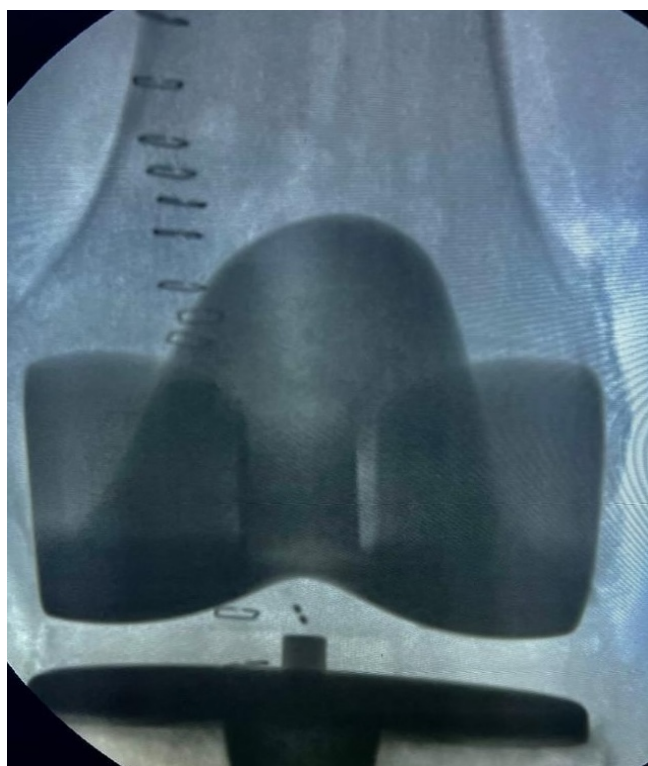
Figure 1: Anteroposterior radiograph of the knee in the post-operative period.

Traditional plain radiographs often fail to adequately visualize retained drain segments due to the radiolucent nature of drain materials and the superimposition of anatomic structures. In both our cases, post-operative radiographs could not clearly

demonstrate the retained drain segments.

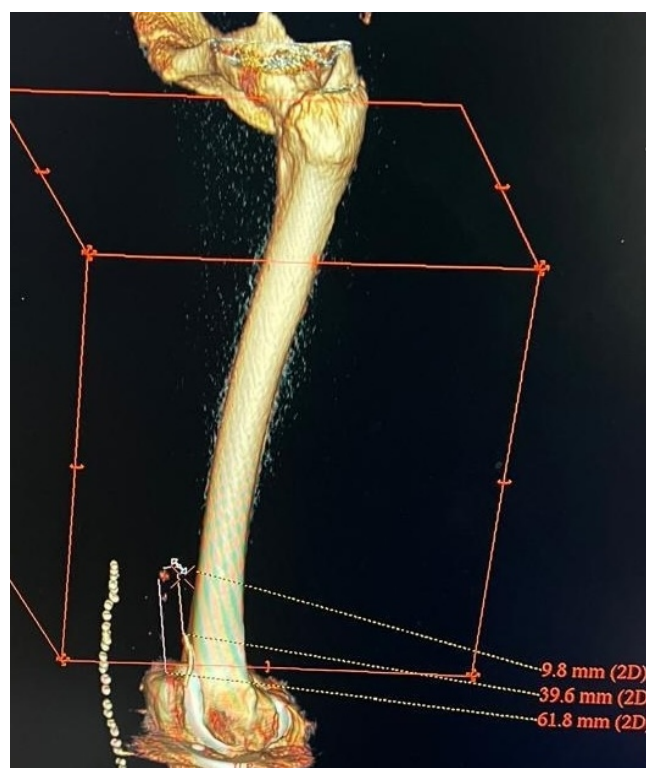
As per institutional protocol, drain removal was attempted after 24 h of surgery. Despite a moderate traction force, the drain could not be withdrawn. Repositioning the knee into flexion was attempted, but this resulted in the drain breakage with retention of the proximal segment. An investigation was undertaken to determine the cause. Post-operative radiographs of the knee failed to clearly demonstrate the retained drain (Fig. 1). A 3D CT scan was subsequently performed, which precisely localized the retained drain segment lying between the articular surface of the patella and the femoral implant (Fig. 2).

Figure 2: 3D computed tomography scan showing the retained drain segment.

The decision to remove the drain under sedation was made. With the help of the 3D CT scan, the corresponding four stapler sutures were removed. Below that, only one fascial suture was removed, and the retained drain piece was extracted without difficulty. Wound wash was given, and closure was done in layers. The rest of the post-operative period was uneventful, and the patient was discharged in stable condition on the 5th day. On 1- and 3-month follow-up in the outpatient department, the

In both cases, a 3D CT scan was performed to help localize the retained segments. The scan enabled assessment of the distance from the proximal suture line. With these dimensions, the exact location of the retained drain segment was identified. This was immensely helpful in guiding us to the corresponding sutures. Instead of opening all sutures from the proximal or distal end, as documented in the literature, we opened only the four sutures above the drain location. This allowed the removal of the retained segment through a minimally invasive approach. Despite these advantages, 3D CT scan has limitations, including radiation exposure, added cost, and availability at the medical center. These factors need to be weighed against potential benefits.

In our cases, 3D CT precisely localized the retained segments and their relationship to surrounding structures. This information was crucial in planning a minimally invasive retrieval approach. Instead of extensive wound exploration with removal of all sutures, we were able to target only the specific area containing the retained drain. This reduced surgical trauma, operative time, and potentially lowered infection risk.

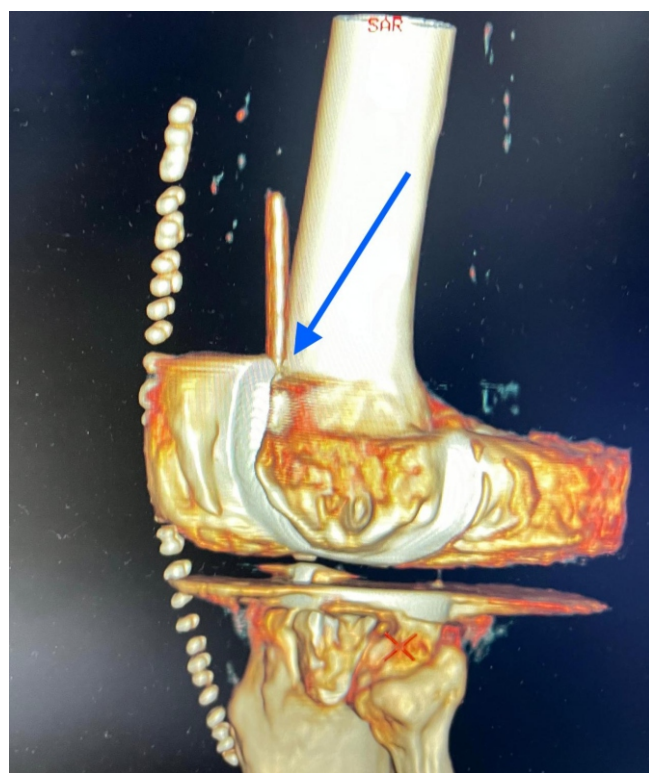
Figure 3: 3D computed tomography scan showing the point of impingement (indicated by blue arrow).

impingement between the articular surface of the patella and the femoral component, which was confirmed on the 3D CT scan.

In Case 2, the drain broke while being removed with the knee in extension. This may have been due to weakening from

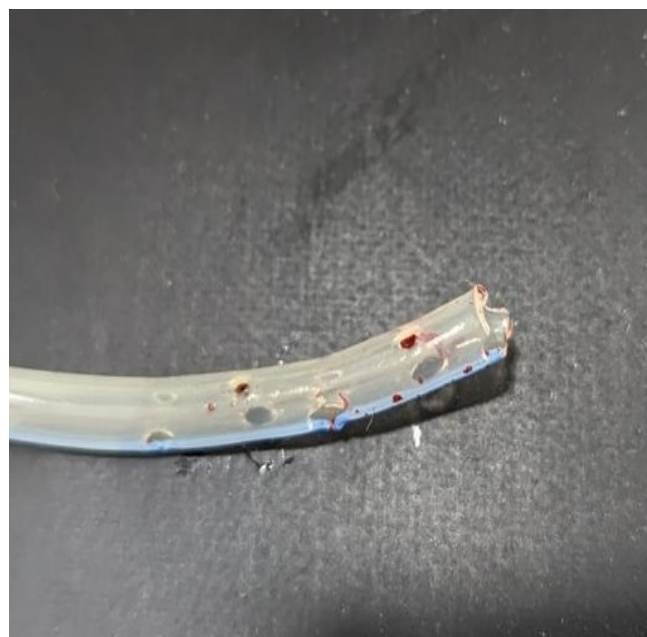
Fig. 4 demonstrates the tethered junction points of the retrieved drain segments.

Figure 4: The drain with its broken junction of the retained segment.
