# Technical Note in Case Series a Novel Recent Technique for the Removal of Broken PFNA-II Blade in Intertrochanteric Fractures is a Technical Challenge

Easy innovative method for removal of PFNA II when conventional methods fail.  
With the modification of a new implant for fracture fixation, removal also needs innovation techniques.

**Keywords:** PFNA- II, implant removal, helical blade, coupling screw

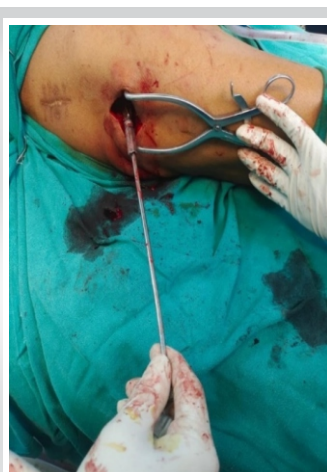
**Figure 3:** DHS Richard screw guide wire removing the broken PFNA- II blade.

The surgery was done under spinal anesthesia, utilizing the original lateral approach. The end cap and distal locking bolt were successfully removed in the initial step of surgery. To remove the helical blade hexagonal socket was locked up with the extraction screw. The broken distal part of the PFNA- II blade was taken out. However, now technical demand was removing the proximal long part of the PFNA- II blade which was buried in bone. The technical problem was how to hold the broken proximal PFNA- II blade buried inside the bone and nail shaft. We used the coupling screw for inserting DHS Screw/Long Coupling Screw for DHS Screw Removal is fixed to the broken proximal part of the PFNA- II blade on the guide wire. Then, it is pulled out under c arm guidance. DHS dynamic hip set is an easily available and cheap instrument to remove (Fig. 2a and b, 3-7) Mandrel devices, osteotomes, hook rods, Steinman pins, broken screw carbon drill bit, Kuntcher groovers, cerclage wire, and laparoscopic forceps should also be kept for this procedure.

We developed a new technique for the removal of a broken PFNA- II blade with a very easily available DHS Dynamic Hip Screw set -Screw/Long Coupling Screw for DHS Screw removal which is fixed to the broken proximal part of the PFNA- II blade on the guide wire. Then, proximal part of the PFNA- II blade is pulled out under c-arm guidance.

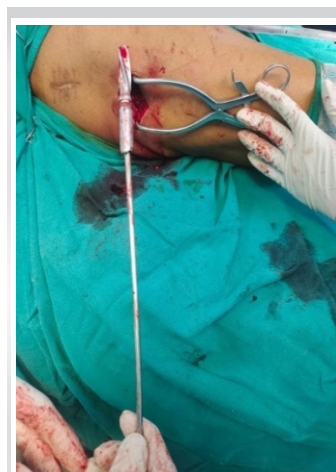
**Figure 4:** DHS Richard screw guide wire removed the broken PFNA- II blade.

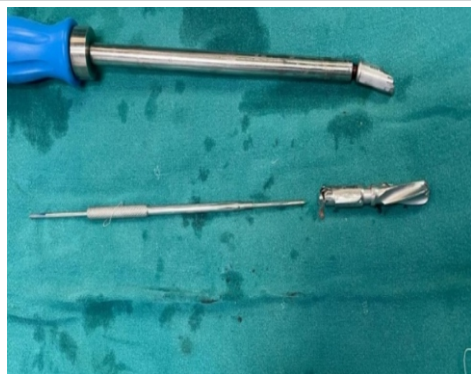
**Figure 5:** Screwdriver removed the broken piece of the PFNA- II blade.

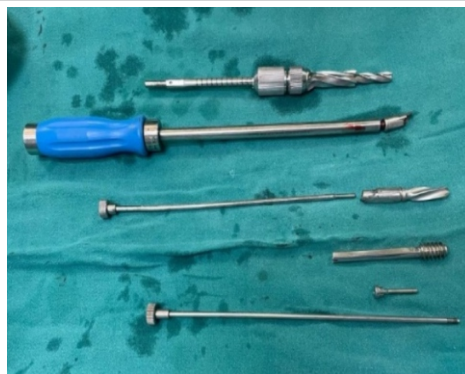
**Figure 6:** All instruments required to remove broken PFNA- II Blade (Manufacture Sarma Ltd).

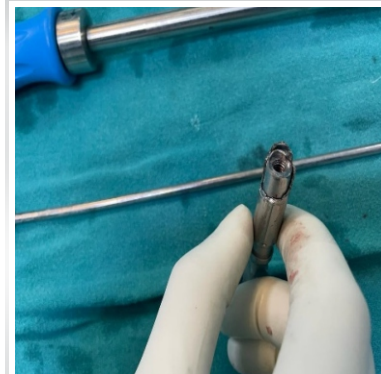
**Figure 7:** Pitch in Blade to tighten DHS Richard screw guide wire (Manufacture Sarma Ltd).
