The Price of Poor Cementing: A Case Report on Chronic Hip Dislocation and Revision

Learning Point of the Article:

Meticulous cementing technique during hemiarthroplasty is essential to prevent cement interposition, which can lead to chronic hip dislocation, instability, and the need for complex revision surgery.

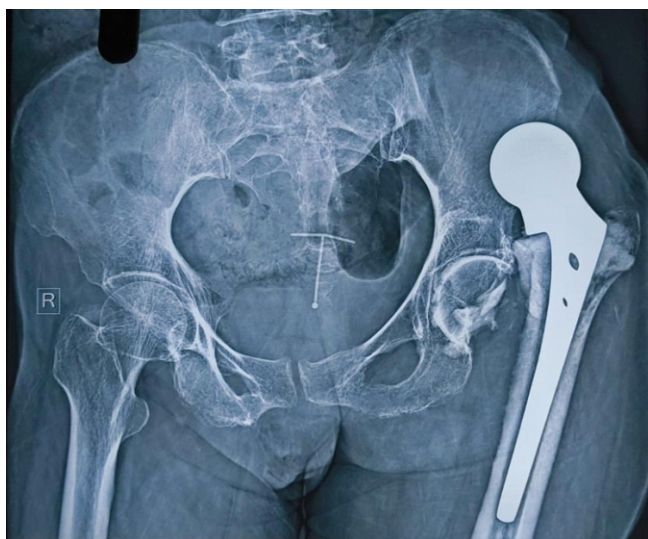
Figure 1: Pre-operative anteroposterior radiograph of the pelvis showing a dislocated left hemiarthroplasty with the femoral head displaced superiorly and posteriorly. Multiple irregular radio-opacities are visible in the acetabular fossa, suggestive of cement interposition.

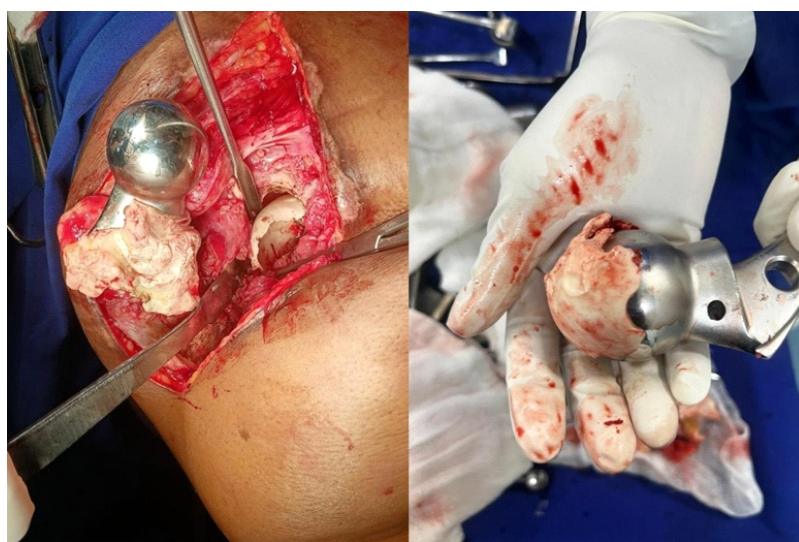
Figure 2: Intraoperative image showing cement interposition within the acetabular fossa. A well-formed, dense cement fragment conforming to the acetabular contour is visualized, confirming the migration of bone cement during the index hemiarthroplasty.

observed, effectively ruling out residual femoral head fragments and intra-articular loose bodies. The acetabular walls were intact, and no signs of osteolysis, sequestrum, or infection were observed. The extracted cement was removed en bloc (Fig. 2). A bipolar prosthesis was chosen over total hip replacement (THR) due to the patient's advanced age, lower functional demands, and intact acetabular wall with no significant erosion or osteolysis. In contrast to the index surgery, meticulous cementing technique was followed. The acetabulum was protected using moist gauze to prevent cement entry, and the cement was introduced only in its doughy phase. The femoral canal was thoroughly prepared, and cement was introduced retrograde with controlled pressurization to achieve a uniform mantle and secure implant fixation. The hip was successfully reduced, ensuring good stability and range of motion (Fig. 3). Given the patient's advanced age and osteoporotic bone quality, prophylactic cerclage wiring was applied in the subtrochanteric region to reinforce the femur and minimize the risk of intraoperative or post-operative periprosthetic fracture. Thorough irrigation to minimize the risk of infection, careful soft tissue balancing to optimize hip biomechanics, and repair of the posterior capsule to enhance stability were done. Intraoperative assessment confirmed satisfactory positioning of the prosthesis with no undue impingement or instability. Closure was performed in layers, and the patient was stabilized post-operatively. Standard operating procedures were maintained. The immediate post-operative radiograph demonstrated a well-seated bipolar prosthesis with concentric reduction of the hip joint. The acetabular contours appeared intact with no residual cement fragments or signs of joint incongruity. Limb alignment was restored with no limb length discrepancy, and the implant position was stable without evidence of subsidence or malposition (Fig. 4). The patient had

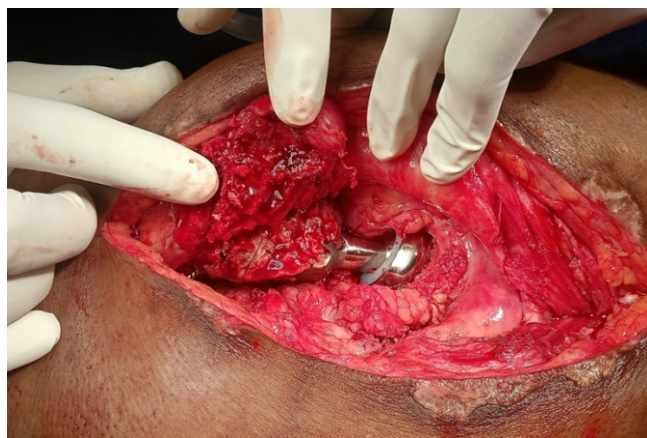
Figure 3: Intraoperative image following cement removal, prosthesis revision, and hip reduction. The bipolar prosthesis is securely positioned with a congruent articulation in the acetabulum.

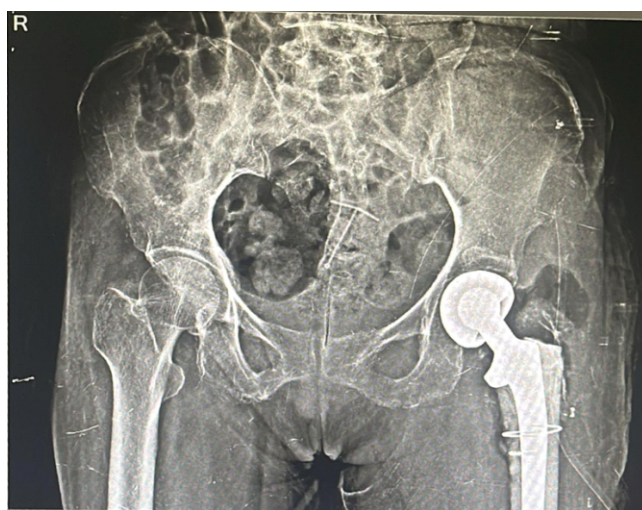
Figure 4: Post-operative anteroposterior radiograph of the pelvis showing a well-aligned bipolar prosthesis in situ with concentric reduction of the left hip joint.
