# Failure of a Modular Femoral Revision Stem in Hip Arthroplasty: A Rare Complication and Literature Review

Fracture of the ZMR modular stem is a rare, catastrophic complication in revision hip arthroplasty, often caused by cantilever fatigue; monoblock stems may reduce this risk.

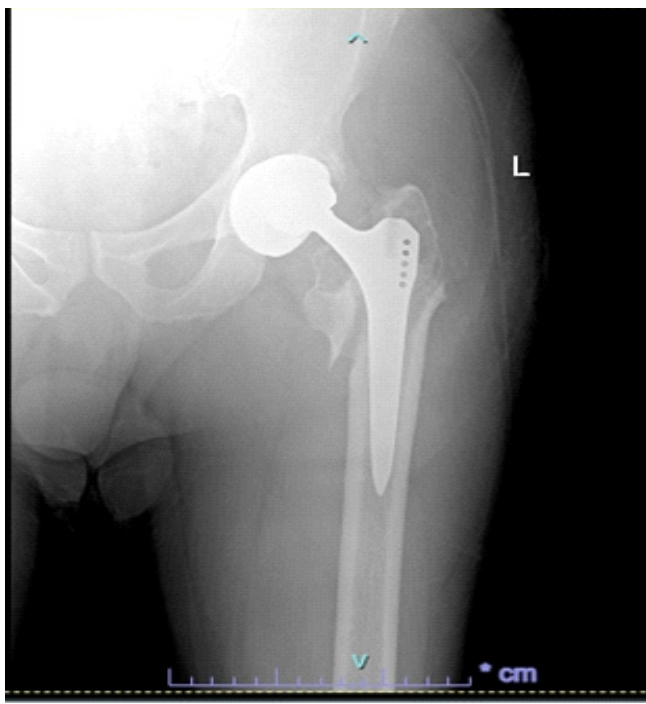
**Figure 1:** Vancouver B2 periprosthetic fracture of the left total hip arthroplasty.

In 2021, the patient sustained a fall onto his left side, resulting in a periprosthetic proximal femoral fracture, classified as a Vancouver B2 (Fig. 1). He underwent surgical management involving stem exchange using a long revision stem (ZMR Stem), with revision of the acetabular shell (Fig. 2), the approach for femoral stem

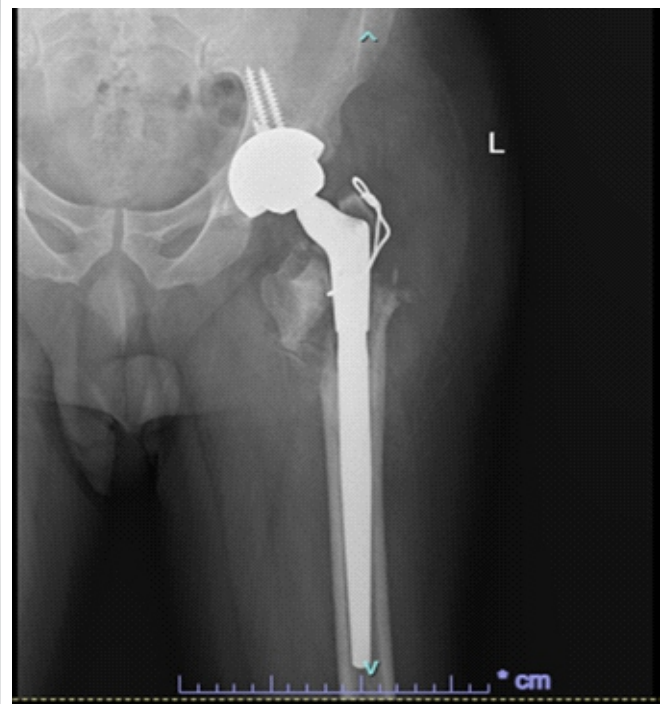
**Figure 2:** Revision of the left total hip arthroplasty using Zimmer modular revision stem.

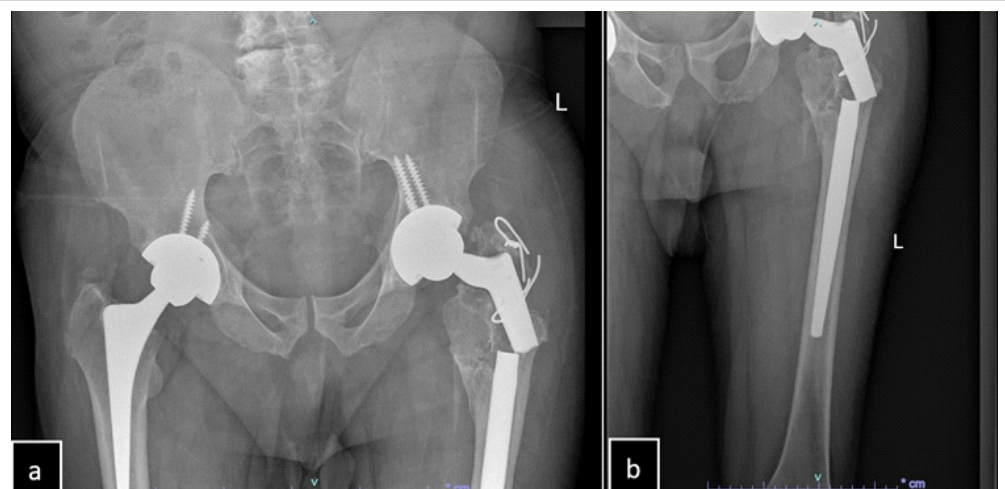
**Figure 3:** (a) Pelvic X-ray demonstrating failure of the left Zimmer modular revision system at the body-stem junction; (b) Left femur radiograph showing the same stem failure at the body-stem junction. Both images also reveal non-union of the greater trochanteric osteotomy from the prior revision surgery, with the distal stem appearing well-fixed.

Given the patient's history and clinical presentation, an urgent radiographic evaluation was performed. The X-ray images obtained in the emergency department are shown in Fig. 3a and b, showing a catastrophic failure of the system at the stem junction, noted along the cone taper stem junction. The patient was admitted for pain management and pre-operative planning.

After careful review of all clinical photographs of the failed implants, a consistent finding was noted: the fracture occurred near the body-stem junction, precisely where the stem diameter tapers. The fracture lines were transverse, indicative of a high bending moment acting at this junction, ultimately resulting in this catastrophic failure [11-14] (Table 2).

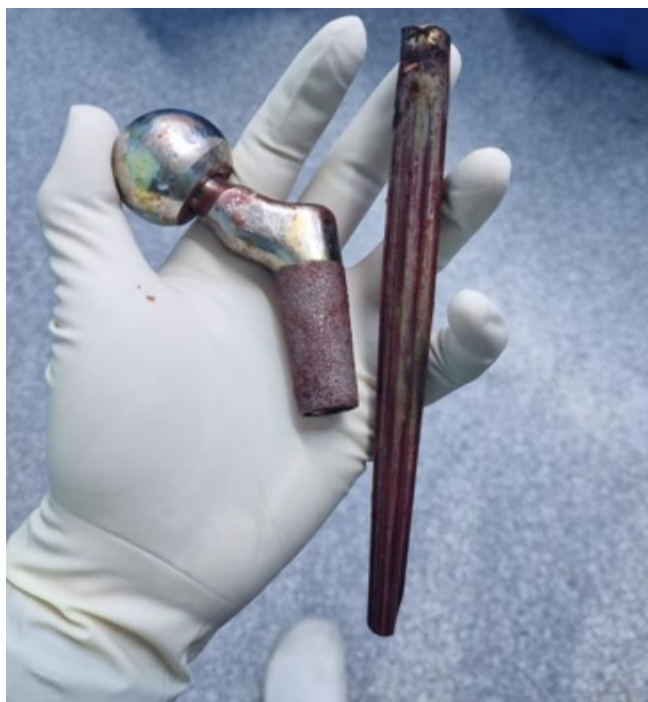
**Figure 4:** Clinical photograph showing the failed Zimmer modular revision stem.

approach was inadequate. Therefore, a diamond-tip drill bit was used to create a precise hole in the stem's taper to enable the insertion of a punch, which allows retrograde hammering. This technique, which was described by Hafez et al., enables easier stem manipulation and prevents further femoral bone loss (9). The failed stem is shown in Figure 4.

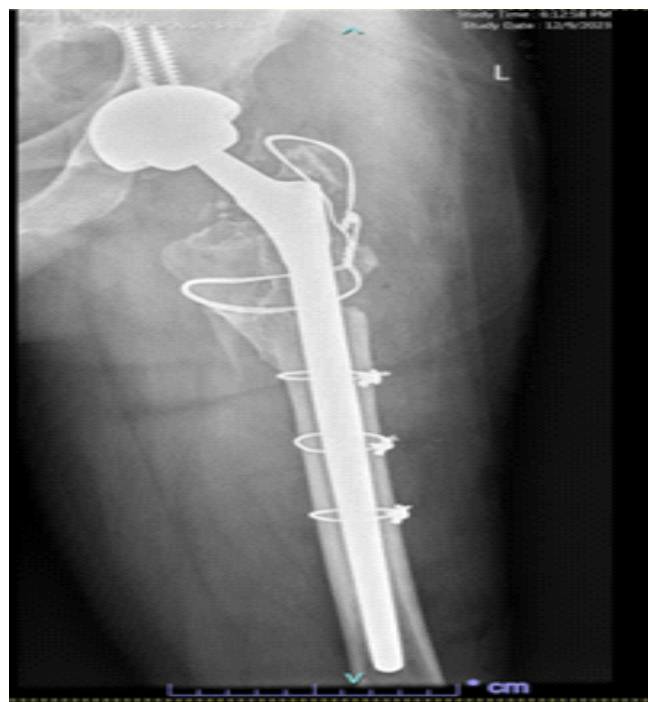
**Figure 5:** Post-operative radiograph demonstrating revision of the failed Zimmer modular revision stem using a monoblock, non-modular femoral component (Wagner SL Revision, length 305, diameter 16 mm).

After thorough irrigation and bone preparation, a nonmodular Zimmer Wagner stem SL (size 16 mm diameter, 305 mm length) was implanted, ensuring a proper femoral anteversion. A reinforcement of the construct with multi-level cerclage wiring was applied, later followed by insertion of a ceramic head (size 52 mm, offset +0 mm) coupled with a new polyethylene liner (Fig. 5).

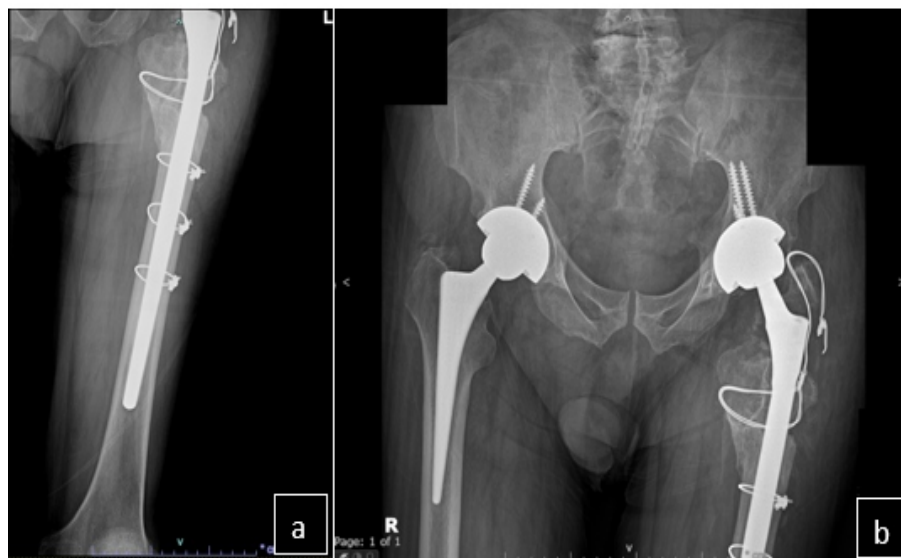
**Figure 6:** (a and b) Follow up left femur and pelvis AP radiographs, showing the revision using a Wagner SL stem remains well-fixed along with the cables and wires.

weight bearing for 6 weeks. The patient was discharged on post-operative day 4 with no recorded complications. An outpatient X-ray 3 months after the surgery is shown in Fig. 6a and 6b.

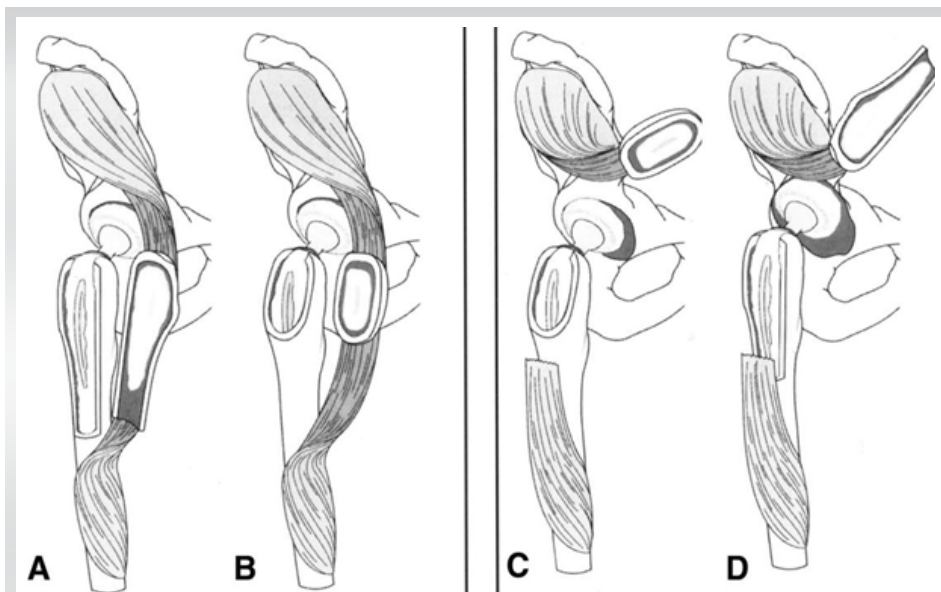
**Figure 7:** Sliding and conventional versions of the trochanteric osteotomy. (a) Extended slide; (b) simple slide; (c) conventional osteotomy; (d) extended conventional [25].

On review of the radiographs, all cases exhibited some degree of proximal femoral bone deficiency. This was mainly due to prior surgical interventions – most cases involved femoral osteotomies (10 out of 12) (Fig. 7 is showing various types of trochanteric osteotomies), with six reported as extended trochanteric osteotomies and four classified as standard trochanteric osteotomies. The type of osteotomy was determined based on radiographic evaluation, specifically the position of cerclage and/or cable wires, as not all the original articles specify the technique. It was not possible to distinguish whether a sliding or conventional osteotomy was performed in any of the cases. Four cases had persistent greater trochanteric non-unions. Such proximal bone stock deficiency resulted in inadequate support around the stem and contributed to a cantilever effect, intensifying the bending moment on the implant.
