Early Mechanical Dissociation of Helical Blade-Barrel Interface in Proximal Femoral Nail: A Case Report

Rare mechanical dissociation at the helical blade-barrel interface can occur early after PFN fixation even without classical cut-out or infection.

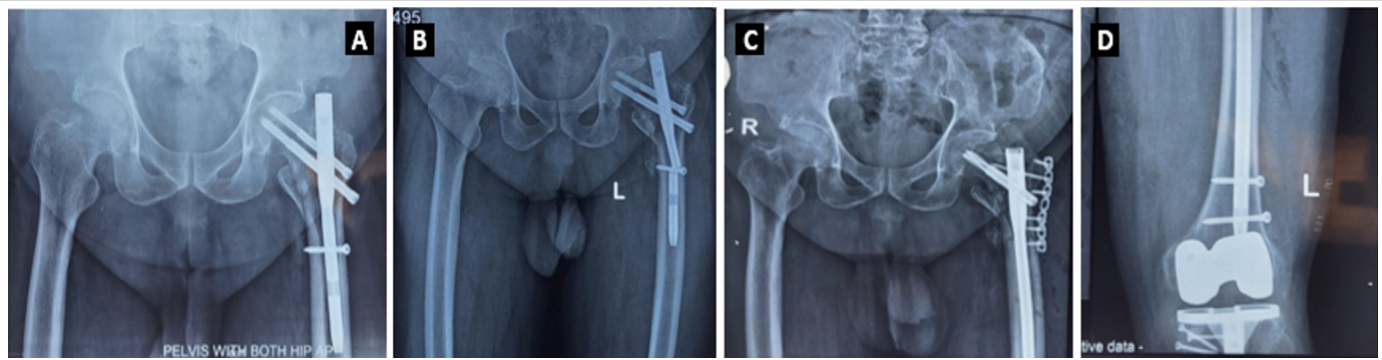
Figure 1: Proximal femoral nail done for intertrochanteric fracture (a); broken nail (b); revised with proximal femoral nail anti-rotation Asia 2 with helical blade and supported by lateral plate (c); distal locking showing prior total knee replacement (d).

A 62-year-old male presented with complaints of pain in the left hip region. He had previously sustained a left-sided IT femur fracture (AO/OTA type 31-A2), for which he underwent fixation with a short PFN at an outside institution. The patient had a history of bilateral total knee replacement performed 8 months prior and comorbidities including Type 2 diabetes mellitus and hypertension, both medically managed. At presentation, clinical and radiographic evaluation revealed implant failure in the form of PFN nail breakage (Fig. 1a and b), which was considered the probable time point of failure. The patient subsequently underwent revision surgery at our center with removal of the broken implant and fixation using a long PFN construct with a helical blade, augmented with an additional lateral support plate (Fig. 1c and d). Postoperatively, he was mobilized with partial weight bearing using a walker.

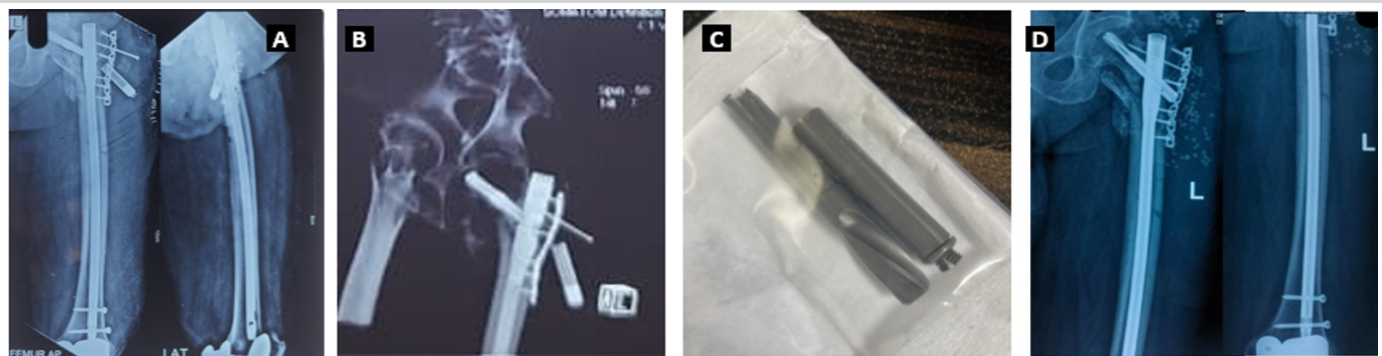
mechanical disengagement of the barrel component from the helical blade within the PFN assembly (Fig. 2a), suggestive of failure at the blade-barrel interface rather than classical cut-out or migration. Clinically, there was exposure of the barrel through the previous surgical incision, associated with serosanguinous discharge, without systemic signs of infection. To further delineate the implant failure and assess the fracture-implant relationship, a three-dimensional computed tomography scan was performed. The imaging confirmed dissociation of the barrel from the helical blade, with the blade remaining in situ within the femoral head and no evidence of intra-articular penetration or significant osteolysis (Fig. 2b).

Figure 2: Disengagement of the helical blade from its barrel seen on X-ray (a); Computed tomography scan (b); removed helical blade and barrel (c); revised blade with plate construct with antibiotic stimulants (d).

In contrast to these well-described mechanisms, the present case demonstrates a rare and distinct mode of failure involving dissociation at the helical blade-barrel interface. Unlike classical cut-out or back-out, the helical blade in this case remained in situ within the femoral head, while the barrel component disengaged from the nail assembly. This indicates a failure of the internal locking mechanism rather than failure at the bone-implant interface.

The early onset of failure in our case, occurring within 3 weeks of revision surgery, suggests a primary mechanical issue rather than fatigue-related failure. Possible mechanisms include incomplete locking of the blade during insertion, manufacturing defects, or micro-motion at the interface leading to progressive loosening under cyclic loading conditions. Importantly, infection was ruled out in this case by sterile microbiological cultures and absence of intraoperative purulence, further supporting a purely mechanical etiology.

The patient subsequently underwent revision surgery. Intraoperatively, the dissociated components were removed (Fig. 2c), and a new helical blade was inserted with restoration of the locking mechanism under fluoroscopic guidance. Post-operative radiographs confirmed satisfactory implant positioning (Fig. 2d).

Thorough wound debridement and excision of the sinus tract were performed, and local antibiotic delivery was achieved using calcium sulfate. There was no evidence of purulence or deep infection intraoperatively, and bone quality was considered suboptimal without significant osteolysis. Microbiological cultures obtained intraoperatively were sterile, and histopathological examination did not reveal any evidence

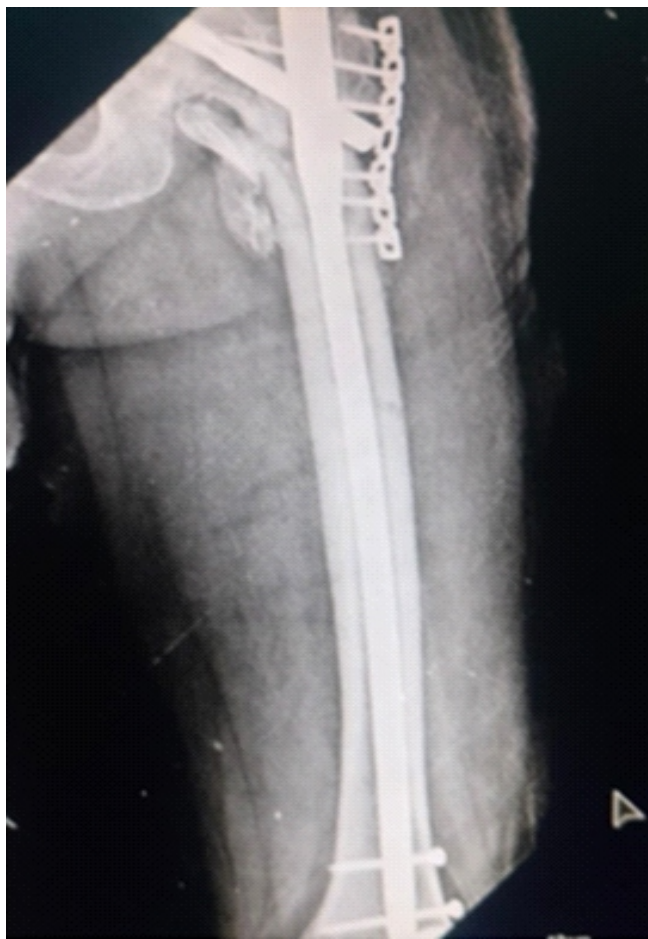
Figure 3: Implants in place and union in progress.

of active infection, supporting a mechanical etiology of failure. The post-operative course was uneventful, with satisfactory implant positioning confirmed on radiographs. The patient was advised strict non-weight bearing for 6 weeks along with supervised physiotherapy. At 3 months follow-up, the patient demonstrated complete clinical recovery with satisfactory functional outcome (Fig. 3)
