# Medial Malleolar Screw Fixation Causing Flexor Hallucis Longus Impingement: A Rare Case of Checkrein Deformity

Even minimal prominence of medial malleolar screws can cause mechanical impingement of the flexor hallucis longus tendon, leading to checkrein deformity; early dynamic imaging enables diagnosis and successful treatment through simple hardware removal.

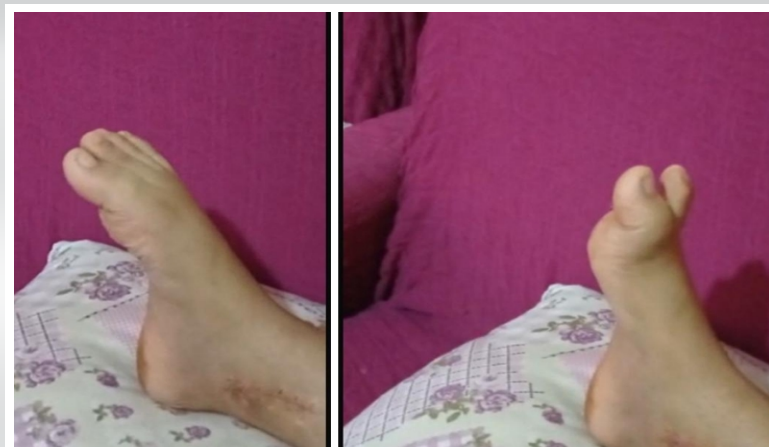
**Figure 3:** Checkrein deformity in the patient, which resolved during plantar flexion but appeared during dorsiflexion after cast removal at the 1-month follow-up.

At the 1-month follow-up, after cast removal, the patient reported an abnormal motion of the great toe. During ankle dorsiflexion, the hallux developed a flexion deformity and could not return to neutral; this deformity resolved completely during plantar flexion (Fig. 3).

The patient experienced discomfort while walking, though ankle and lesser toe motion remained normal in the neutral position.

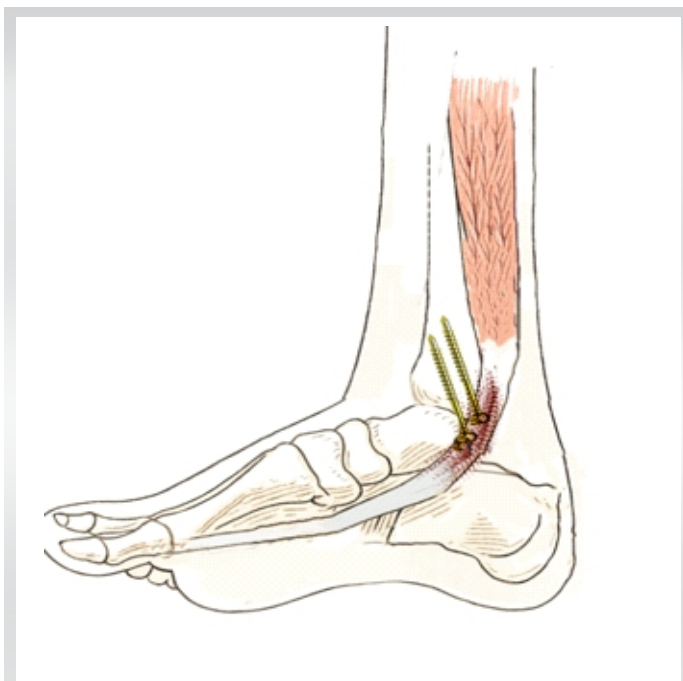
Dynamic ultrasonography was performed to identify the cause of this phenomenon. The examination revealed impingement of the FHL tendon beneath the medial malleolar screws, producing mechanical compression during ankle motion. No peritendinous adhesions, fibrosis, or tendon rupture were observed. These findings confirmed a diagnosis of FHL impingement-induced checkrein deformity (Fig. 4).

**Figure 4:** Schematic illustration showing flexor hallucis longus tendon impingement beneath the medial malleolar screws during dorsiflexion.

In contrast, the present case demonstrates a purely mechanical cause of checkrein deformity, where the FHL tendon was directly compressed by the medial malleolar screws used for fixation. Dynamic ultrasonography allowed real-time

Immediate resolution of the deformity following screw removal further supports the mechanical nature of the problem and highlights the importance of understanding tendon anatomy and movement during surgical planning. Even minimal prominence or malposition of medial malleolar screws can result in tendon irritation or compression.

Based on the imaging findings, hardware removal was planned to relieve the mechanical restriction. Under spinal anesthesia, both medial malleolar screws were removed through the previous incision. Intraoperative assessment showed immediate correction of the deformity when the ankle was dorsiflexed, confirming the mechanical nature of the impingement. No additional soft-tissue release was required. Postoperatively, the patient began early range-of-motion and strengthening exercises for the ankle and great toe. At 6 weeks after screw removal, full, pain-free movement of the hallux and ankle had been restored, with no recurrence of deformity. At the 6-month follow-up, the patient had returned to all daily activities without any functional limitations or discomfort.
