# A Case of Catastrophic Failure of Tibial Component with Extensive Metallosis Following Total Knee Arthroplasty: A Case Report

**Case Report:** A 72-year-old woman who had undergone bilateral primary TKA in 2008 developed extensive metallosis after a twisting injury to the right knee in 2021, resulting in pain, swelling, and a progressive varus deformity. In September 2023, following a fall, she experienced acute pain and was found to have loosening of the prosthesis secondary to metallosis. Radiographs showed a loose tibial component with significant wear, and the "cloud and bubble sign" characteristic of metal-induced synovitis. After infection was excluded, a one-stage revision was performed using a cemented semi-constrained modular knee system. Surgery revealed severe synovial staining, metal debris, and extensive wear of the tibial base plate; the components were removed and the joint reconstructed with a constrained condylar prosthesis.

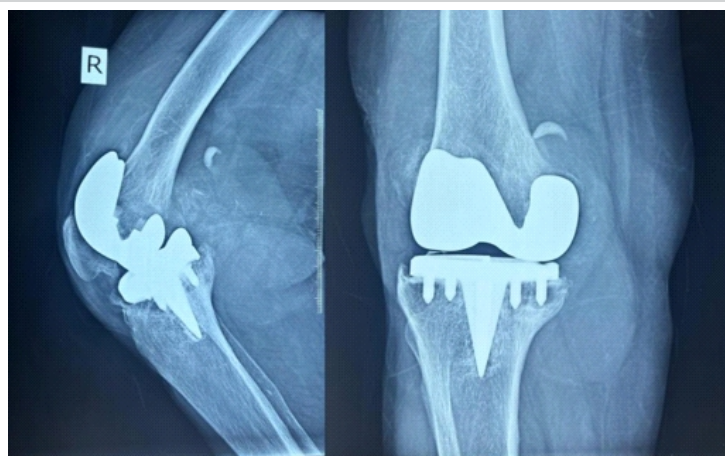
**Figure 1:** Anteroposterior and lateral radiographs of the right knee showing significant wear of the tibial component on the medial side after complete degradation of the polyethylene inlay.

Radiographs revealed osteolysis affecting both the femur and tibia, with loosening of the tibial component. Amorphous, fluffy areas of increased density were seen within the periprosthetic soft tissues, along with bubble-like radiodensities outlining the supra- and retro-patellar capsule – findings characteristic of the ‘cloud and bubble sign’ associated with metallosis. A thin rim of linear increased density was also noted surrounding the infra- and retro-patellar regions. These imaging findings were consistent with advanced metallosis. Significant wear of the tibial component on the medial side was evident, occurring after complete wear-through of the medial polyethylene inlay (Fig. 1).

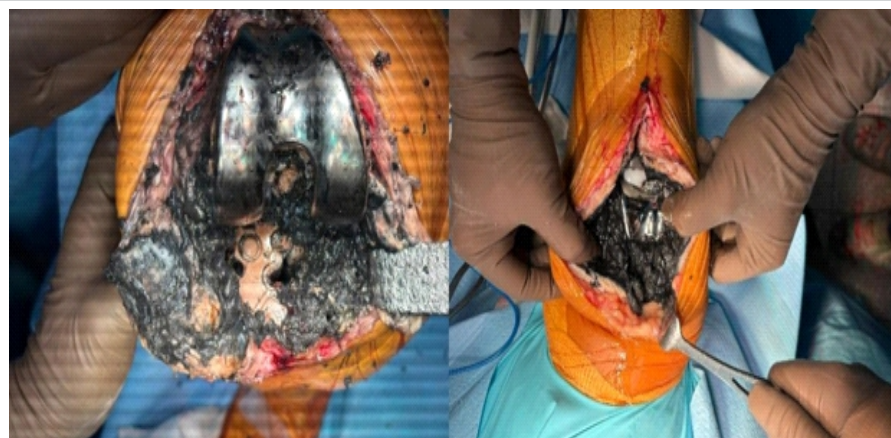
A diagnosis of metallosis-induced prosthetic loosening was confirmed, and a one-stage TKA revision was performed using a cemented semi-constrained modular revision knee system (Zimmer Legacy constrained condylar knee [CCK]). Intraoperatively, extensive black staining was observed in the synovium, joint fluid, and surrounding soft tissue (Fig. 2). Thorough debridement and lavage were performed. Significant wear of the medial tibial tray was noted following complete

**Figure 2:** Intraoperative photograph showing extensive black staining of the synovium, joint fluid, and surrounding soft tissue, consistent with metallosis.

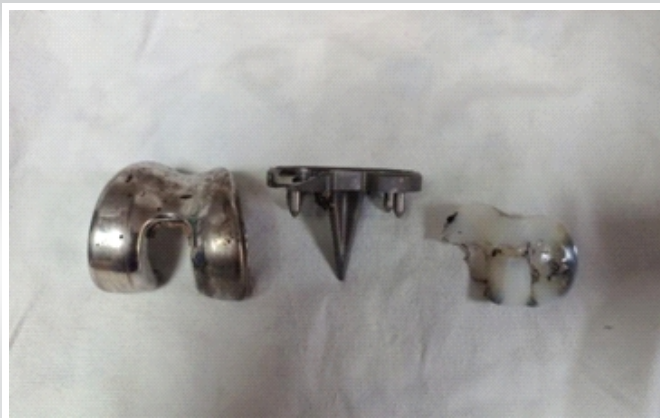
**Figure 3:** Intraoperative photograph showing significant wear of the medial part of the tibial tray and polyethylene inlay.

wear-through of the medial polyethylene inlay (Fig. 3). The components were removed using osteotomies; the femoral component showed aseptic loosening with severe distal femoral osteolysis, and there was significant bone loss posteriorly on the femur with metal fragments in the region of the femoral canal. Abnormal tissue was excised, and bone and soft-tissue samples were sent for histopathological and microbiological analysis. Residual cement was removed, and revision TKA was performed using press-fit diaphyseal stems and a constrained component with tibial wedges to reconstitute bone loss and restore the jointline (Fig. 4).
