# Early Post-operative Fracture of Titanium Cementless Tibial Baseplate: Case Report and Review of the Literature

**Case Report:** Here, we report a 70-year-old female with a case of early fracture of the tibial component in a cementless, highly porous titanium-coated baseplate (Triathlon Tritanium, Stryker Orthopaedics), occurring within 20 months of the index procedure. Our case was successfully managed with a cemented tibial cone and stem construct; however, the etiology of failure remains uncertain.

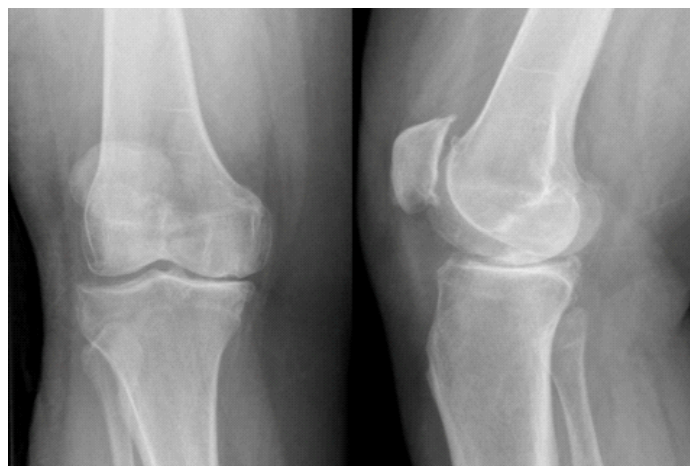
**Figure 1:** Pre-operative anteroposterior and lateral radiographs of the right knee obtained 1 month before the patient undergoing total knee arthroplasty.

on post-operative day 1 (Fig. 1 and 2). We are not able to determine the degree of varus/valgus deformity pre-operatively, as full-length standing radiographs were not obtained at her original surgery. In the immediate post-operative period, her tibial component was in 3° of varus, femoral component was in 4° of varus, and tibial slope was 3° of posterior slope on short Anteroposterior and lateral radiographs (Fig. 2). The patient had a medical history notable for obesity (body mass index [BMI] 40.77 kg/m<sup>2</sup>), type 2 diabetes mellitus (hemoglobin A1C 6.1%), hypertension, hyperlipidemia, obstructive sleep apnea, chronic obstructive pulmonary disease, non-ST segment elevation myocardial infarction, and prior aortic valve replacement. One month post-operatively, she began to develop sharp right knee pain with ambulation and was referred to pain management. Her radiographs at that time did not show any clear signs of implant failure, and she was referred to pain management after unrevealing radiographic and infectious workups (Fig. 3). Over the course of the next year, she experienced progressively worsening medial knee pain preventing full weight-bearing. She presented for a second opinion to our institution 20 months post-operatively and was found to have catastrophic failure of the polyethylene insert and a fractured tibial baseplate (Fig. 4); she was indicated for revision surgery.

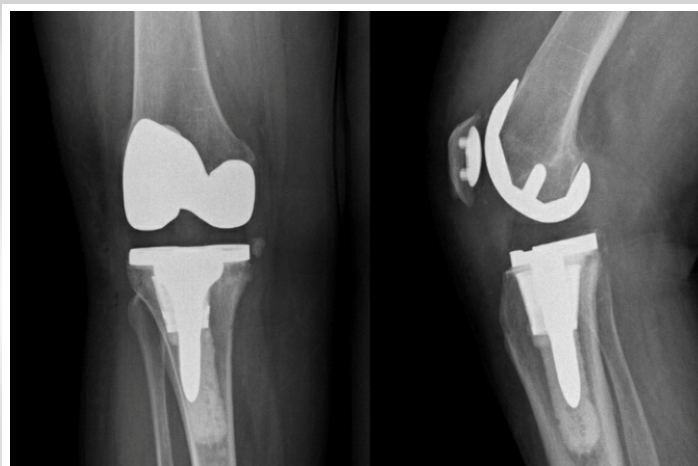
**Figure 5:** Anteroposterior and lateral radiographs taken post-operatively demonstrating revision of tibial baseplate with retention of femoral and patellar components.

a combination of an oscillating saw and flexible osteotomes. Due to some bone loss following extraction of the primary baseplate, along with her body weight and relative osteopenia, a press-fit cone and short, fully cemented tibial stem construct were used for additional fixation (Stryker Triathlon Revision Knee System; Stryker Corporation, Kalamazoo, MI) (Fig. 5). Intraoperative cultures taken were ultimately negative for any signs of infection. She had no complications in the post-operative period. At her most recent follow-up, approximately 3.5 years after surgery, she was ambulating using a cane outdoors or without assistive devices around the house with resolution of her pre-operative pain.
