Unusual Case of Failure of Tibial Polyethylene Insert Locking Mechanism in a Design of Cruciate Retaining Total Knee Arthroplasty – A Case Report

Chandan Mehta¹, Mohan Madhav Desai¹, Kushagra Jain¹, Urvil Shah¹

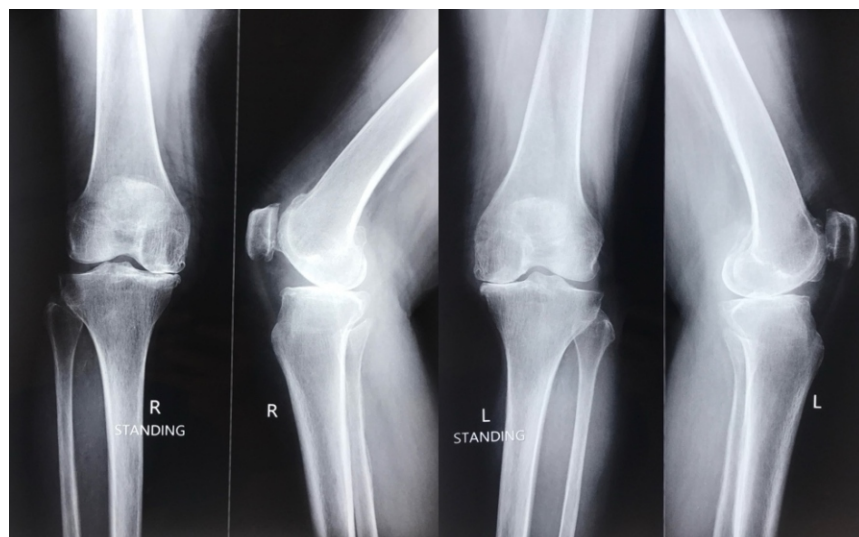
Figure 1: Pre-operative right and left knee radiographs. Pre-operative radiographs showing bilateral tricompartmental osteoarthritis of the knee.

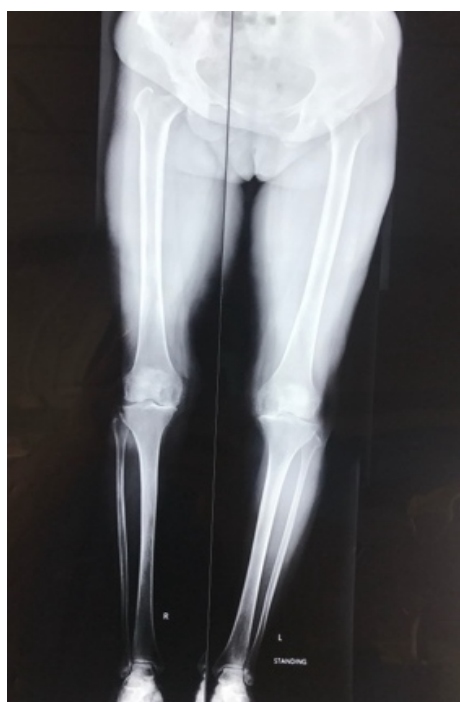
Figure 2: Pre-operative bilateral lower limb standing scannogram.

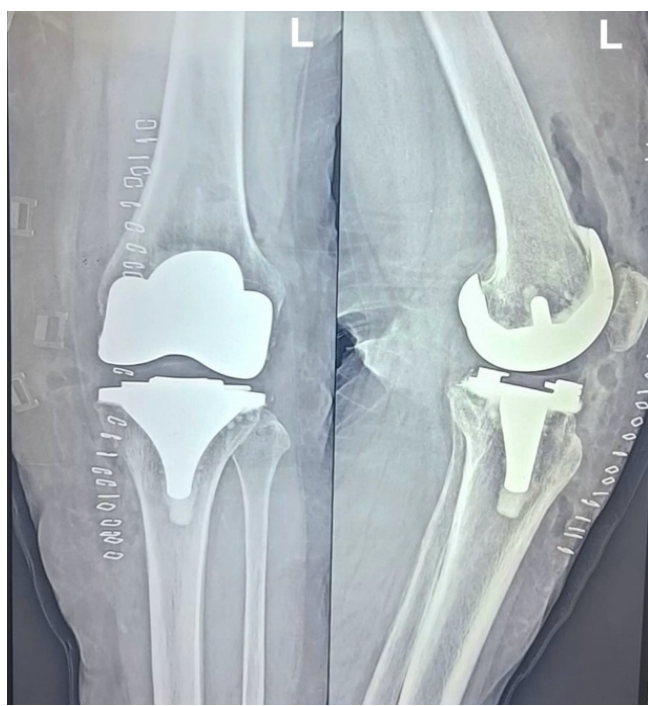
Figure 11: Immediate post-operative radiograph.

Figure 10: Anterior stabilized (deep dish) polyethylene insert. Substitution of cruciate retaining polyethylene insert with anterior stabilized polyethylene insert of 10 mm thickness and reducing tibia back on femur.
