# Retrieval of a Broken Cannulated Drill Bit from the Femoral Neck during Proximal Femoral Nailing: Case Report of a Novel Lever Technique Using a Depth Gauge

**Case Report:** We describe the case of a male patient in his mid-sixties who sustained a left intertrochanteric femur fracture and underwent proximal femoral nailing (PFN). During reaming for the compression screw, an 8 mm cannulated drill bit fractured and became lodged within the femoral neck over the guide wire. A novel lever technique using a standard PFN-set depth gauge was employed. The hooked tip of the depth gauge was passed through the lumen of the broken cannulated drill bit under fluoroscopic guidance. The instrument was then rotated so that the hook faced medially, and the external arm was levered laterally away from the limb to engage the hook firmly against the medial wall of the broken fragment. Gentle traction successfully retrieved the drill bit, allowing completion of fracture fixation with a new drill bit in the optimal tip-apex position.

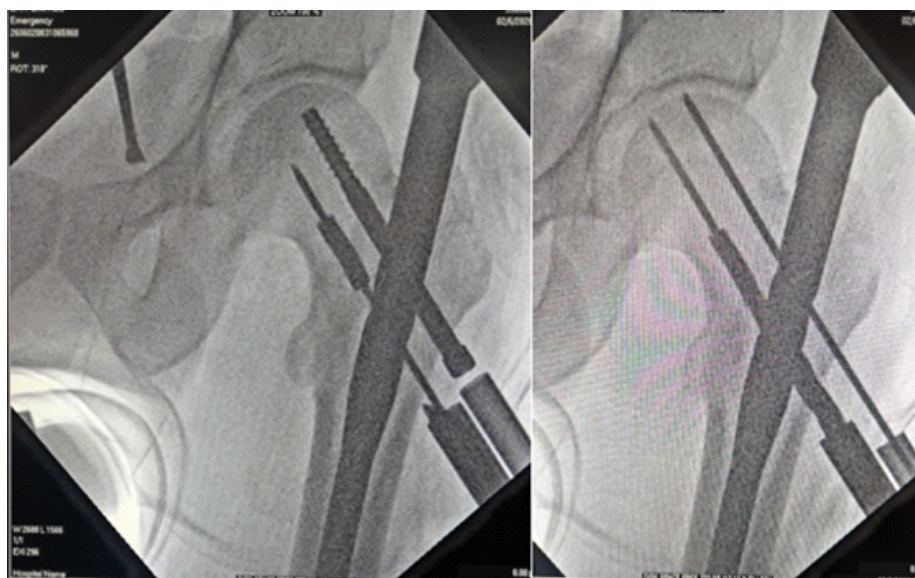
**Figure 1:** Fractured drill bit at mid-shaft, leaving the distal portion lodged within the reamed canal in the femoral neck. Intraoperative fluoroscopic image showing the fractured 8-mm cannulated drill bit with the distal fragment lodged within the femoral neck during proximal femoral nailing. The retained fragment lies along the compression-screw trajectory and necessitates retrieval to permit optimal implant positioning.

The patient was positioned in hemilithotomy position on a fracture table. Closed reduction was achieved under fluoroscopic guidance. The intramedullary nail was inserted through a standard trochanteric entry point, and two guide wires were placed into the femoral neck and head using the targeting jig and biplanar fluoroscopic confirmation. During reaming over the inferior (compression) guide wire with an 8 mm cannulated drill bit, the drill bit fractured at mid-shaft, leaving the distal portion lodged within the reamed canal in the femoral neck (Fig. 1).

Retrieval of the broken fragment was necessary before proceeding, as its position directly obstructed placement of the compression screw at the desired TAD. Leaving it in situ would have necessitated a significantly suboptimal screw trajectory, increasing the risk of fixation failure.

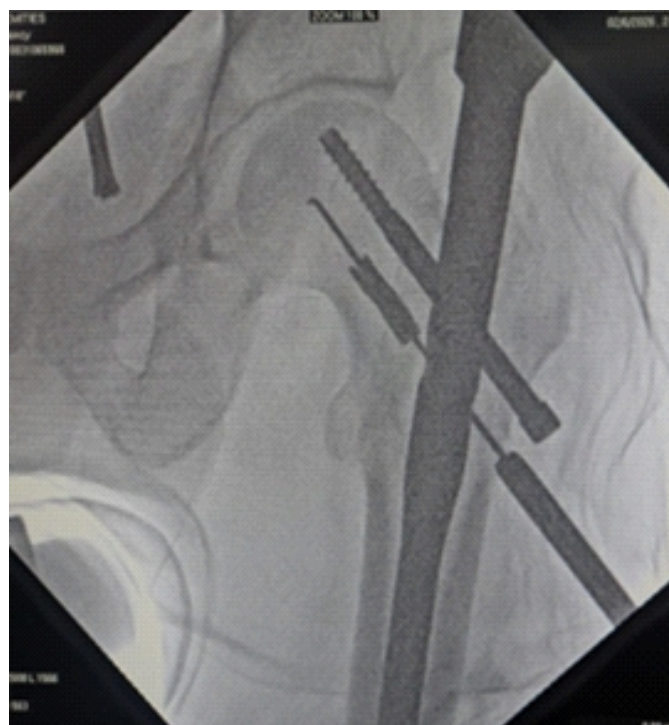
**Figure 2:** Engaging depth gauge with the broken drill bit. Intraoperative fluoroscopic images demonstrating advancement of the hooked depth gauge through the cannulation of the retained broken drill bit. The hooked tip is passed beyond the distal end of the fragment under fluoroscopic guidance and rotated axially so that its hooked tip was oriented to face medially and to facilitate mechanical engagement.

rotated axially so that its hooked tip was oriented to face medially.

Under continuous fluoroscopic guidance, the depth gauge was carefully advanced through the reamed canal and through the cannulation of the broken drill bit until its hooked tip emerged from the far (medial) end (Fig. 2). The depth gauge was then

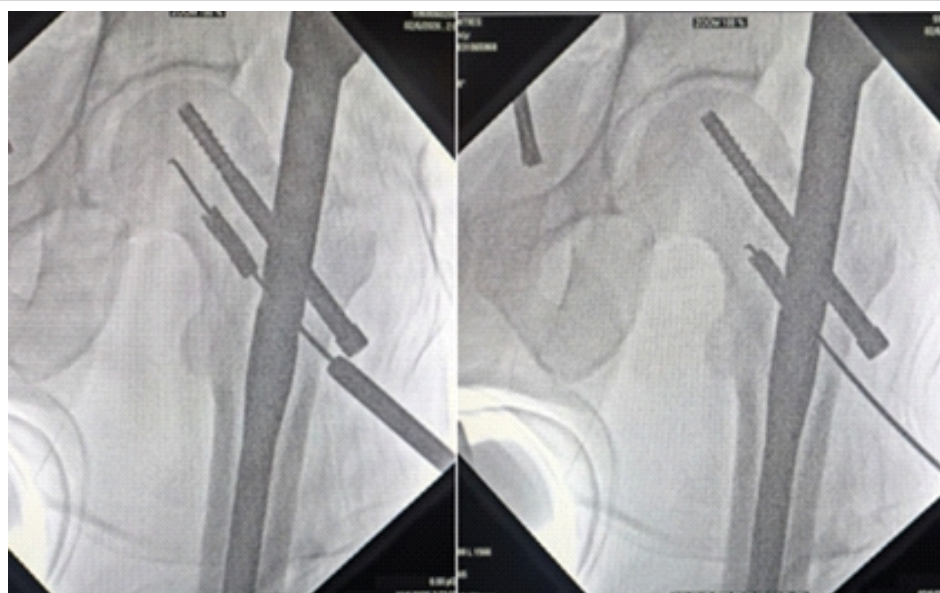
**Figure 3:** Performing the lever maneuver with depth gauge. Intraoperative fluoroscopic images demonstrating the depth-gauge lever maneuver used for retrieval of the broken drill-bit fragment. The hooked tip is engaged with the inner surface of the fragment, allowing controlled extraction through the proximal femoral nail.

The key technical step – the lever maneuver – was then performed: While maintaining the hooked tip in its medial orientation, the proximal (external) arm of the depth gauge was levered firmly in the lateral direction, away from the limb (Fig. 3). This created a lever-arm effect that drove the hooked distal tip against the medial wall of the broken drill bit, establishing firm mechanical engagement with the inner surface of the fragment.

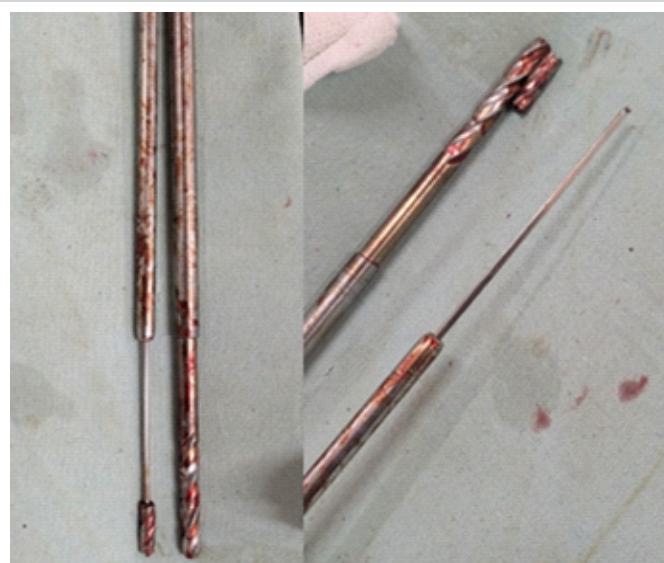
**Figure 4:** Intraoperative picture of broken drill bit post-retrieval. Intraoperative photograph demonstrating the retrieved broken 8-mm cannulated drill bit alongside the depth gauge used for its extraction. The intact cannulated drill bit is shown for comparison.

Fluoroscopic confirmation of hook engagement was obtained before applying steady, axial traction along the instrument axis. The broken 8 mm cannulated drill bit was retrieved in its entirety through the nail locking hole without any additional soft tissue dissection or cortical disruption (Fig.

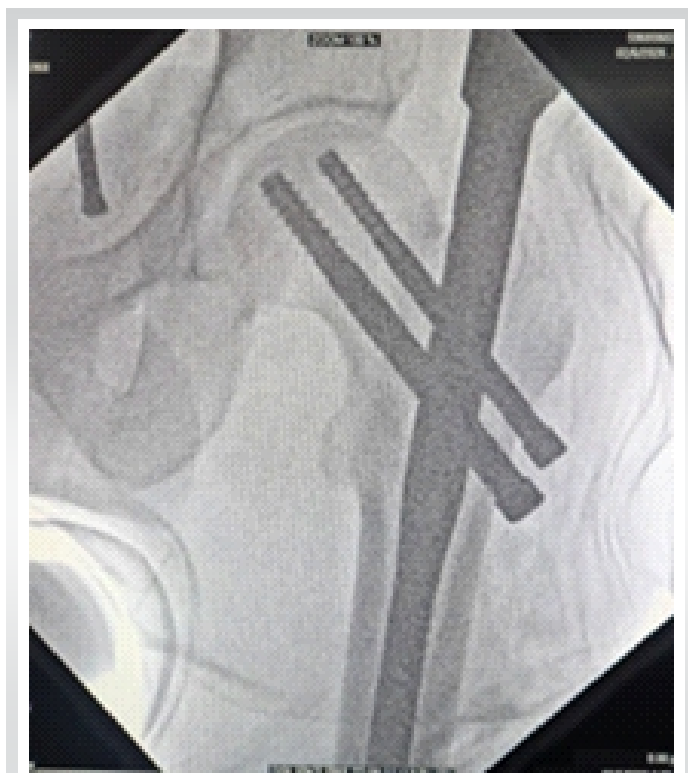
**Figure 5:** Final intraoperative C-arm image of completed procedure post-retrieval. Intraoperative fluoroscopic image following retrieval of the broken drill bit, demonstrating restoration of the compression-screw trajectory and satisfactory positioning of the proximal femoral nail and cephalon-cervical screws.

The guide wire was reinserted over the original trajectory, the canal was reamed with a new 8 mm cannulated drill bit, and the compression screw was placed in the optimal central-inferior position with a TAD of <25 mm (Fig. 5). The remainder of the procedure was uneventful.
